**COM PROJ. NO. 100.21.019
SEAWALL REPAIR (INSPECTION PROJECT)
FINAL FINDINGS/ASSESSMENT REPORT**

The City of Mandeville
1100 Mandeville High Blvd.
Mandeville, LA 70471

Prepared by
BURK-KLEINPETER, INC.
4176 Canal Street
New Orleans, LA 70119

APRIL 2023

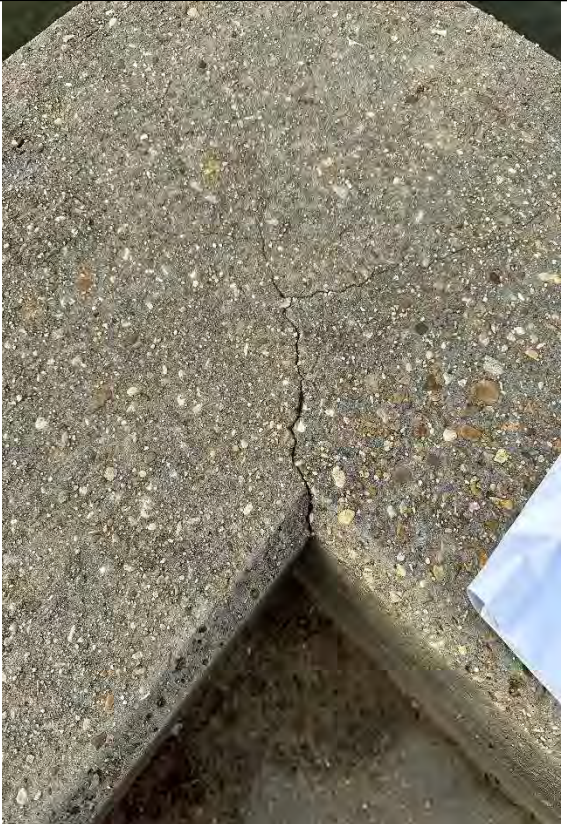
<p>Photo Name: IMG_0048 Inspection Field Notes Photo # : 2 Date: 12-12-2022 Approximate Station: Station 09+57 Description: Horizontal Crack in Corner of Cap Coordinates: Latitude: 90 ; 4 ; 58.03 Longitude: 30 ; 21 ; 35.0099</p>

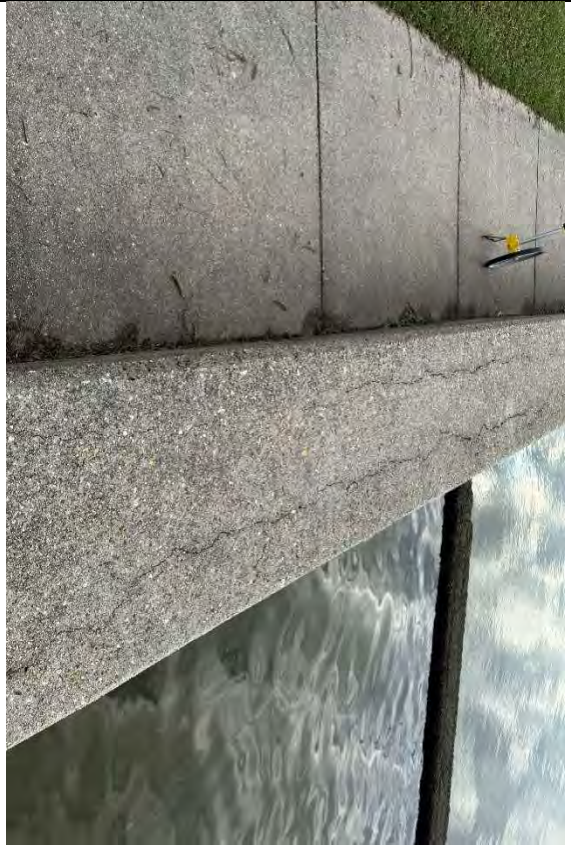
<p>Photo Name: IMG_0049 Inspection Field Notes Photo # : 3 Date: 12-12-22 Approximate Station: Station 1+13 to 1+23 Description: Horizontal cracks that are reflective of sheet pile Coordinates: Latitude: 30 ; 21 ; 34.97 Longitude: 90 ; 4 ; 57.84</p>

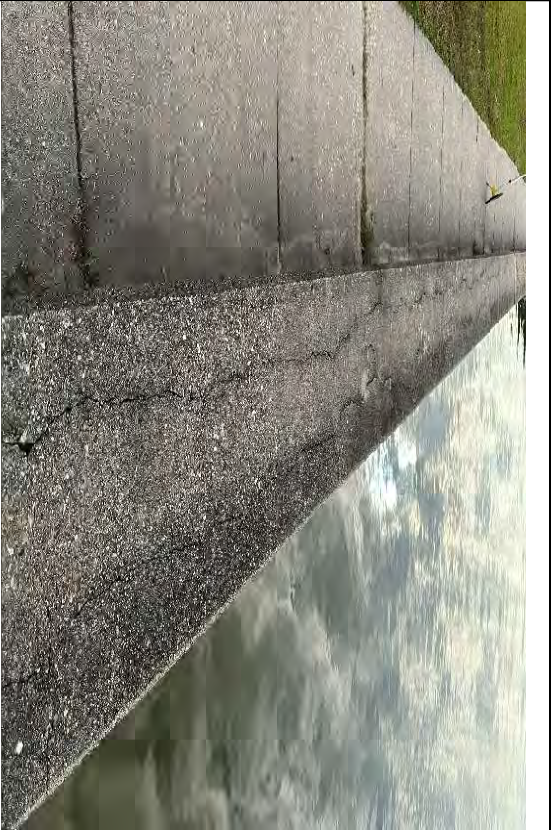
<p>Photo Name: IMG_0050 Inspection Field Notes Photo # : 3 Date: 12-12-2022 Approximate Station: Station 1+13 to 1+23 Description: Horizontal cracks that are reflective of sheet pile Coordinates: Latitude: 30 ; 21 ; 34.77 Longitude: 90 ; 4 ; 57.45</p>

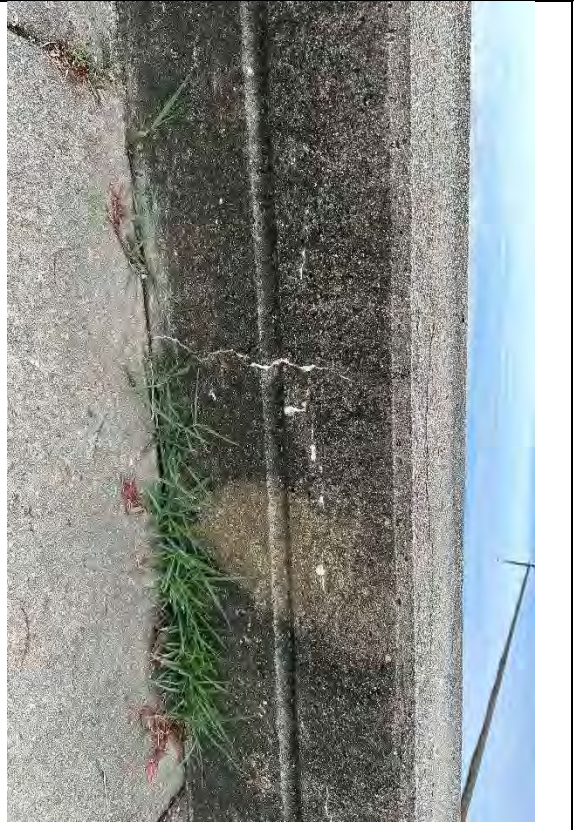
<p>Photo Name: IMG_0051 Inspection Field Notes Photo # : 4 Date: 12-12-2022 Approximate Station: Station 1+25 to 1+82 Description: Horizontal and Vertical cracks in the wall Coordinates: Latitude: 30 ; 21 ; 34.7599 Longitude: 90 ; 4 ; 57.45</p>

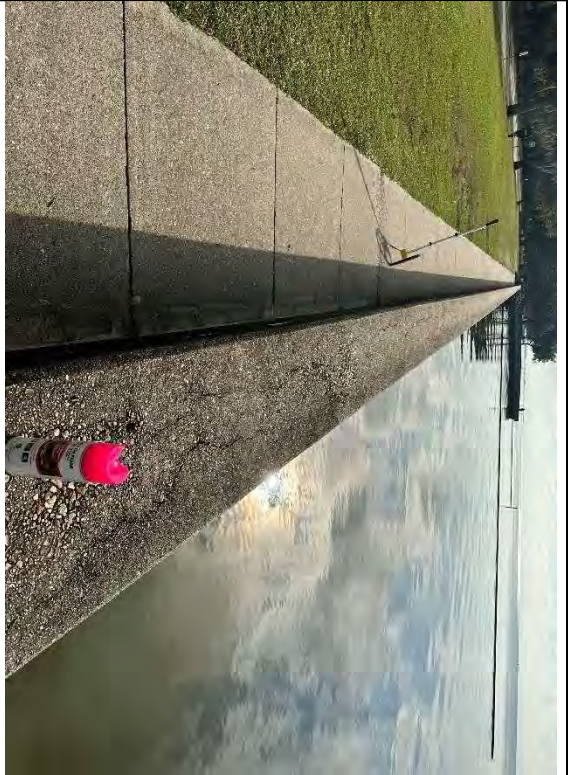
<p>Photo Name: IMG_0055 Inspection Field Notes Photo # : 8 Date: 12-12-22 Approximate Station: Station 1+82 to 2+00 Description: Horizontal cracks and vertical cracks on land face side Coordinates: Latitude: 30 ; 21 ; 34.49 Longitude: 90 ; 4 ; 57.1799</p>
 	<p>Photo Name: IMG_0056 Inspection Field Notes Photo # : 9 Date: 12-12-2022 Approximate Station: Station 2+00 Description: N/A Coordinates: Latitude: 30 ; 21 ; 34.55 Longitude: 90 ; 4 ; 56.9899</p>

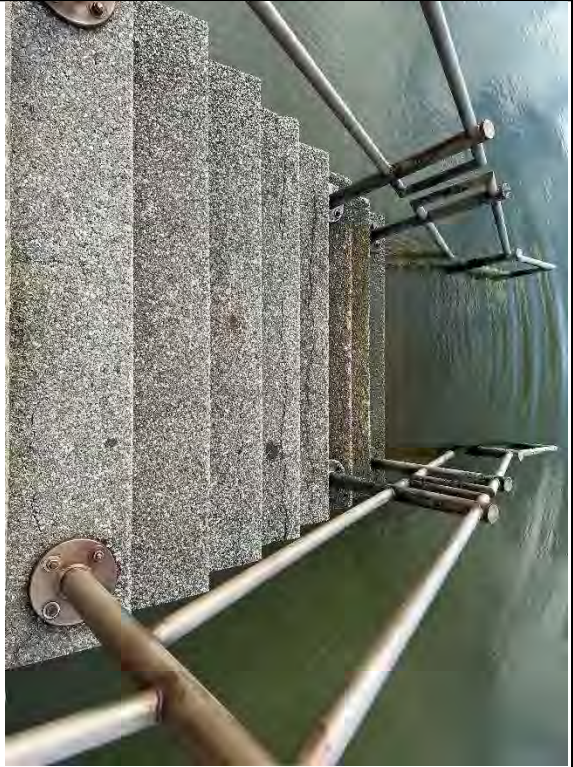
<p>Photo Name: IMG_0061 Inspection Field Notes Photo # : 16 Date: 12-12-22 Approximate Station: Station N/A Description: Stairs with steps 5 through 7 being cracked Coordinates: Latitude: 30 ; 21 ; 33.49 Longitude: 90 ; 4 ; 54.76</p>

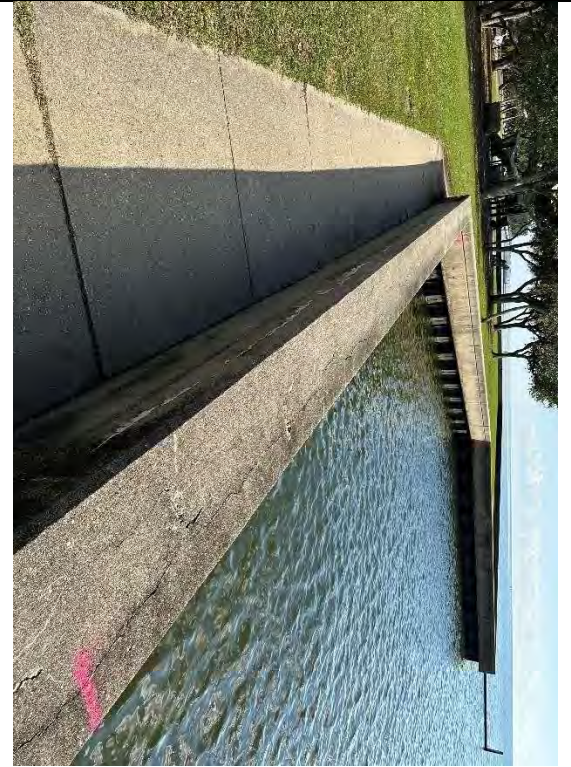
<p>Photo Name: IMG_0066 Inspection Field Notes Photo # : 17 Date: 12-12-22 Approximate Station: Station 4+24 to 4+92 Description: Horizontal and vertical cracks reflective of sheet pile. Land side cracks alongside of cap Coordinates: Latitude: 30 ; 21 ; 33.30 Longitude: 90 ; 4 ; 54.57</p>

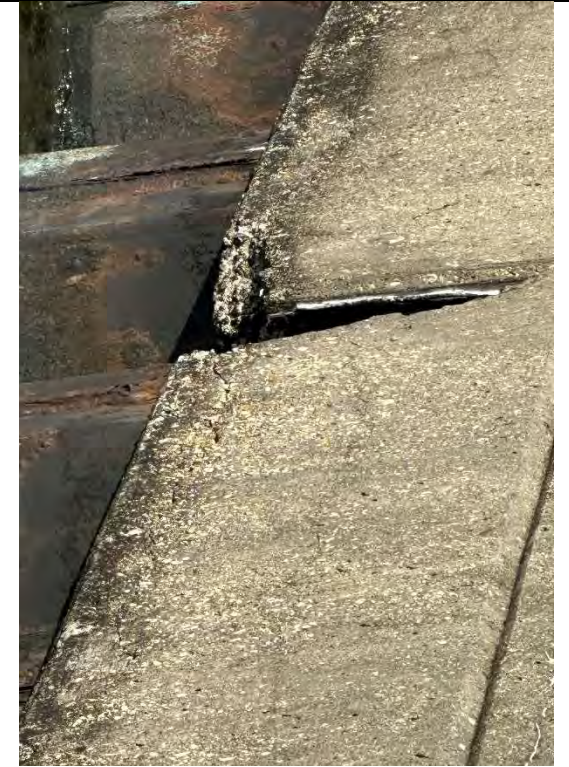
<p>Photo Name: IMG_0068 Inspection Field Notes Photo # : 19 Date: 12-12-22 Approximate Station: Station 4+70 Description: Spall on Lake Side at End joint Coordinates: Latitude: 30 ; 21 ; 32.919 Longitude: 90 ; 4 ; 54.080</p>

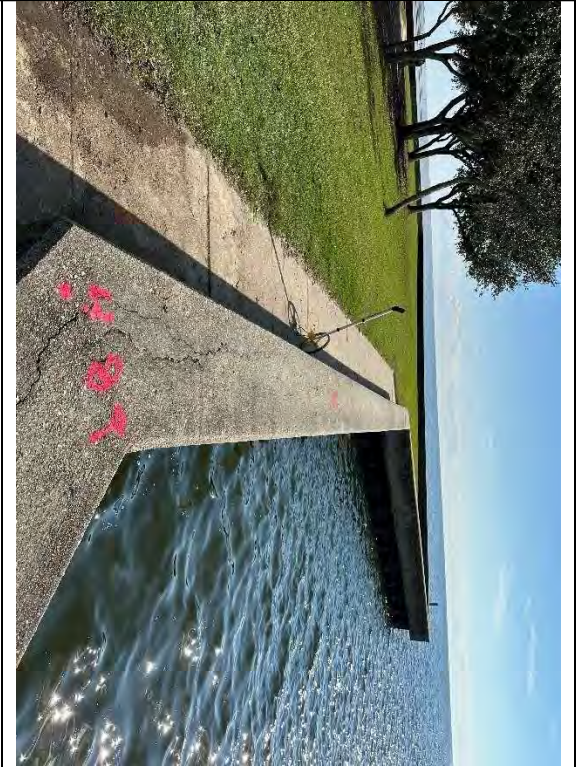
<p>Photo Name: IMG_0069 Inspection Field Notes Photo # : 20 Date: 12-12-22 Approximate Station: Station 4+89 to 5+02 Description: Horizontal cracks reflective of sheet pile. Some vertical cracks along land side of wall face Coordinates: Latitude: 30 ; 21 ; 33.1399 Longitude: 90 ; 4 ; 54.02</p>

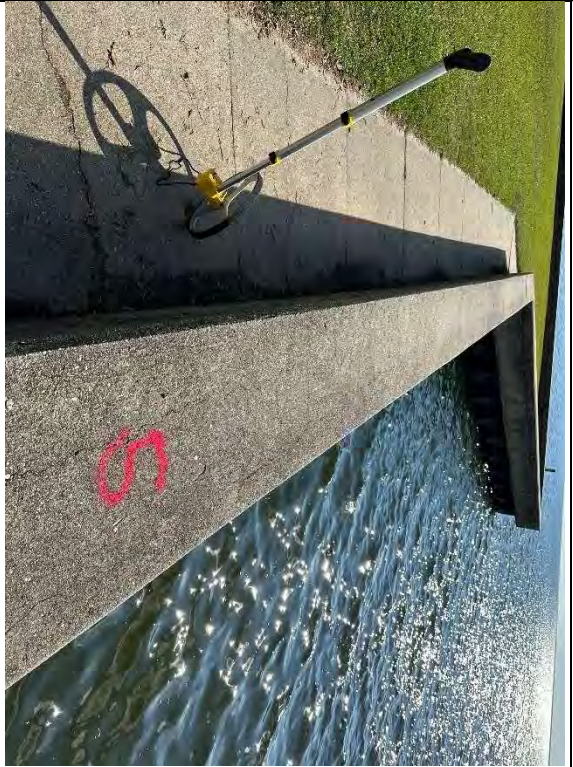
<p>Photo Name: IMG_0070 Inspection Field Notes Photo # : 21 Date: 12-12-22 Approximate Station: Station 5+00 Description: Minor horizontal and vertical surface cracks Coordinates: Latitude: 30 ; 21 ; 32.74 Longitude: 90 ; 4 ; 53.9899</p>

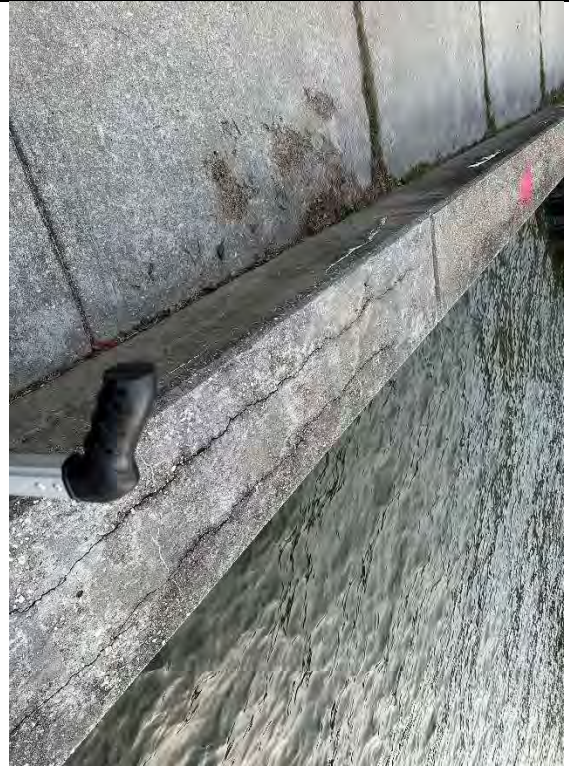
<p>Photo Name: IMG_0076 Inspection Field Notes Photo # : 25 Date: 12-13-22 Approximate Station: Station 6+95 to 7+02 Description: Top of seawall contains horizontal cracks reflective of the sheet pile. Land face side contains horizontal cracks every 10' Coordinates: Latitude: 30 ; 21 ; 31.610 Longitude: 90 ; 4 ; 52.7899</p>

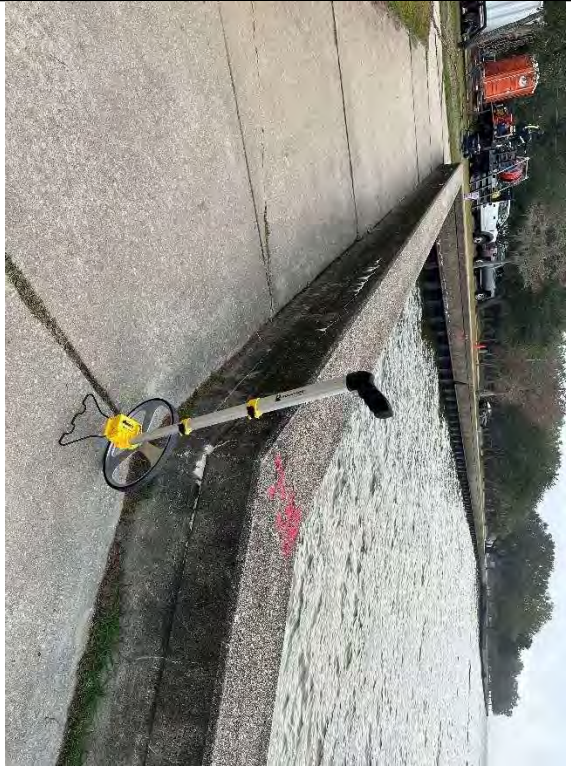
<p>Photo Name: IMG_0077 Inspection Field Notes Photo # : 26 Date: 12-13-22 Approximate Station: Station 7+38 to 7+84 Description: Top of seawall contains horizontal cracks reflective of the sheet pile. Land face side contains horizontal cracks with minor vertical cracks as well Coordinates: Latitude: 30 ; 21 ; 31.9799 Longitude: 90 ; 4 ; 52.900</p>

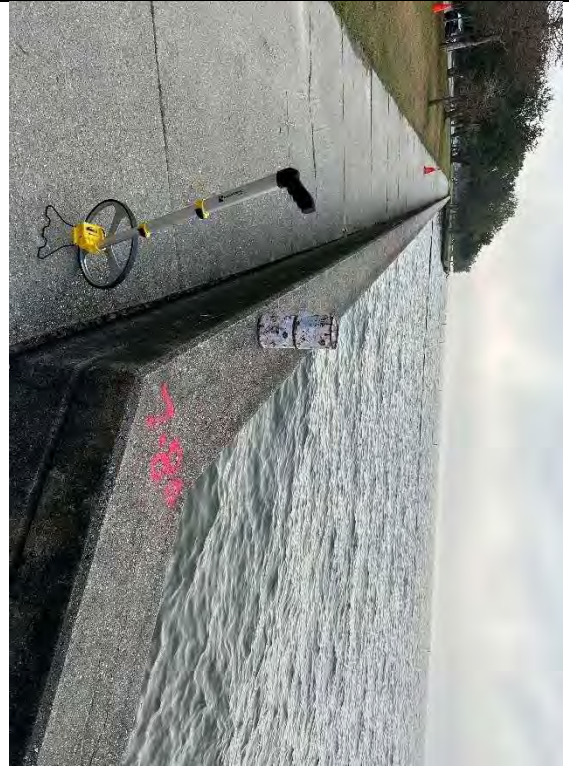
<p>Photo Name: IMG_0078 Inspection Field Notes Photo # : 27 Date: 12-13-22 Approximate Station: Station 7+80 to 8+00 Description: Minor cracks on top of seawall. Horizontal cracks on both land and sea face sides Coordinates: Latitude: 30 ; 21 ; 32.25 Longitude: 90 ; 4 ; 52.400</p>

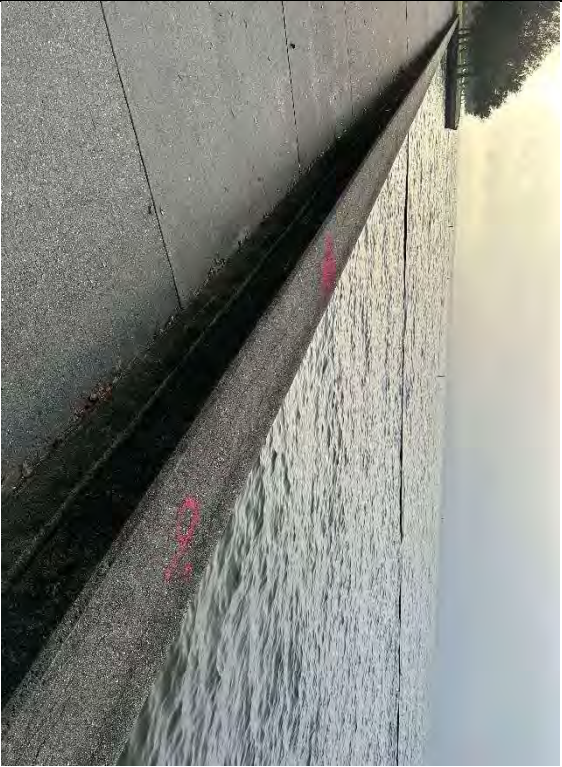
<p>Photo Name: IMG_0080 Inspection Field Notes Photo # : 29 Date: 12-13-22 Approximate Station: Station 8+25 to 9+00 Description: Horizontal cracks on the top of the seawall that is reflective of sheet pile Coordinates: Latitude: 30 ; 21 ; 31.600 Longitude: 90 ; 4 ; 51.19</p>

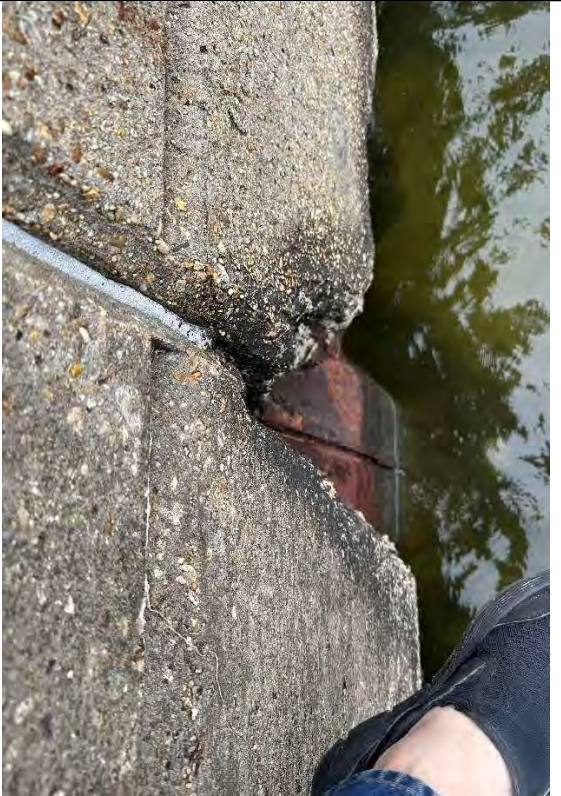
<p>Photo Name: IMG_0083 Inspection Field Notes Photo # : 33 Date: 12-13-22 Approximate Station: Station 11+16 Description: Concrete spall at seaside of expansion joint Coordinates: Latitude: 30 ; 21 ; 30.499 Longitude: 90 ; 4 ; 49.0499</p>

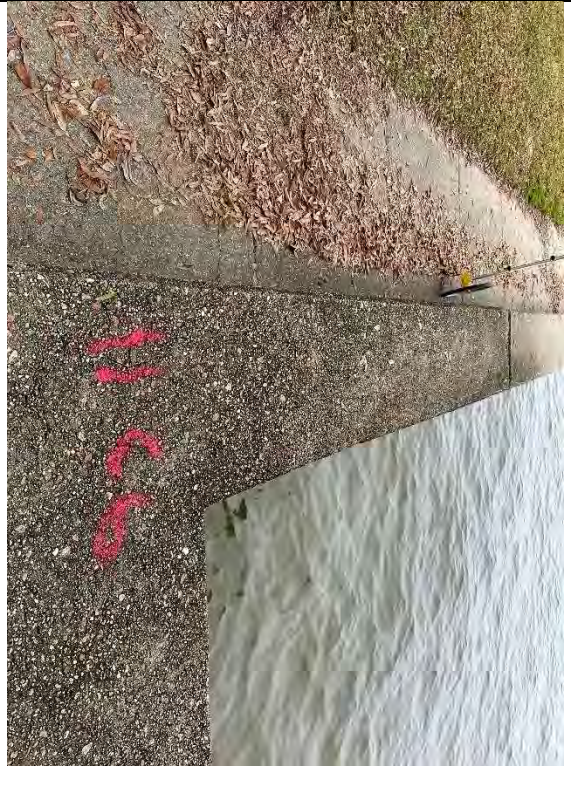
<p>Photo Name: IMG_0084 Inspection Field Notes Photo # : 34 Date: 12-13-22 Approximate Station: Station 11+66 to 11+76 Description: Top of seawall contains horizontal cracks that are reflective of the sheet pile Coordinates: Latitude: 30 ; 21 ; 30.33 Longitude: 90 ; 4 ; 48.4199</p>

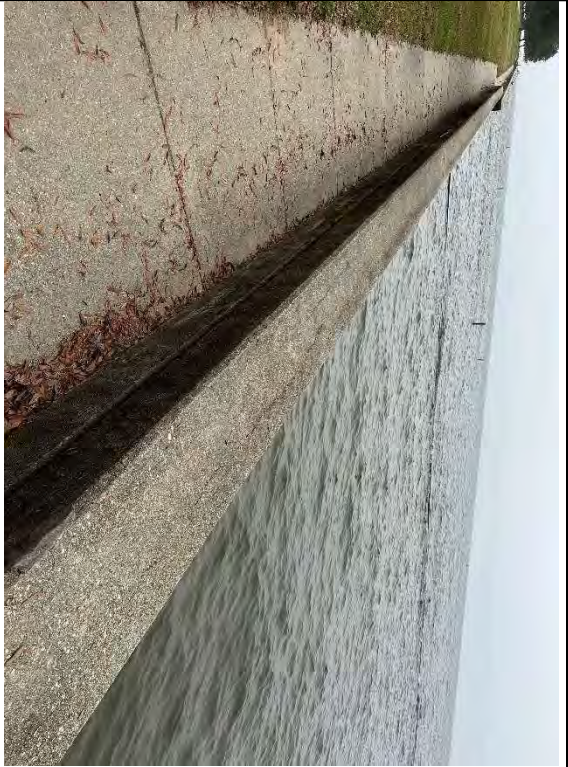
<p>Photo Name: IMG_0085 Inspection Field Notes Photo # : 35 Date: 12-13-22 Approximate Station: Station 12+07 to 13+00 Description: Horizontal cracks at top of seawall that are reflective of the sheet pile. Landside contains minor cracks as well Coordinates: Latitude: 30 ; 21 ; 29.94 Longitude: 90 ; 4 ; 48.7199</p>

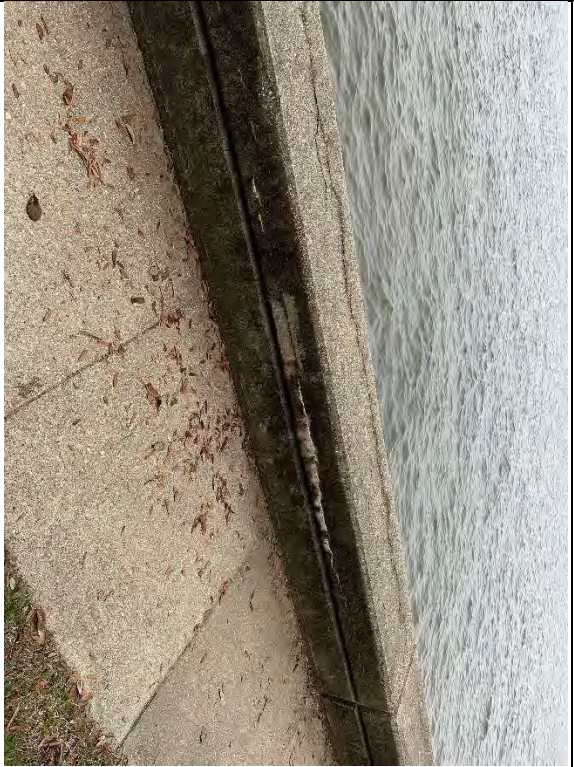
<p>Photo Name: IMG_0086 Inspection Field Notes Photo # : 36 Date: 12-13-22 Approximate Station: Station 12+25 to 12+35 Description: Top side and land side of the seawall both contain horizontal cracks Coordinates: Latitude: 30 ; 21 ; 29.8899 Longitude: 90 ; 4 ; 48.28</p>

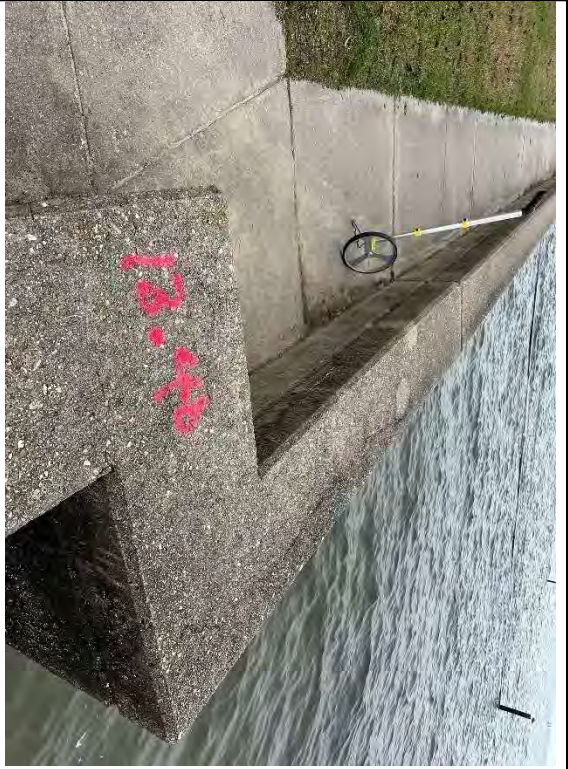
<p>Photo Name: IMG_0089 Inspection Field Notes Photo # : 39 Date: 12-13-22 Approximate Station: Station 13+40 to 13+50 Description: Minor horizontal cracks on top side of seawall. Minor cracks on seaside of seawall as well. Coordinates: Latitude: 30 ; 21 ; 29.0899 Longitude: 90 ; 4 ; 47.4299</p>

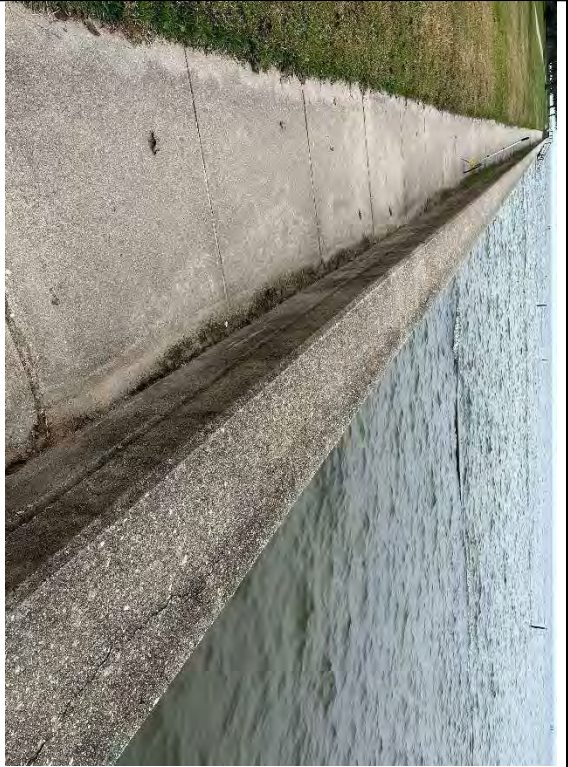
<p>Photo Name: IMG_0091 Inspection Field Notes Photo # : 38.2 Date: 12-13-22 Approximate Station: Station 13+50 to 14+00 Description: Top side of seawall contains horizontal cracks and minor vertical cracks along land face side Coordinates: Latitude: 30 ; 21 ; 29.0399 Longitude: 90 ; 4 ; 47.1599</p>

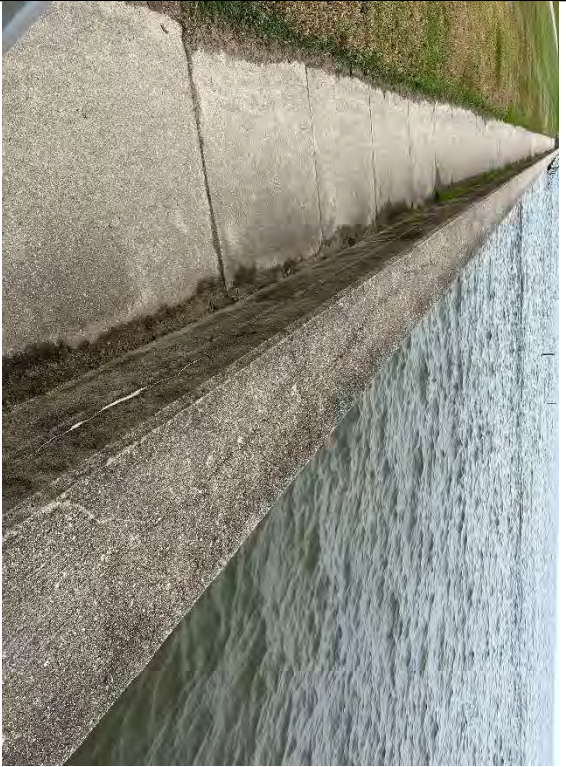
<p>Photo Name: IMG_0093 Inspection Field Notes Photo # : 39.3 Date: 12-13-22 Approximate Station: Station 14+28 to 15+00 Description: Top side of seawall contains horizontal cracks and minor horizontal and vertical cracks on the land face side Coordinates: Latitude: 30 ; 21 ; 28.55 Longitude: 90 ; 4 ; 46.799</p>

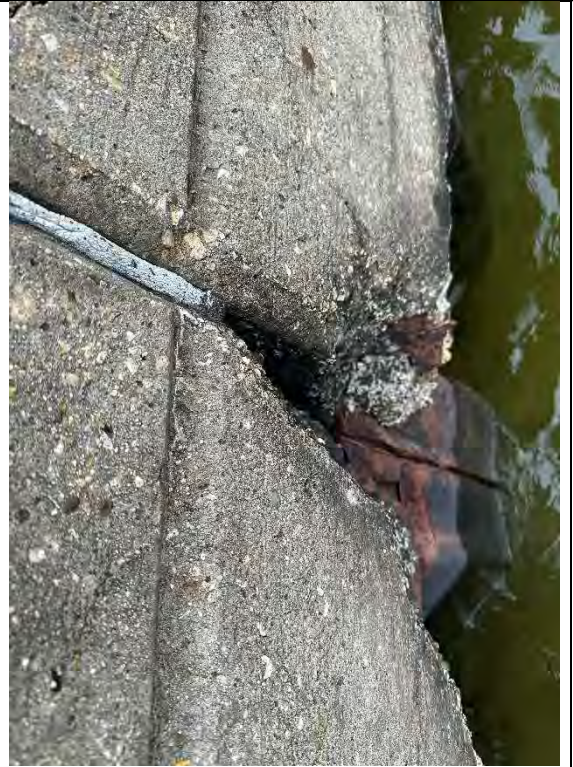
<p>Photo Name: IMG_0094 Inspection Field Notes Photo # : 40 Date: 12-13-22 Approximate Station: Station 14+67 Description: Concrete spall on seaside of expansion joint Coordinates: Latitude: 30 ; 21 ; 28.4299 Longitude: 90 ; 4 ; 46.299</p>

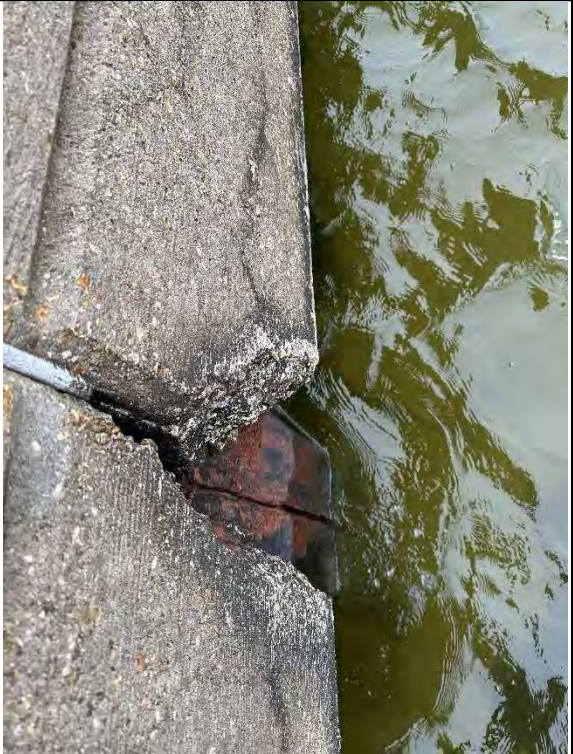
<p>Photo Name: IMG_0101 Inspection Field Notes Photo # : 47 Date: 12-13-22 Approximate Station: Station 16+47 Description: Concrete spall on seaside of expansion joint Coordinates: Latitude: 30 ; 21 ; 27.19 Longitude: 90 ; 4 ; 44.8499</p>

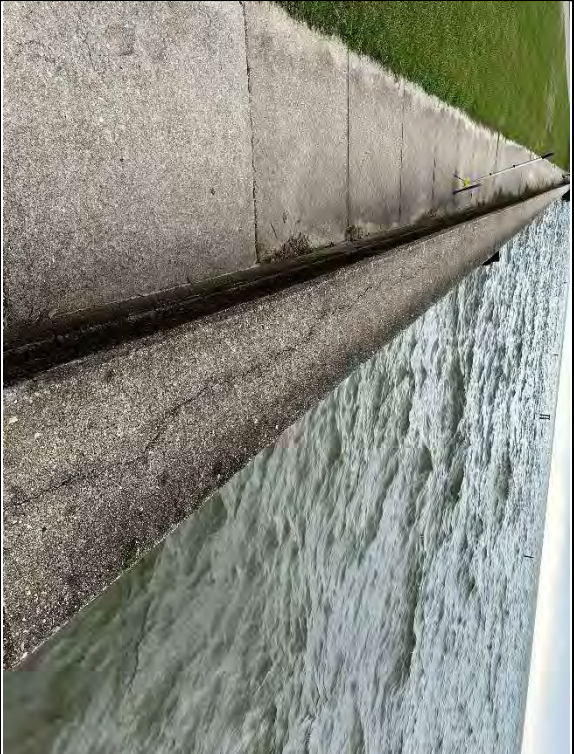
<p>Photo Name: IMG_0107 Inspection Field Notes Photo # : 53 Date: 12-13-22 Approximate Station: Station 18+21 to 18+43 Description: Horizontal and vertical cracks on top side of seawall. Horizontal cracks on face of landside of seawall Coordinates: Latitude: 30 ; 21 ; 26.2599 Longitude: 90 ; 4 ; 43.28</p>

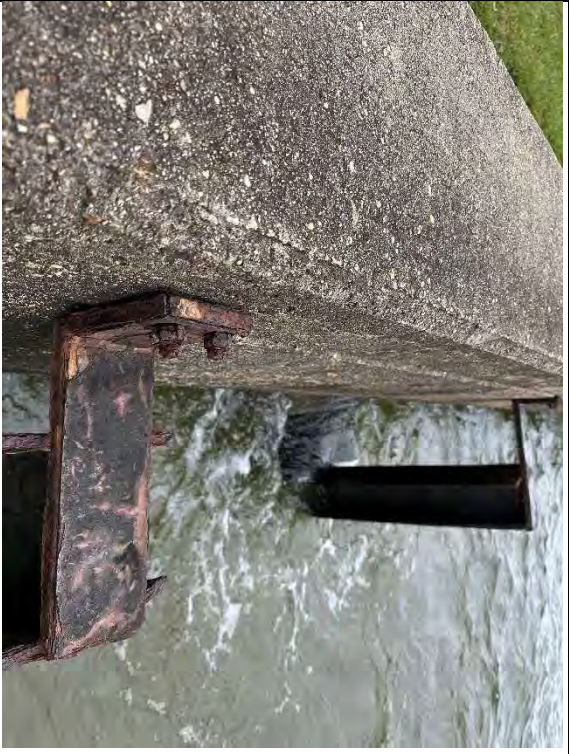
<p>Photo Name: IMG_0108 Inspection Field Notes Photo # : 54 Date: 12-13-22 Approximate Station: Station 18+50 Description: Steel hatch structure on seaside of seawall. Possibly for drainage pipe? Coordinates: Latitude: 30 ; 21 ; 26.1799 Longitude: 90 ; 4 ; 42.9799</p>

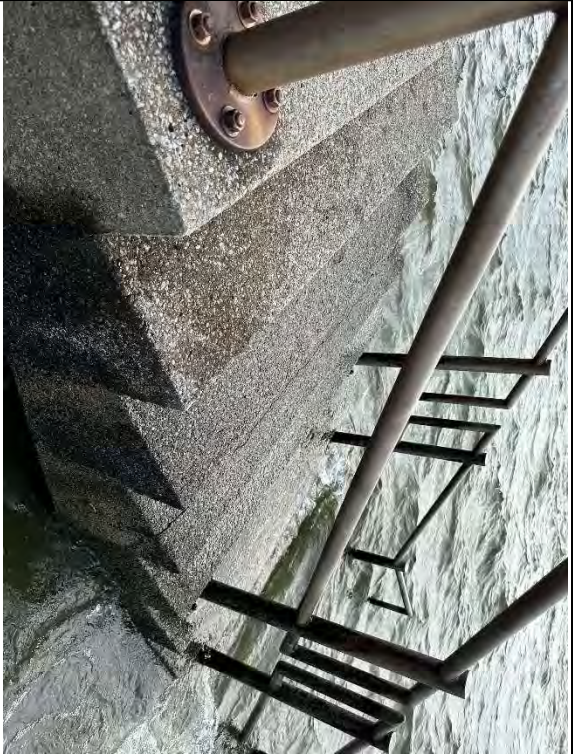
<p>Photo Name: IMG_0117 Inspection Field Notes Photo # : 64 Date: 12-13-22 Approximate Station: Station 22+08 Description: Stairway. Steps 3 and 4 are cracked Coordinates: Latitude: 30 ; 21 ; 23.9199 Longitude: 90 ; 4 ; 39.6799</p>

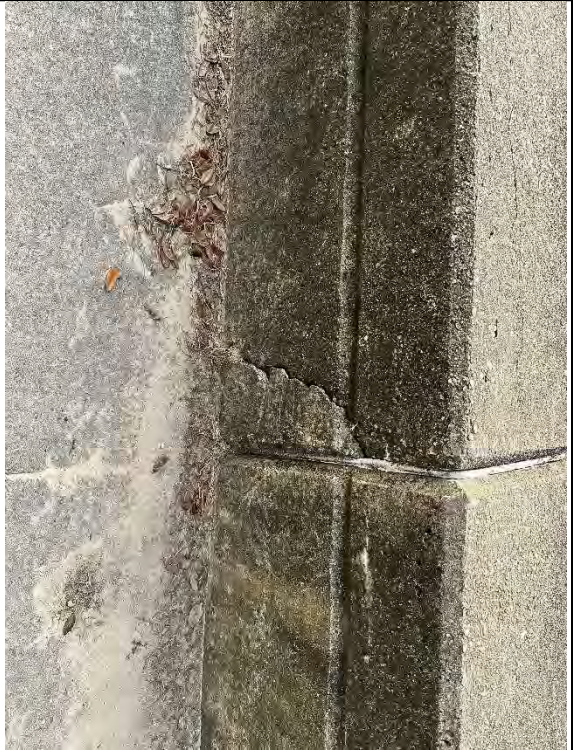
<p>Photo Name: IMG_0123 Inspection Field Notes Photo # : 70 Date: 12-13-22 Approximate Station: Station 23+33 Description: Concrete spall along land face side of expansion joint of seawall Coordinates: Latitude: 30 ; 21 ; 23.3399 Longitude: 90 ; 4 ; 38.01</p>

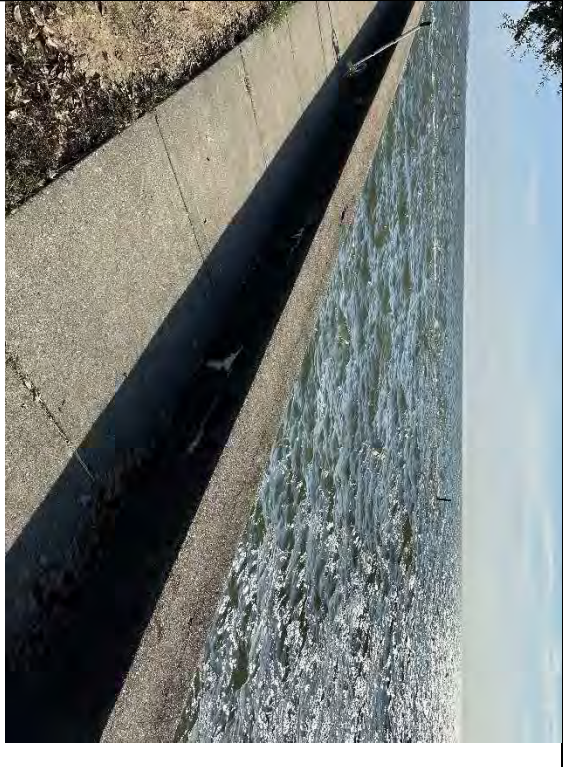
<p>Photo Name: IMG_0139 Inspection Field Notes Photo # : 87 Date: 12-13-22 Approximate Station: Station 29+00 to 29+38 Description: Horizontal cracks along the top side of the seawall. Horizontal and vertical cracks along the land face side of the seawall as well Coordinates: Latitude: 30 ; 21 ; 21.5899 Longitude: 90 ; 4 ; 33.1199</p>

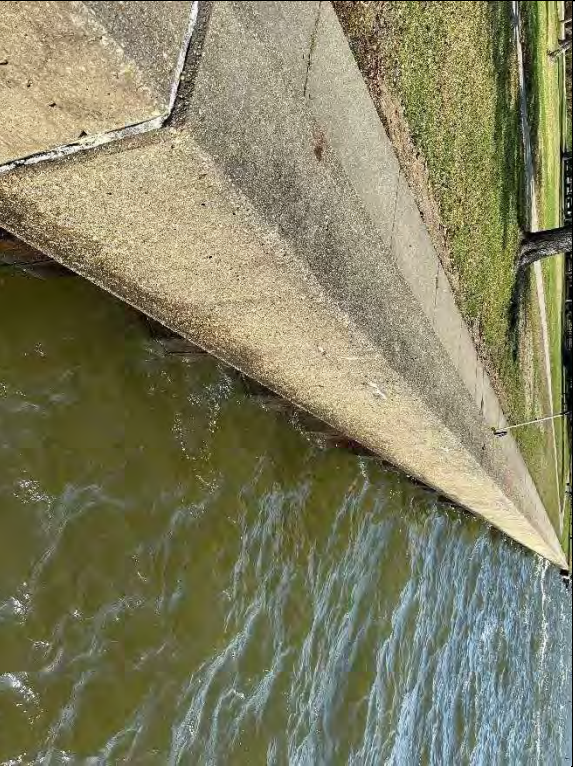
<p>Photo Name: IMG_0140 Inspection Field Notes Photo # : 86 Date: 12-13-22 Approximate Station: Station 28+76 to 29+00 Description: Horizontal and vertical cracks along the top side of the seawall. Horizontal cracks along the seaside face of the seawall as well Coordinates: Latitude: 30 ; 21 ; 20.49 Longitude: 90 ; 4 ; 33.0399</p>

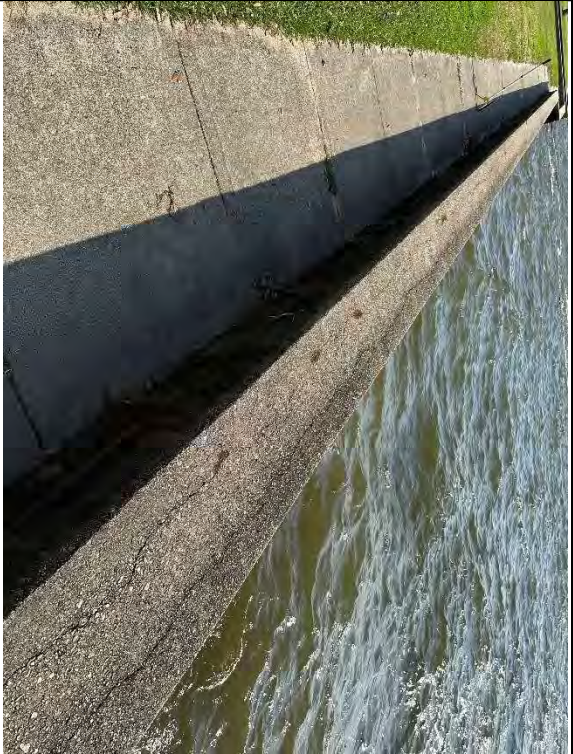
<p>Photo Name: IMG_0143 Inspection Field Notes Photo # : 91 Date: 12-13-22 Approximate Station: Station 32+00 to 32+21 Description: Horizontal cracks along the top side of seawall. Horizontal cracks along the land face side of the seawall as well Coordinates: Latitude: 30 ; 21 ; 19.8899 Longitude: 90 ; 4 ; 30.47999</p>

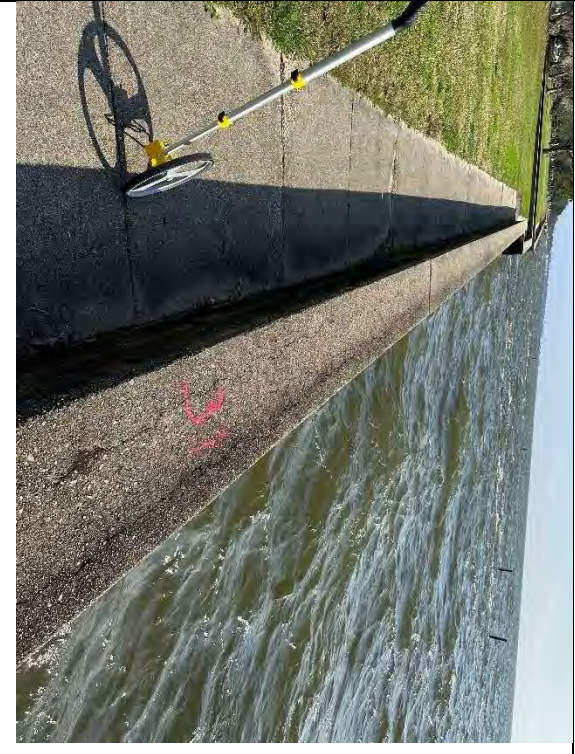
<p>Photo Name: IMG_0144 Inspection Field Notes Photo # : 90 Date: 12-13-22 Approximate Station: Station 31+00 to 32+00 Description: Horizontal cracks along the top side of the seawall. Horizontal cracks along the land face side of the seawall as well. Sidewalk is settling along with seawall. Coordinates: Latitude: 30 ; 21 ; 19.61 Longitude: 90 ; 4 ; 30.9</p>

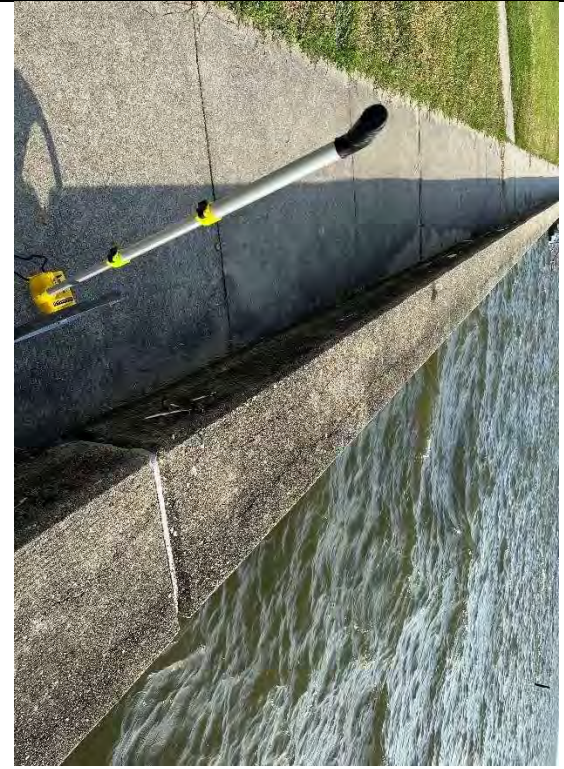
Photo Name: IMG_0153
Inspection Field Notes Photo # : 100
Date: 12-13-22
Approximate Station: Station 36+84 to 37+32
Description: Seawall is in okay condition
Coordinates:
Latitude: 30 ; 21 ; 18.690
Longitude: 90 ; 4 ; 28.590

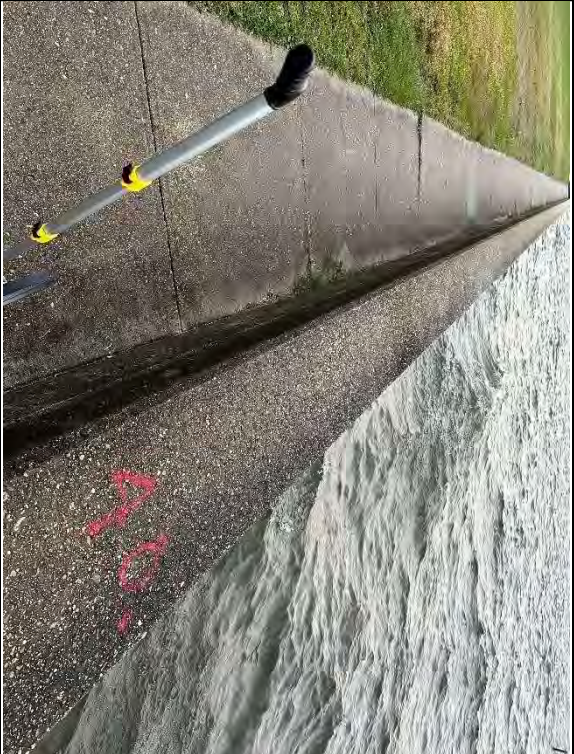
<p>Photo Name: IMG_0164 Inspection Field Notes Photo # : 110 Date: 12-14-22 Approximate Station: Station 40+00 to 41+00 Description: Sidewalk settling along side of seawall. Top side of wall contains minor vertical cracks Coordinates: Latitude: 30 ; 21 ; 17.50 Longitude: 90 ; 4 ; 25.76</p>

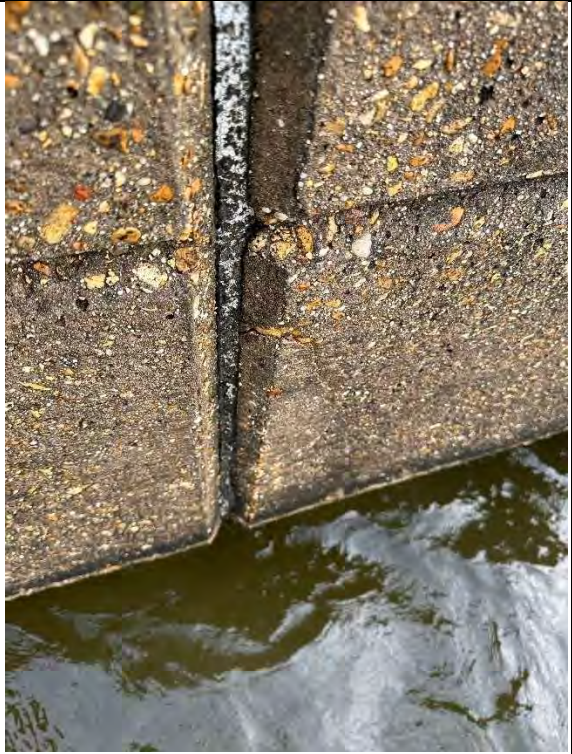
<p>Photo Name: IMG_0165 Inspection Field Notes Photo # : 111 Date: 12-14-22 Approximate Station: Station 40+26 Description: Concrete spall along the seaside of expansion joint Coordinates: Latitude: 30 ; 21 ; 17.57 Longitude: 90 ; 4 ; 25.510</p>

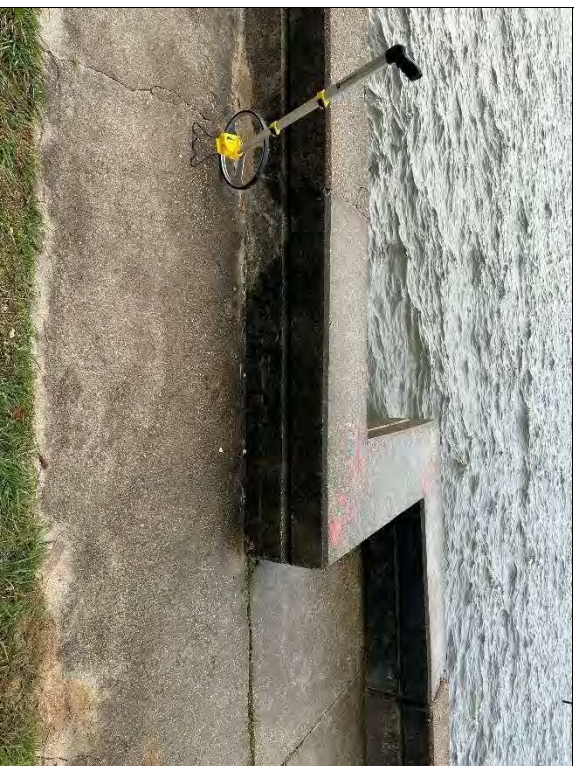
Photo Name: IMG_0171
Inspection Field Notes Photo # : 119
Date: 12-14-22
Approximate Station: Station 42+15 to 42+60
Description: Horizontal cracks along top side of seawall that are reflective of sheet pile. Horizontal cracks along land face side of seawall as well.
Coordinates:
Latitude: 30 ; 21 ; 16.66
Longitude: 90 ; 4 ; 23.5599

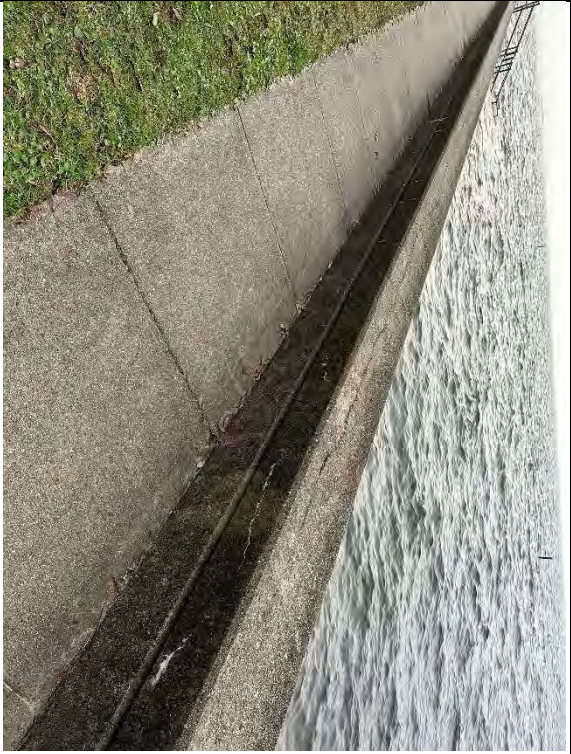
<p>Photo Name: IMG_0173 Inspection Field Notes Photo # : 121 Date: 12-14-22 Approximate Station: Station 42+00 to 43+00 Description: Horizontal cracks along top side of seawall that are reflective of sheet pile. Horizontal and vertical cracks along the land face side of the seawall as well. Coordinates: Latitude: 30 ; 21 ; 16.32 Longitude: 90 ; 4 ; 22.9299</p>

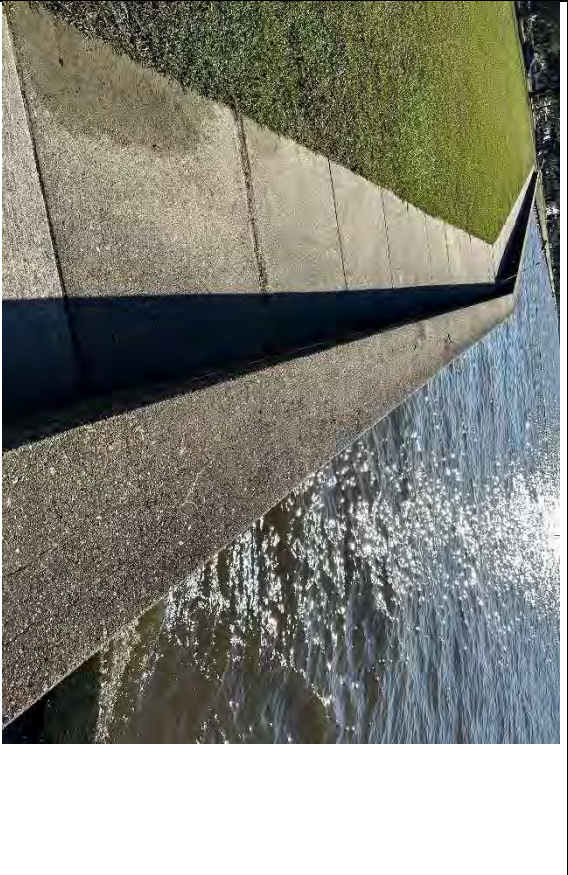
<p>Photo Name: IMG_0196 Inspection Field Notes Photo # : 142.1 Date: 12-15-22 Approximate Station: Station 49+00 to 49+58 Description: Horizontal cracks along the top side of the seawall. Coordinates: Latitude: 30 ; 21 ; 13.5399 Longitude: 90 ; 4 ; 16.26</p>

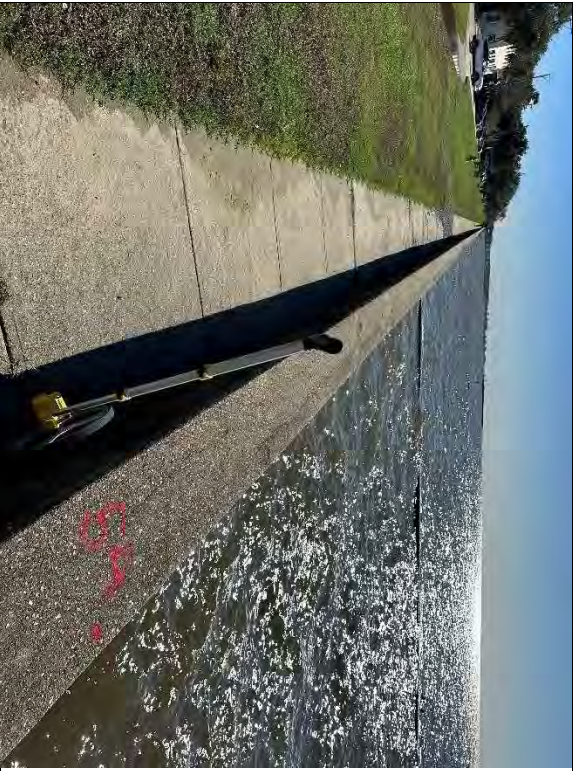
Photo Name: IMG_0212
Inspection Field Notes Photo # : 151
Date: 12-15-22
Approximate Station: Station 54+00 to 54+36
Description: Horizontal cracks along the top side of the seawall. Horizontal cracks along the land face side of the seawall as well.
Coordinates:
Latitude: 30 ; 21 ; 11.49
Longitude: 90 ; 4 ; 11.4799

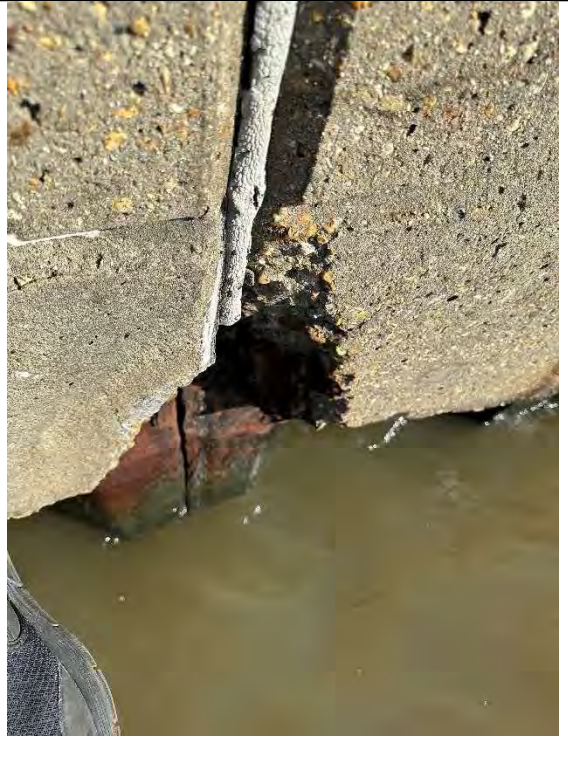
<p>Photo Name: IMG_0213 Inspection Field Notes Photo # : 152 Date: 12-15-22 Approximate Station: Station 54+36 Description: Concrete spall along the seaside face of the expansion joint. Coordinates: Latitude: 30 ; 21 ; 11.32 Longitude: 90 ; 4 ; 11.3699</p>

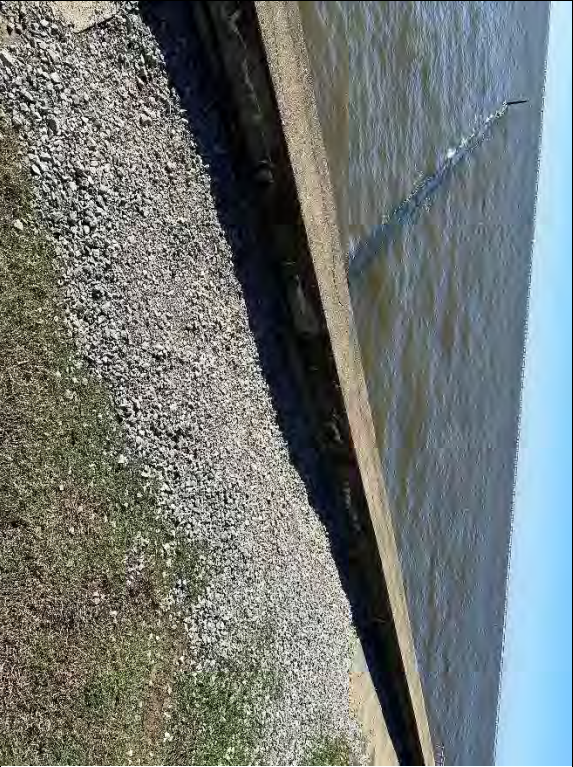
<p>Photo Name: IMG_0214 Inspection Field Notes Photo # : 153 Date: 12-15-22 Approximate Station: Station 54+61 54+81 Description: Sidewalk missing near seawall and needs to be repaired. Coordinates: Latitude: 30 ; 21 ; 11.240 Longitude: 90 ; 4 ; 10.7399</p>

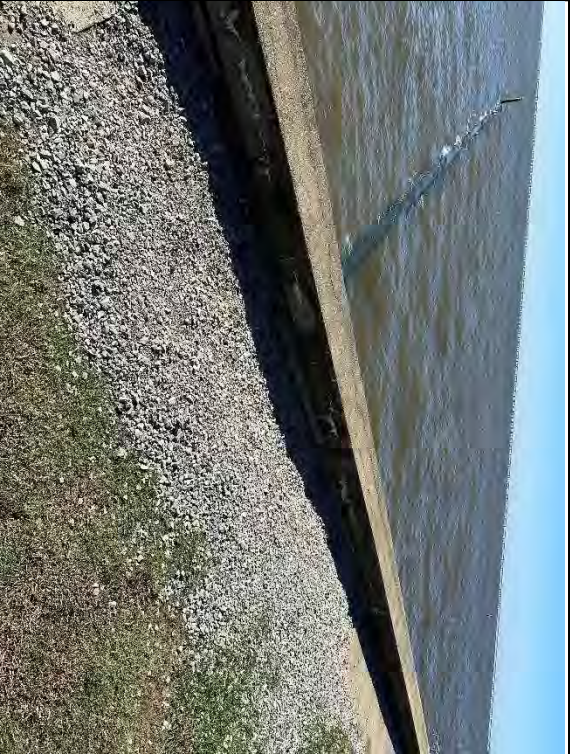
<p>Photo Name: IMG_0214 Inspection Field Notes Photo # : 153 Date: 12-15-22 Approximate Station: Station 54+00 to 55+00 Description: Horizontal cracks with rust spots along the top side of the seawall. Coordinates: Latitude: 30 ; 21 ; 11.240 Longitude: 90 ; 4 ; 10.7399</p>
 	<p>Photo Name: IMG_0215 Inspection Field Notes Photo # : 154 Date: 12-15-22 Approximate Station: Station 54+94 Description: Concrete spall along the seaside face of the expansion joint. Coordinates: Latitude: 30 ; 21 ; 11.0599 Longitude: 90 ; 4 ; 10.82</p>

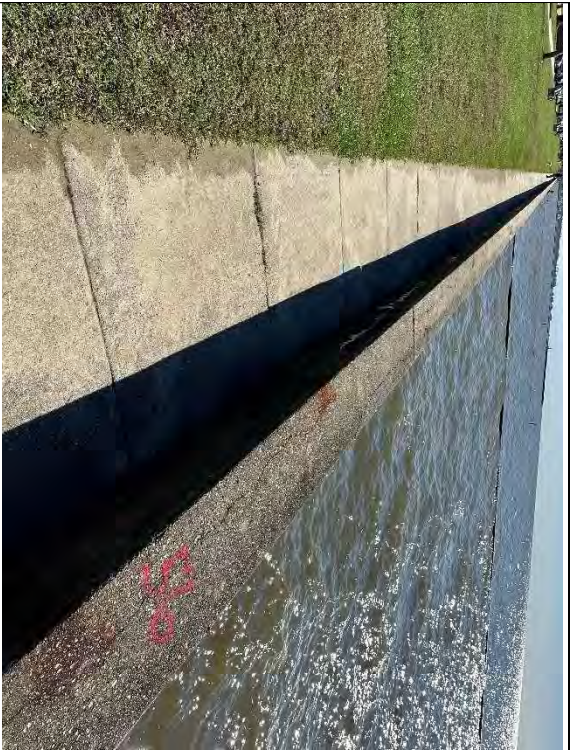
Photo Name: IMG_0218
Inspection Field Notes Photo # : 157
Date: 12-15-22
Approximate Station: Station 56+00 to 57+00
Description: Horizontal and vertical cracks with rust spots along the top side of the seawall. Horizontal and vertical cracks along the land face side as well.
Coordinates:
Latitude: 30 ; 21 ; 10.66
Longitude: 90 ; 4 ; 9.77

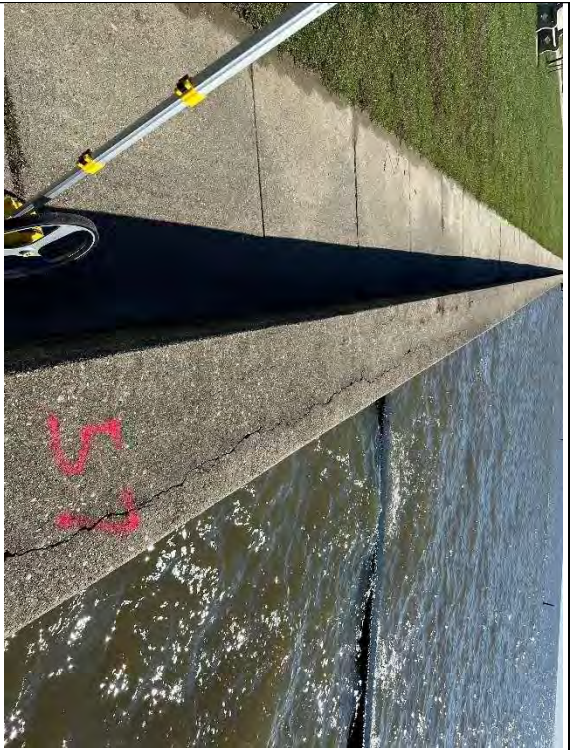
Photo Name: IMG_0222
Inspection Field Notes Photo # : 161
Date: 12-15-22
Approximate Station: Station 57+00 to 57+88
Description: Horizontal cracks and rust spots along the top side of the seawall. Horizontal and vertical cracks along the land face side of the seawall
Coordinates:
Latitude: 30 ; 21 ; 10.13
Longitude: 90 ; 4 ; 8.84
