**COM PROJ. NO. 100.21.019
SEAWALL REPAIR (INSPECTION PROJECT)
FINAL FINDINGS/ASSESSMENT REPORT**

The City of Mandeville
1100 Mandeville High Blvd.
Mandeville, LA 70471

Prepared by
BURK-KLEINPETER, INC.
4176 Canal Street
New Orleans, LA 70119

APRIL 2023

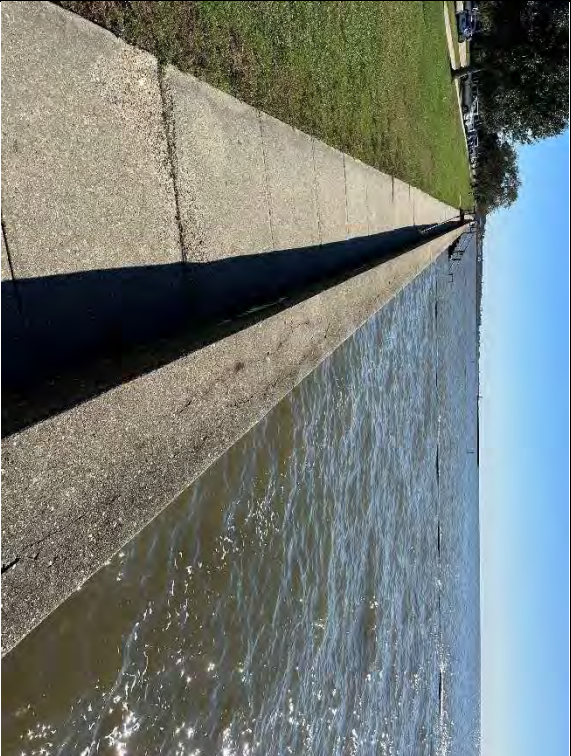
Photo Name: IMG_0228
Inspection Field Notes Photo # : 166
Date: 12-15-22
Approximate Station: Station 58+46 to 59+00
Description: Horizontal cracks along the top side of the seawall that are reflective of the sheet pile along with a few rust spots. Horizontal and vertical cracks along the land face side of the cap.
Coordinates:
Latitude: 30 ; 21 ; 10.88
Longitude: 90 ; 4 ; 6.6699

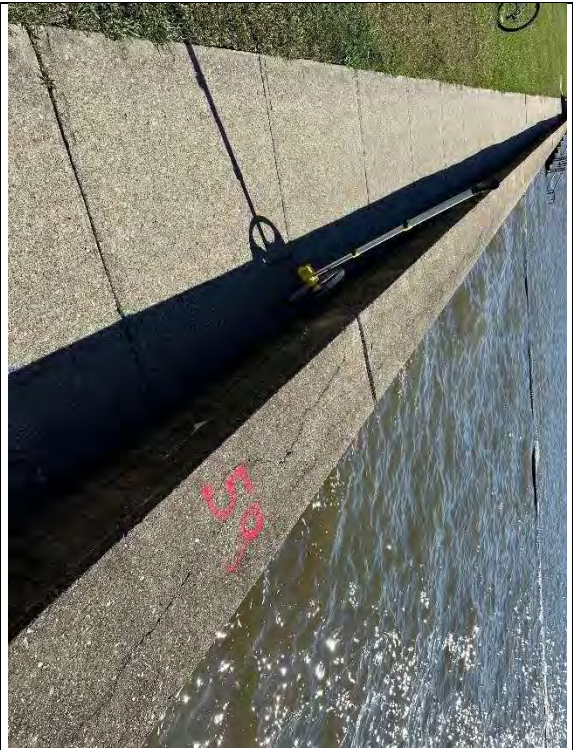
Photo Name: IMG_0230
Inspection Field Notes Photo # : 168
Date: 12-15-22
Approximate Station: Station 59+04 to 59+50
Description: Horizontal cracks along the top side of the cap. Horizontal cracks along the land face side of the cap as well.
Coordinates:
Latitude: 30 ; 21 ; 9.020
Longitude: 90 ; 4 ; 6.5599

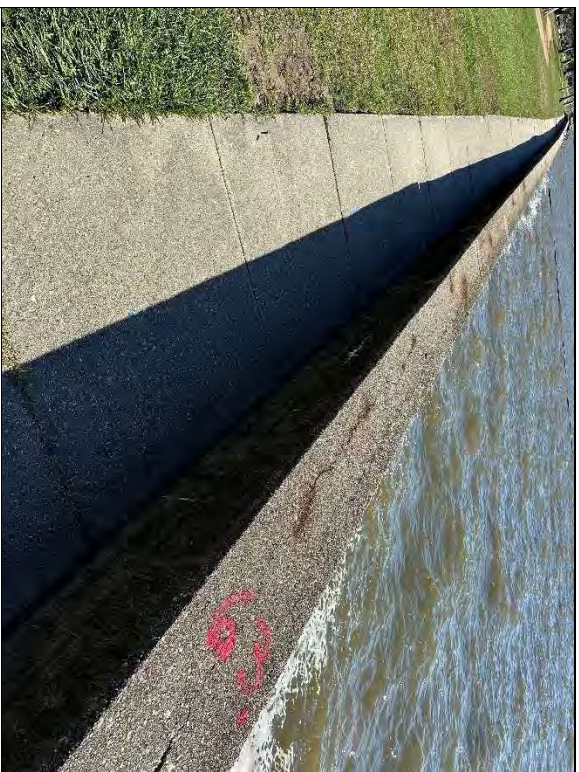
Photo Name: IMG_0243
Inspection Field Notes Photo # : 179
Date: 12-15-22
Approximate Station: Station 63+00 to 64+00
Description: Horizontal cracks and rust spots along the top side of the seawall that are reflective of the sheet pile.
Coordinates:
Latitude: 30 ; 21 ; 7.0299
Longitude: 90 ; 4 ; 2.690

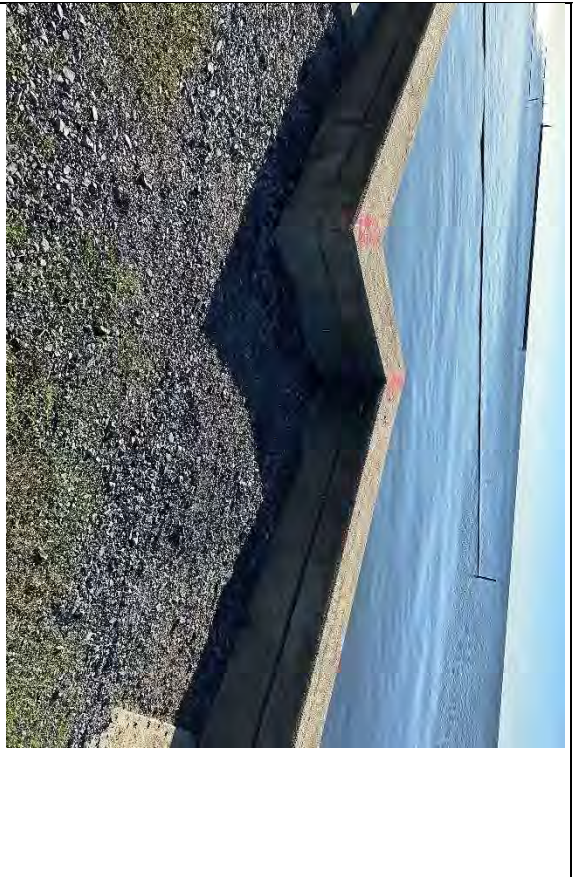
<p>Photo Name: IMG_0266 Inspection Field Notes Photo # : 192 Date: 12-16-22 Approximate Station: Station 68+98 to 69+18 Description: Horizontal and vertical cracks along both the top side, and also the land face side of the seawall. Sidewalk is missing along the seawall as well. Coordinates: Latitude: 30 ; 21 ; 4.1499 Longitude: 90 ; 3 ; 56.8699</p>

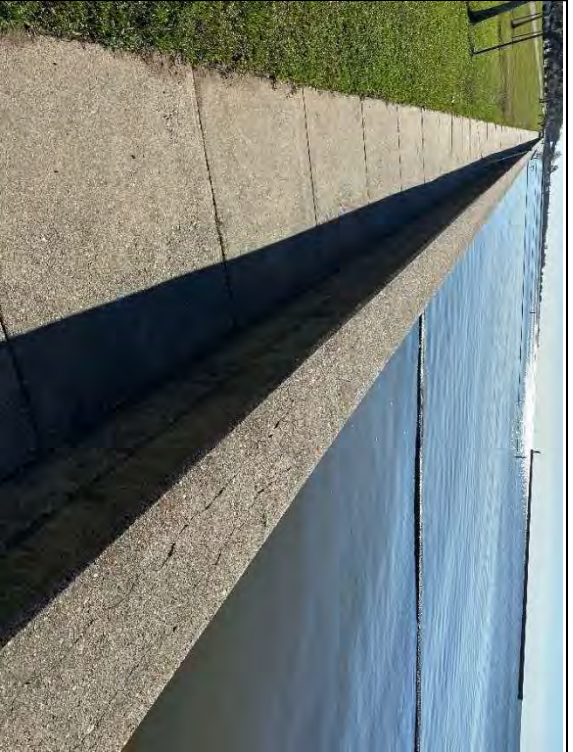
Photo Name: IMG_0270
Inspection Field Notes Photo # : 195
Date: 12-16-22
Approximate Station: Station 69+52 to 70+00
Description: Horizontal cracks along the top side of the cap. Horizontal and vertical cracks along the land face side of the cap as well.
Coordinates:
Latitude: 30 ; 21 ; 4.19
Longitude: 90 ; 3 ; 56.1799
