CASE SUMMARY SHEET**CASE NUMBER: V22-11-33****DATE RECEIVED: September 30, 2022****DATE OF MEETING: November 8, 2022 and December 13, 2022****Address: 200 Lafayette****Subdivision: Old Town of Mandeville****Zoning District: R-1 Single Family Residential****Property Owner: Patrick and Cindy Connolly****REQUEST: V22-11-33 – Patrick and Cindy Connolly request a variance to CLURO Section 9.2.5.7 Live Oak Protection Requirements, Sq 29B Lot 4A, R-1 Single Family Residential, 200 Lafayette****CASE SUMMARY:**

RE: Evaluation of Trees at 200 Lafayette Street Mandeville, LA 70448

CASE NUMBER: V22-11-34

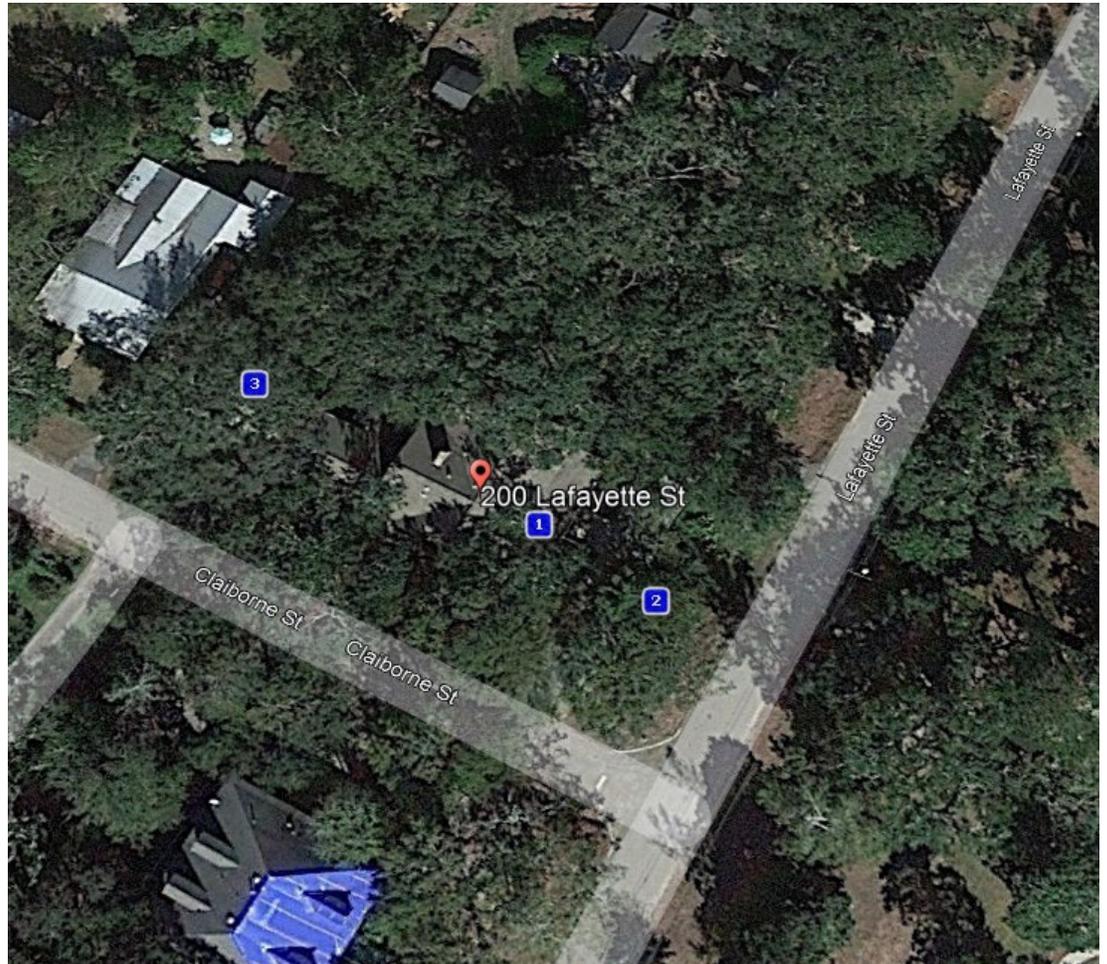
Photo No. 1

The tree subject trees that need immediate attention, are labeled on Photo # 1 of the attached Photo Log.

Description: This photo shows the location of the the Connolly property with three key tree marked, and discussed with in this report in detail.

There is no question that subject trees # 1, # 2 and # 3 need immediate attention.

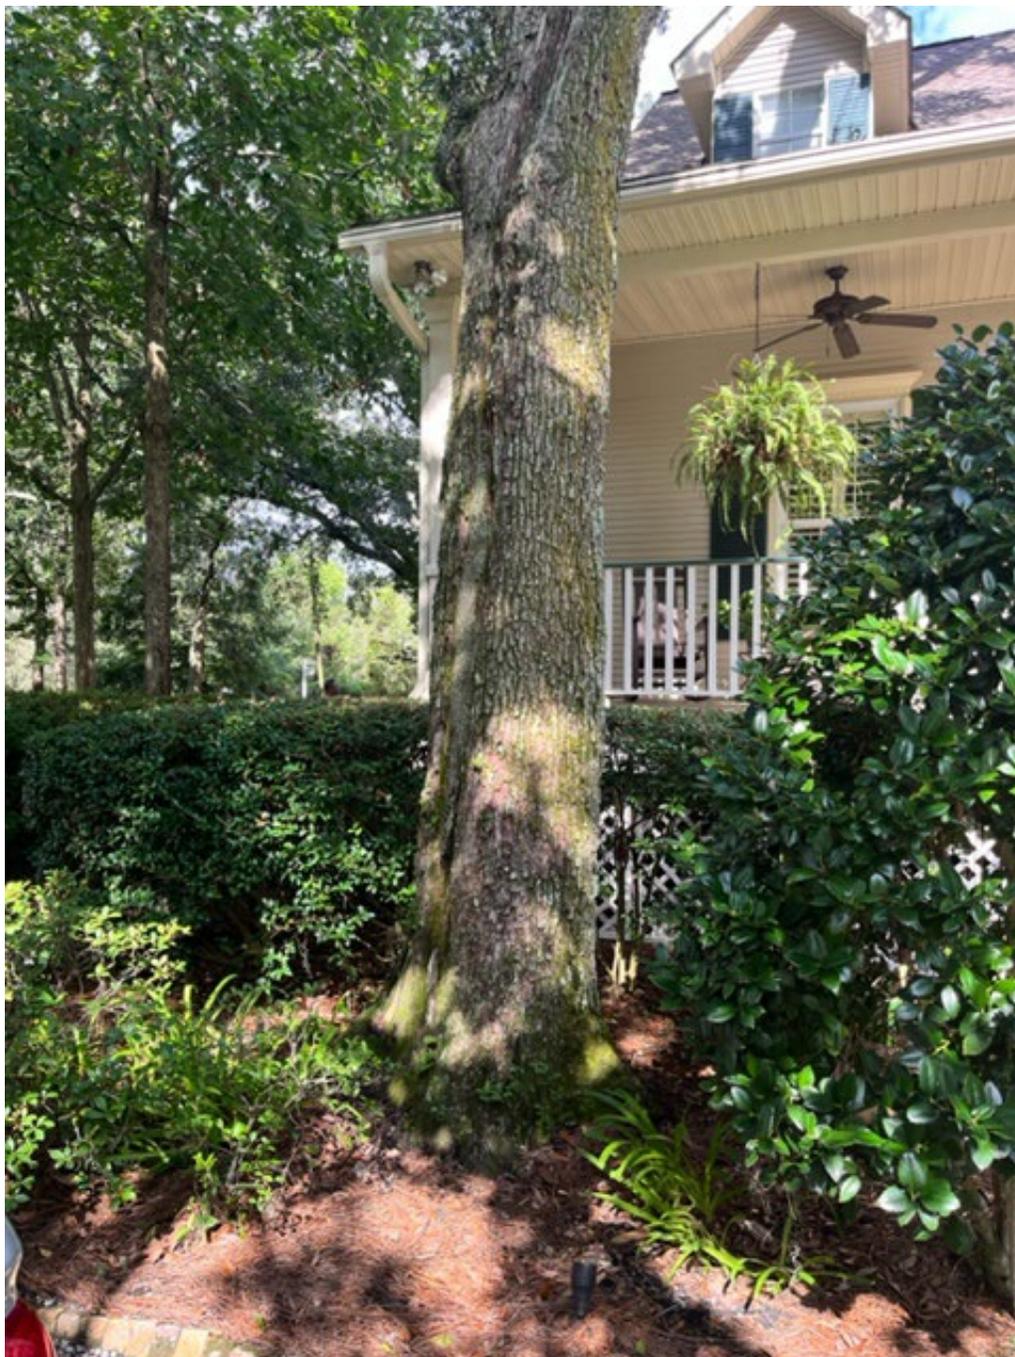
Photo No. 2

Tree # 1 – This subject tree is a mature Live Oak (*Quercus virginiana*) tree with a DBH of 28". The tree is located in your front yard, near to the front walkway. In fact, the tree is only feet away from your home (see Photos # 2 - # 8). The subject tree has been struck by lightning years ago, as the scar and old wound is clearly visible on the side opposite of the home, where guests would pull into your driveway. The lightning strike wound has not closed off completely and there are areas along the wound that are soft and decayed, especially at the base of the tree as seen in photo # 4 of the attached Photo Log). This subject tree also has grown near to other trees in stark competition for space and sunlight which has led to phototropism and a severe lean over the home. Visual evidence of decline can be seen in the crown of this tree in the tip deadwood that is present. This subject tree clearly presents an imminent threat to your home and should be removed now.

Description: This photo shows subject tree # 1, as indicated on the site map in figure 1. From this image, one can clearly see the close proximity of the tree to the house.

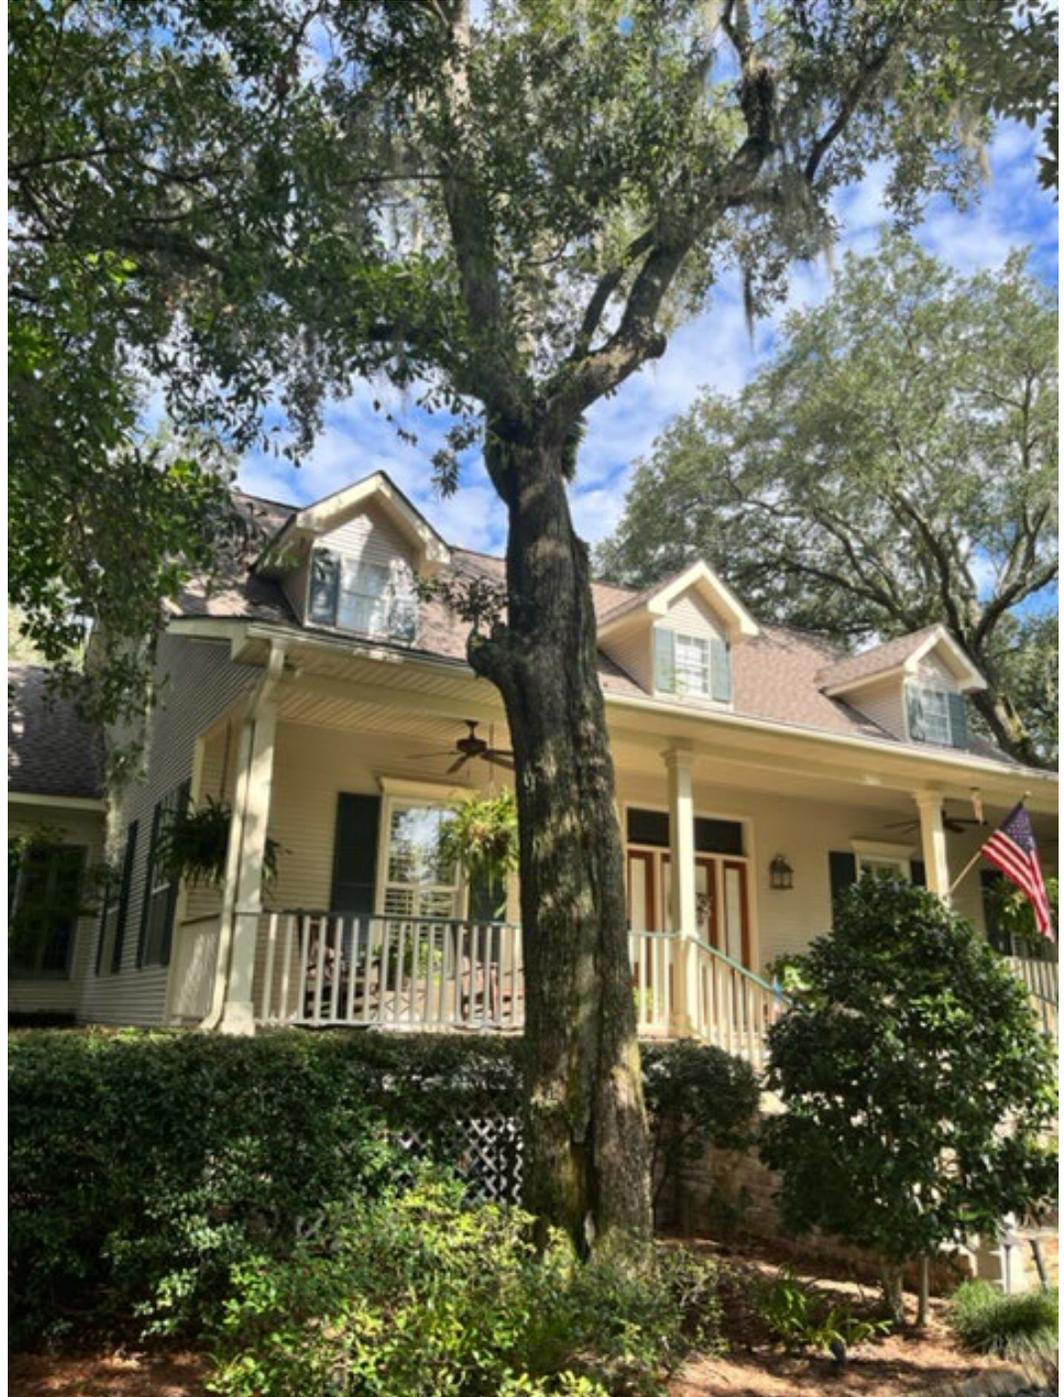
Photo No. 3

Description: This photo shows subject tree # 1, as indicated on the site map in figure 1. From this image one can clearly see the close proximity of the tree to the home. Also the old lightning strike can be seen.

On Friday October 7th, 2022, a site inspection was performed to evaluate the health of a 28” DBH *Quercus virginiana*, live oak, located within the front yard a few feet away from the front porch. The tree exhibits an old lightning strike wound on the southeast side of the tree. The wound shows appropriate woundwood for the age of the tree and for the area the wound covers. Since the lightning strike wound travels along the majority of the tree the woundwood growth would likely never fully close as the amount of energy required to do so would likely never be amassed within the tree’s lifetime. Additionally, woundwood should not be confused compartmentalization. Compartmentalization is the true defense process for trees where protective boundaries are formed to protect the living wood from pathogens. The Compartmentalization of Decay in Trees (CODIT) is the name given for the process trees go through after being wounded to seal off the damage. Live oak trees are exceptionally efficient at CODIT and therefore excellent at repelling decay and rots. Since this is a healthy tree that appears to be structurally sound it should be protected and not removed.

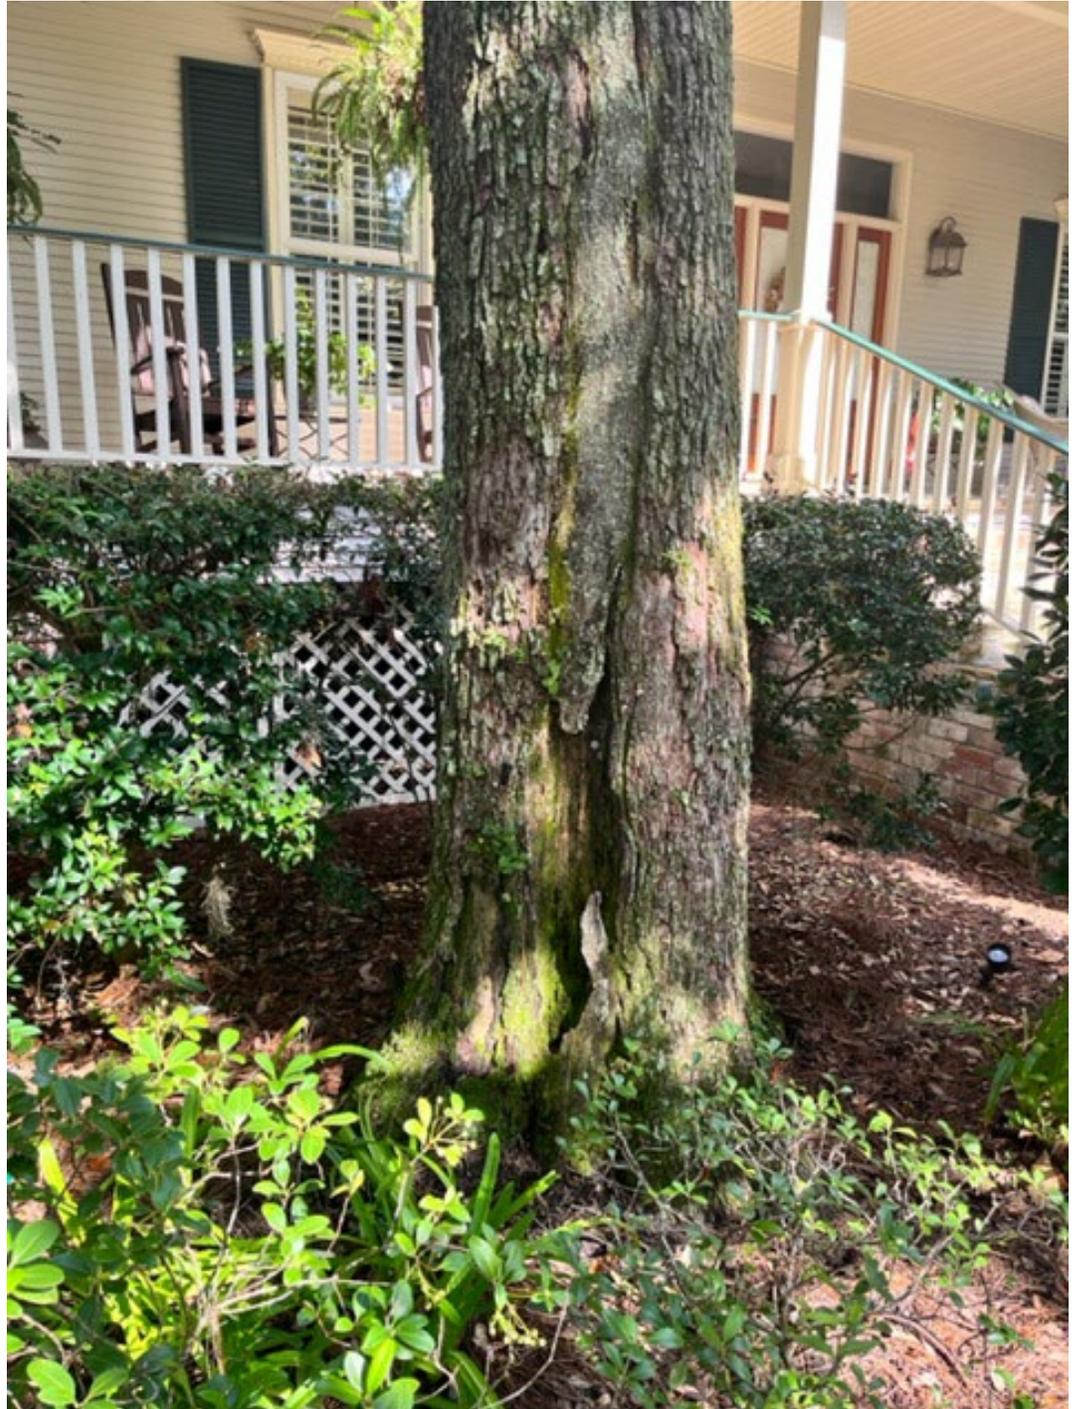
Photo No. 4

Description: This photo shows subject tree # 1, as indicated on the site map in figure 1. From this image one can clearly see the close proximity of the tree to the home. Also the old lightning strike can be seen.

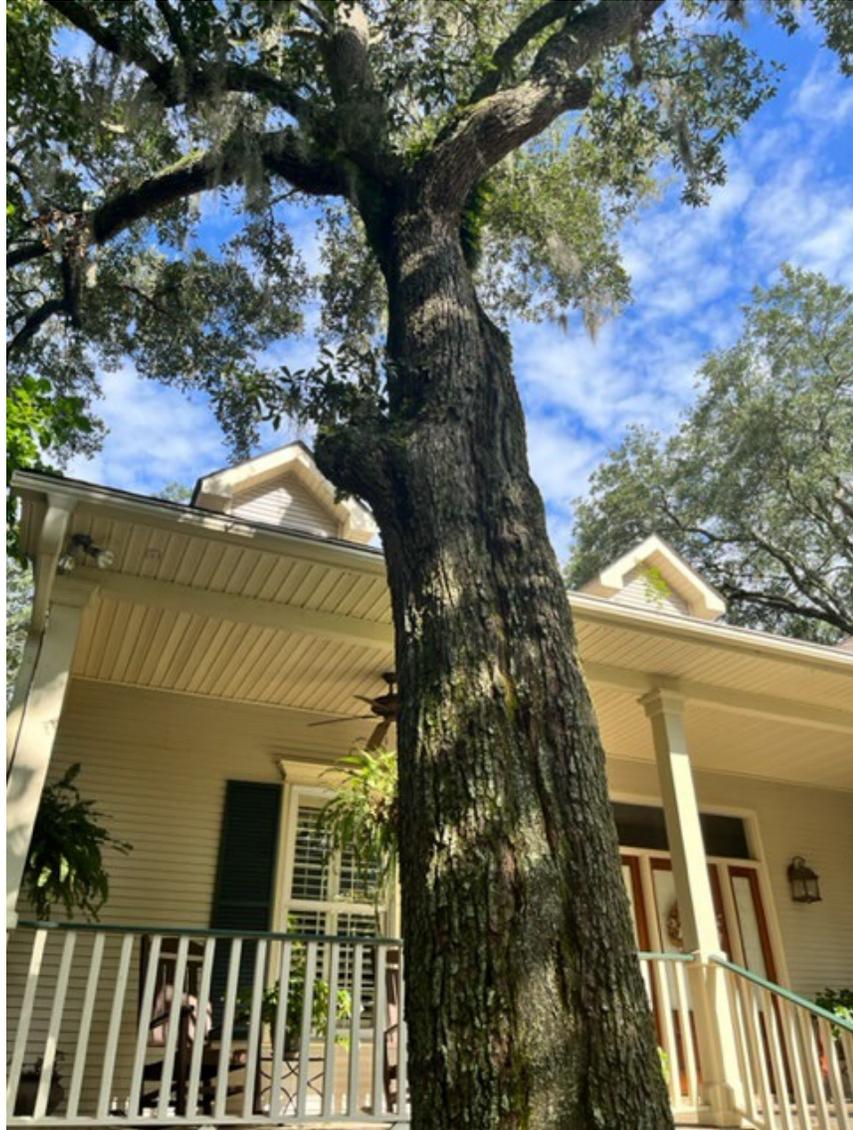
Photo No. 5

Description: This photo shows subject tree # 1, as indicated on the site map in figure 1. From this image one can clearly see the close proximity of the tree to the home. Also the old lightning strike can be seen.

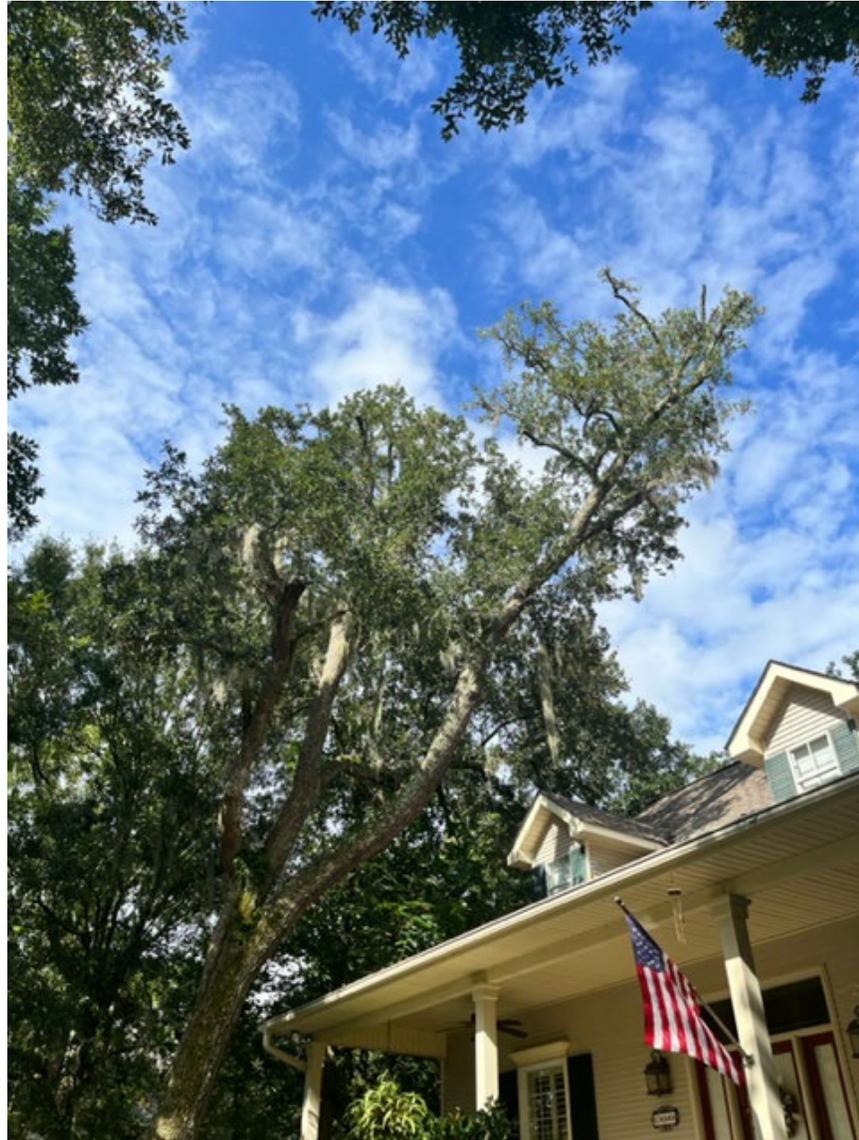
Photo No. 6

Description: This photo shows subject tree # 1, as indicated on the site map in figure 1.

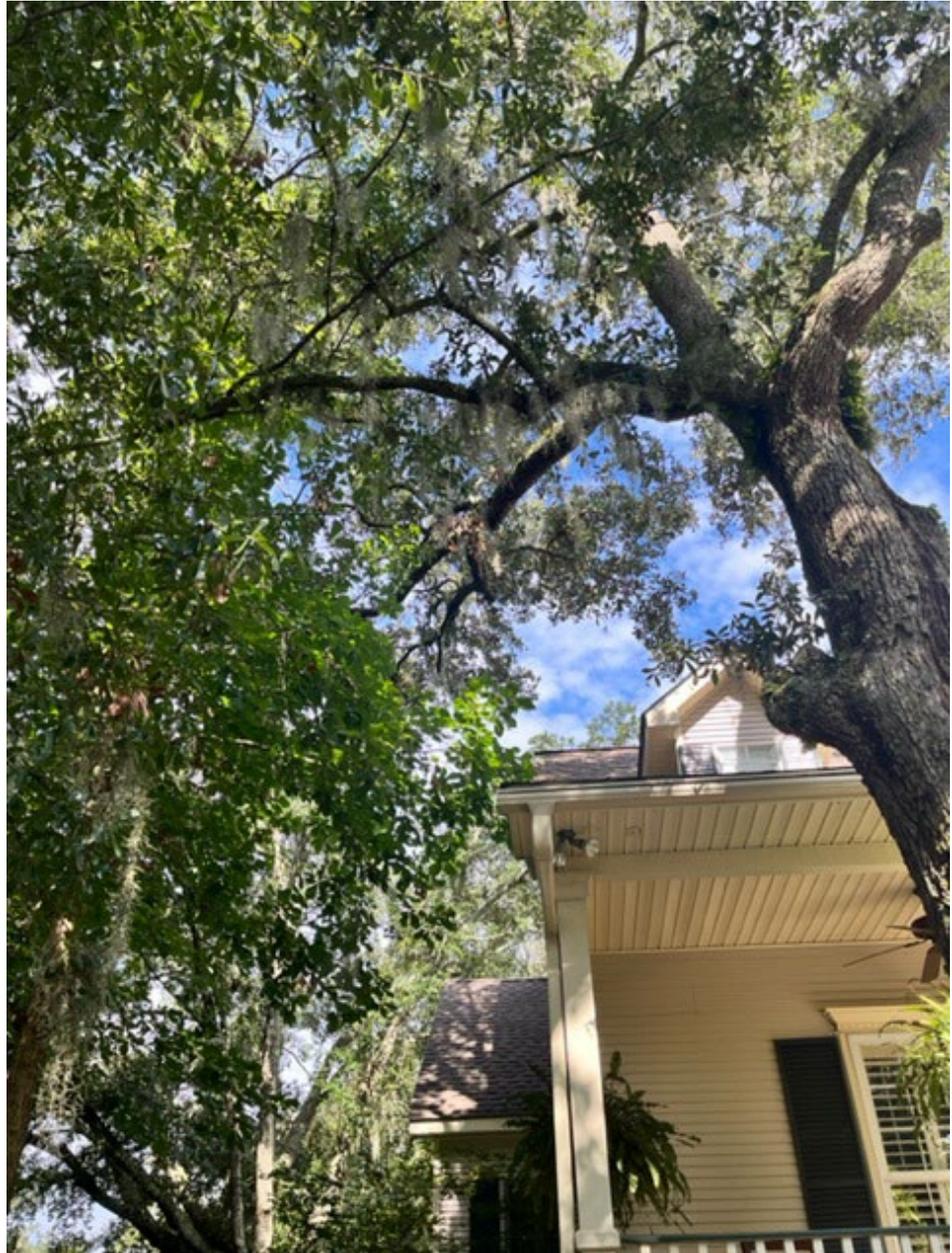
Photo No. 7

Description: This photo shows subject tree # 1, as indicated on the site map in figure 1. From this image one can clearly see the close proximity of the tree to the home.

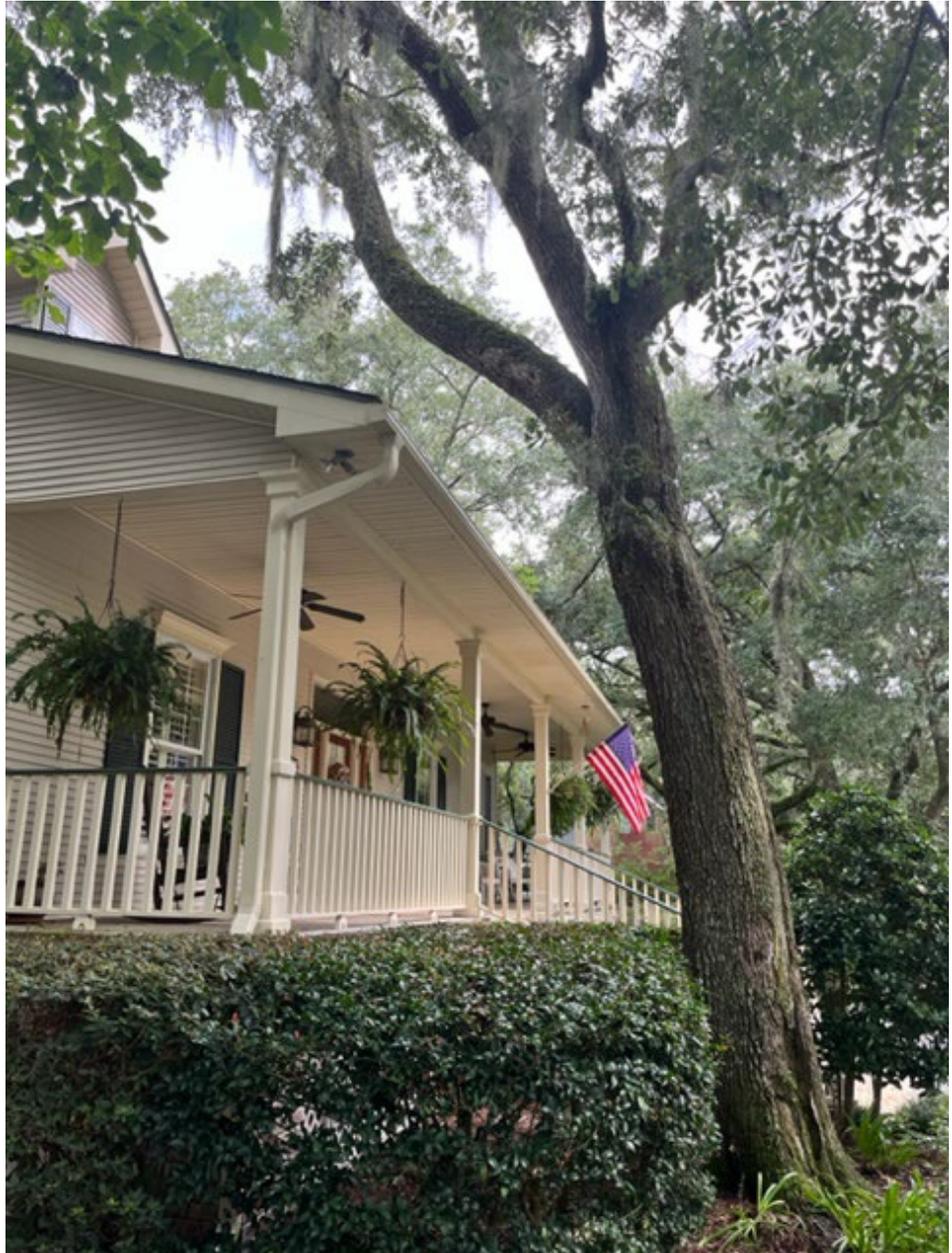
Photo No. 8

Description: This photo shows subject tree # 1, as indicated on the site map in figure 1. From this image one can clearly see the close proximity of the tree to the home.

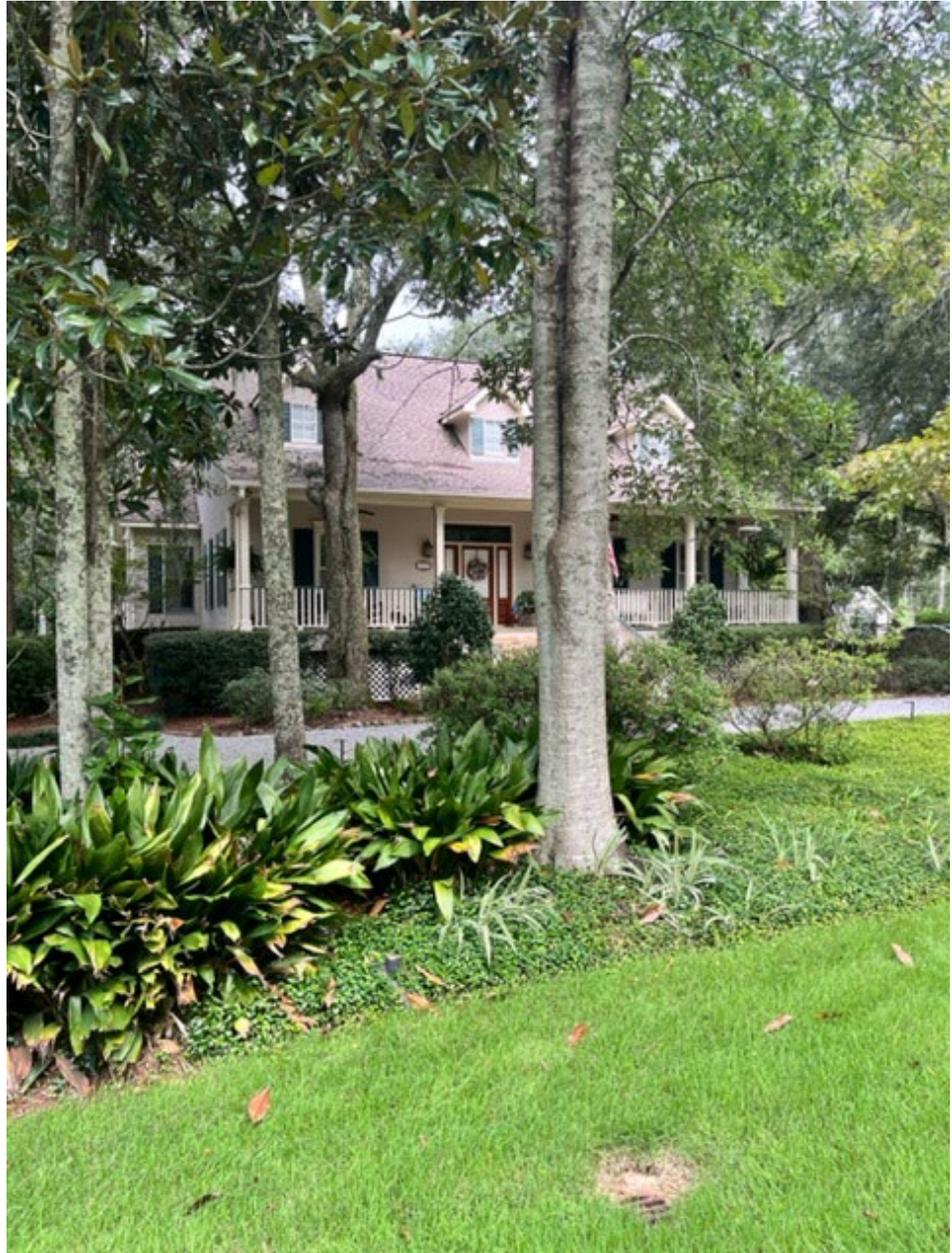
Photo No. 9

Tree # 2 – This subject tree is a young Water Oak (*Quercus nigra*) tree that is in the front yard of the property (see photo # 1 of the attached Photo Log). This tree is native to the region, and is prolific however, it is a terrible urban tree, in my opinion, largely due to growth habit and the growth characteristics of this species. This tree has a co dominant stem, with a tight "v" crotch which has formed inclusion. This tree will fail, and it is highly likely that it will fail at this point. This tree presents a risk to your property, adjacent roadways, and utilities overhead. This tree should be removed now to mitigate the risk of failure of this tree.

Description: This photo shows subject Tree # 2, as shown on the site map (Photo 1). This tree is a young Water Oak with a codominant stem and inclusion.

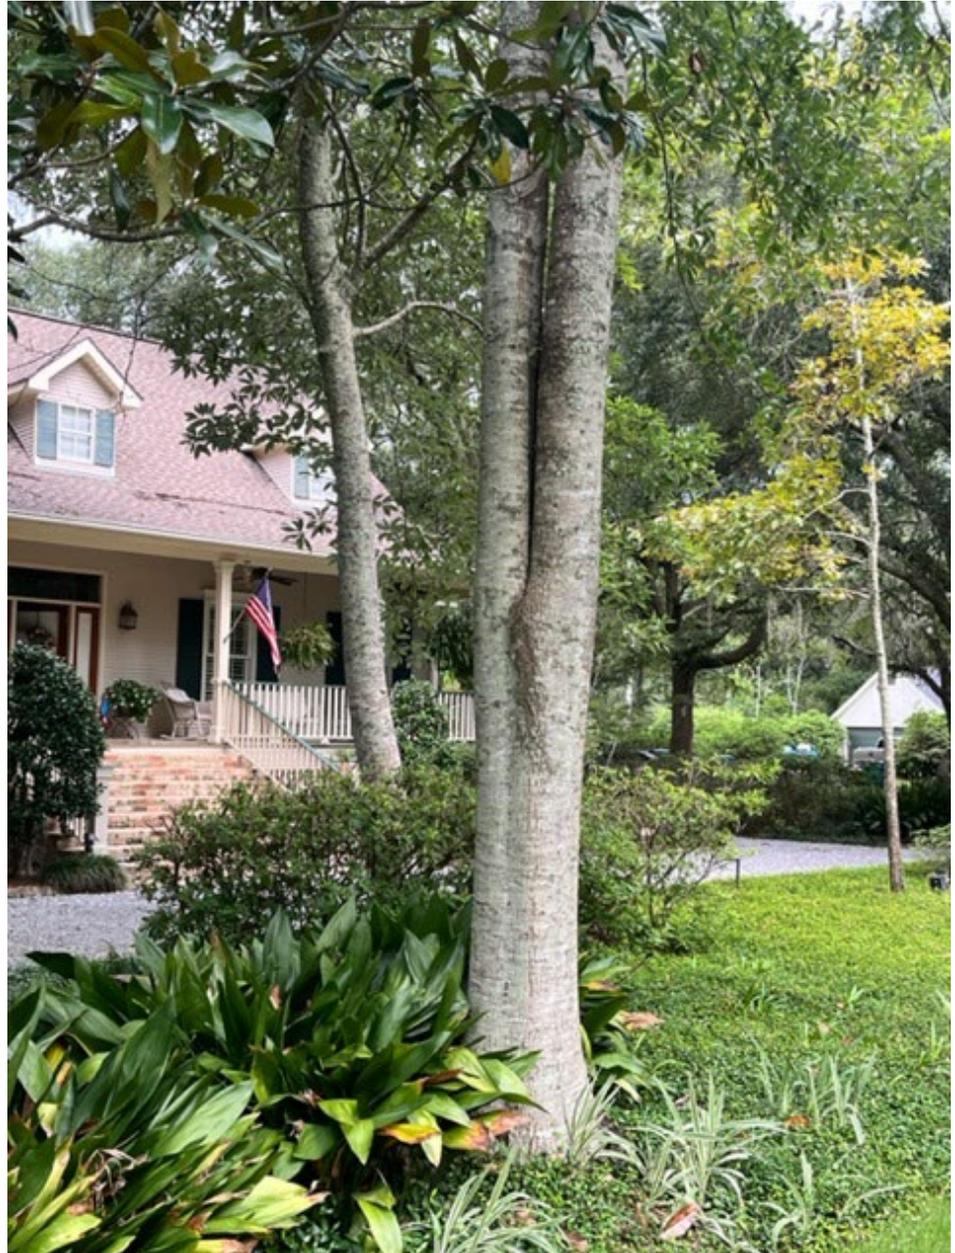
Photo No. 10

Description: This photo shows subject Tree # 2, as shown on the site map (Photo 1). This tree is a young Water Oak with a codominant stem and inclusion.
