**COM PROJ. NO. 100.21.019
SEAWALL REPAIR (INSPECTION PROJECT)
FINAL FINDINGS/ASSESSMENT REPORT**

The City of Mandeville
1100 Mandeville High Blvd.
Mandeville, LA 70471

Prepared by
BURK-KLEINPETER, INC.
4176 Canal Street
New Orleans, LA 70119

APRIL 2023

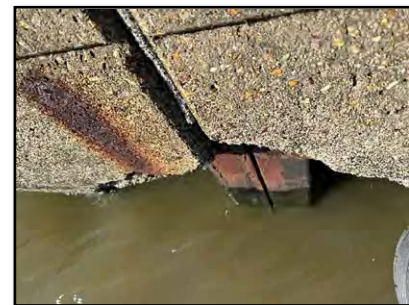
3.1.3 Full-Depth Spalled Concrete Section with Exposed Sheet Piling

This condition was mainly noted at the bulkhead expansion joints. A typical full-depth spall repair can be accomplished in the following steps:

1. Saw-cut full-depth concrete bulkhead to limits extending 2" beyond the spall limits.
2. Carefully chip and remove spalled concrete per plan limits and avoid damaging sheet piling.
3. Remove all heavy oxides and other bond-inhibiting materials from all exposed surfaces.
4. Install epoxy-bonded dowel bars into joint contact surfaces as per plan details.
5. Apply surface bonding agent and pour non-shrink concrete section.
6. Seal Expansion joint with approved marine-grade silicone joint sealant.

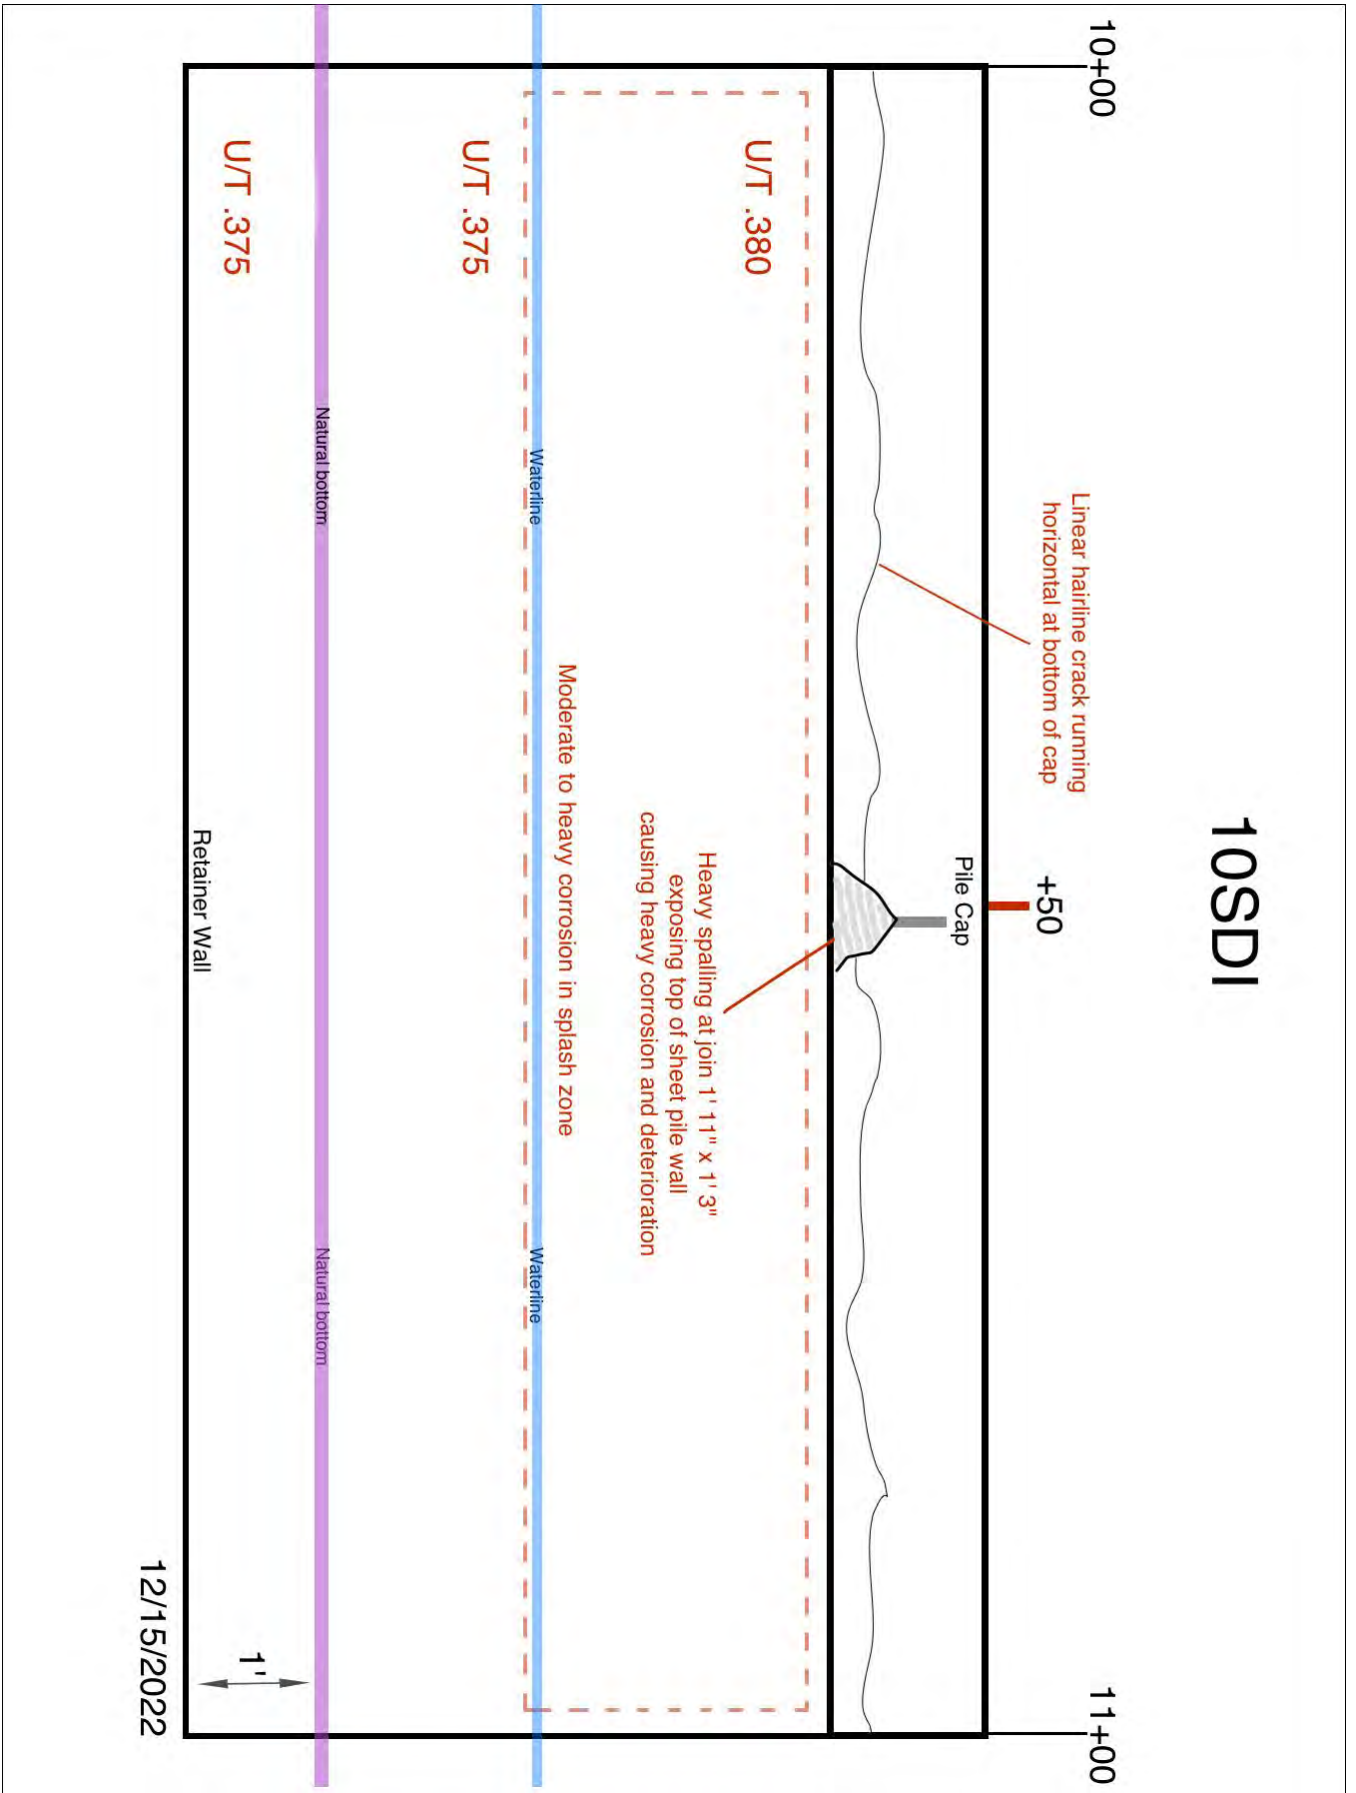
10+00

Linear hairline crack running horizontal at bottom of cap

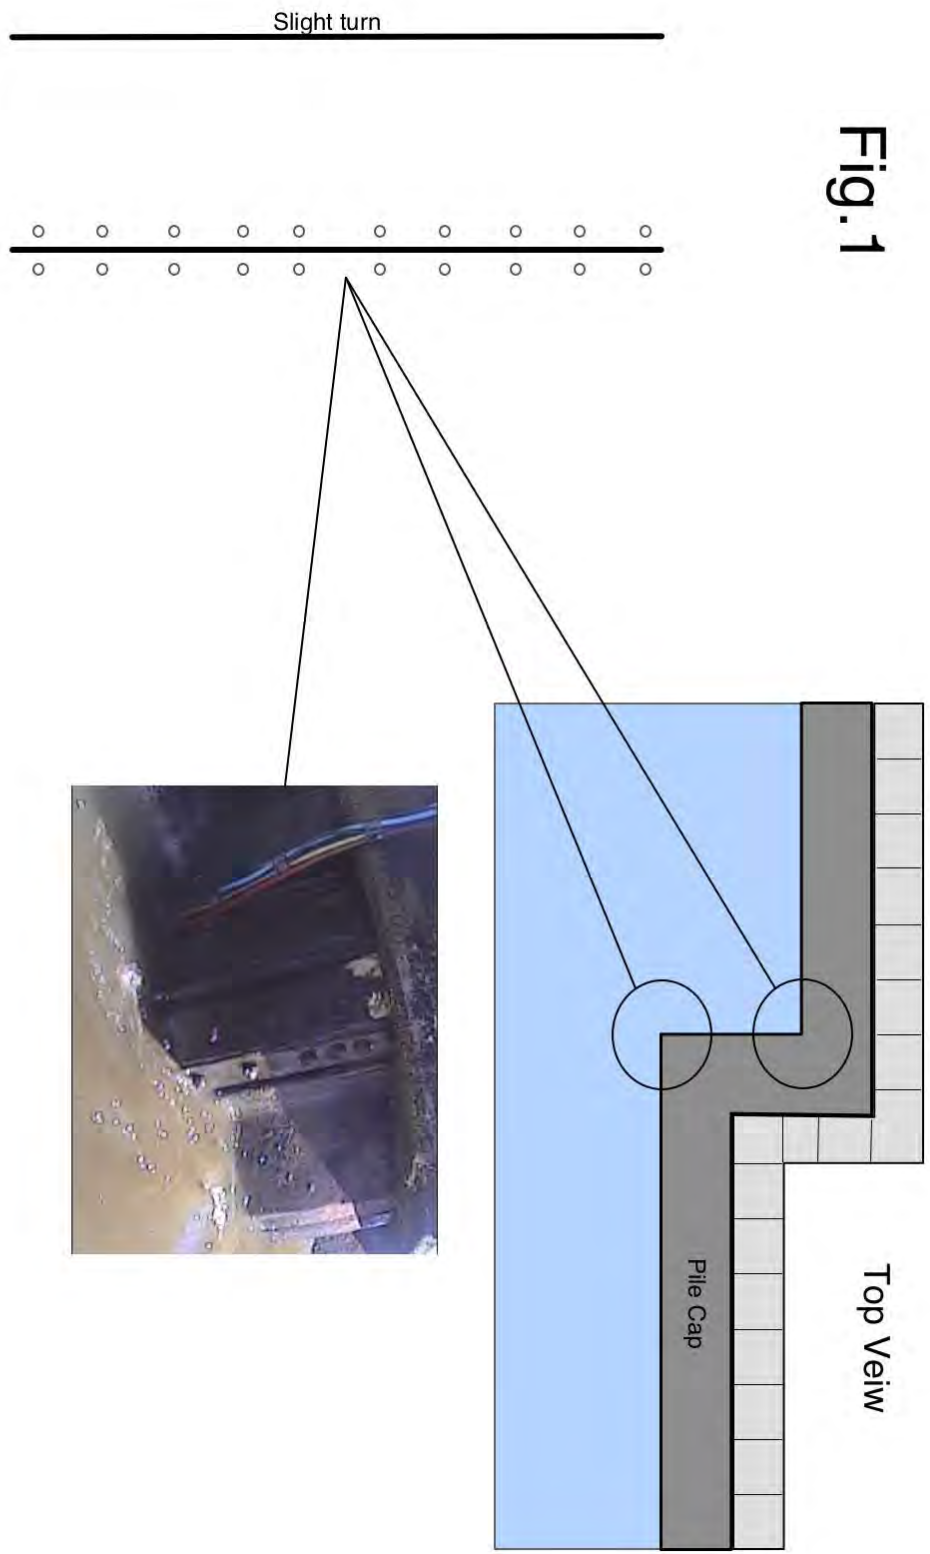
This drawing represents a hard turn on the sea wall with an L shaped bracket and hardware joining two sections of sheet pile. Aslo displayed is a slight turn with no preexisting hardware

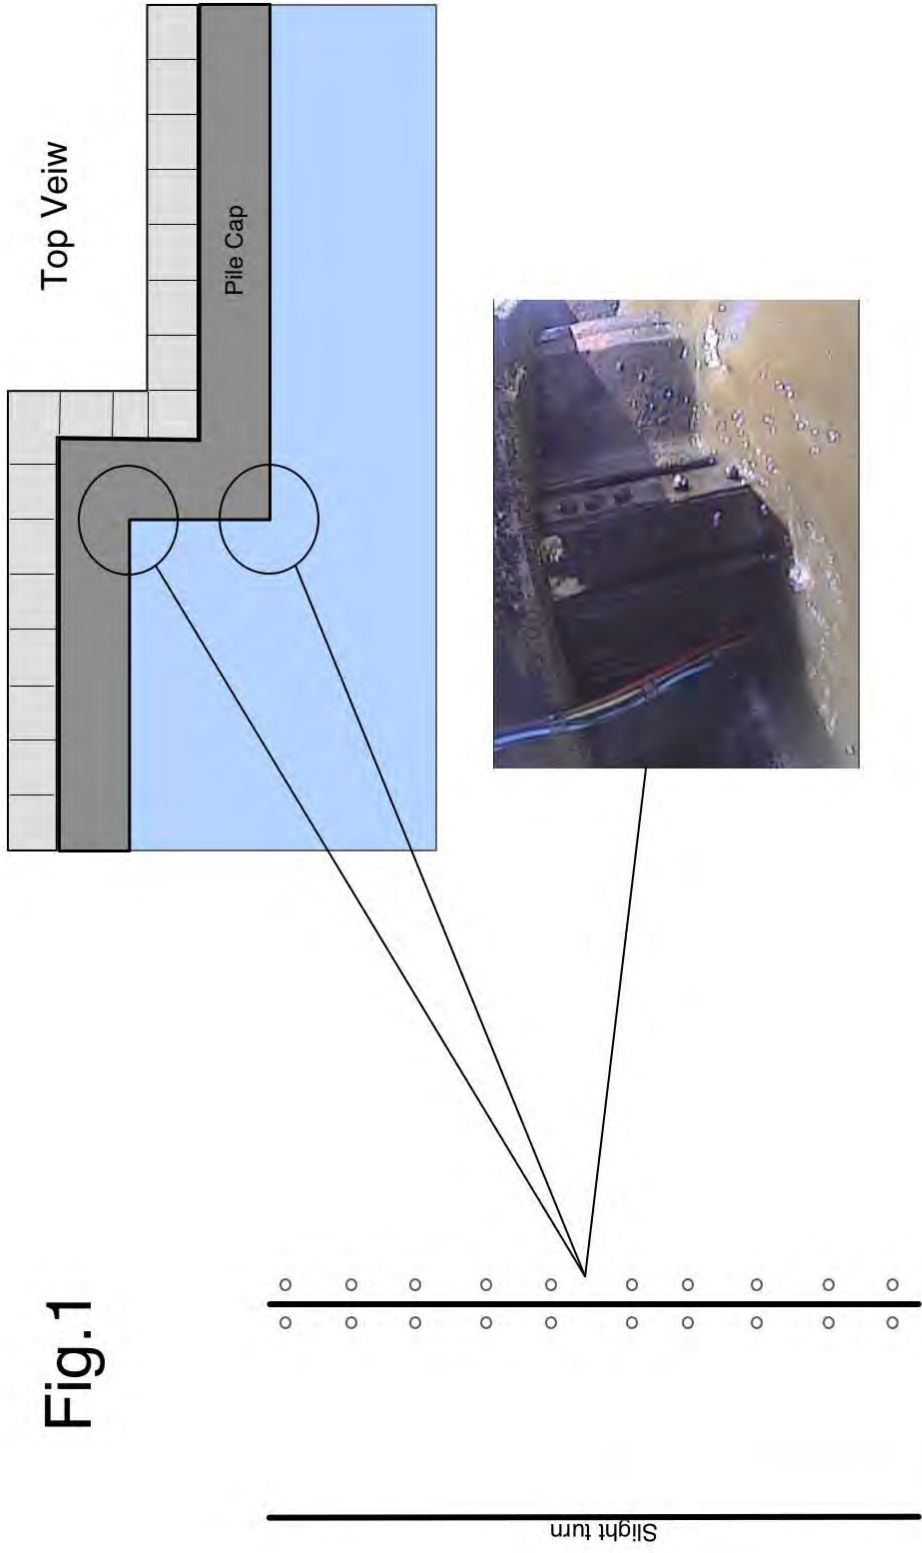
Fig.1

Heavy corrosion on all hardware Fig. 1

Heavy corrosion
on all hardware at joint
Fig:1

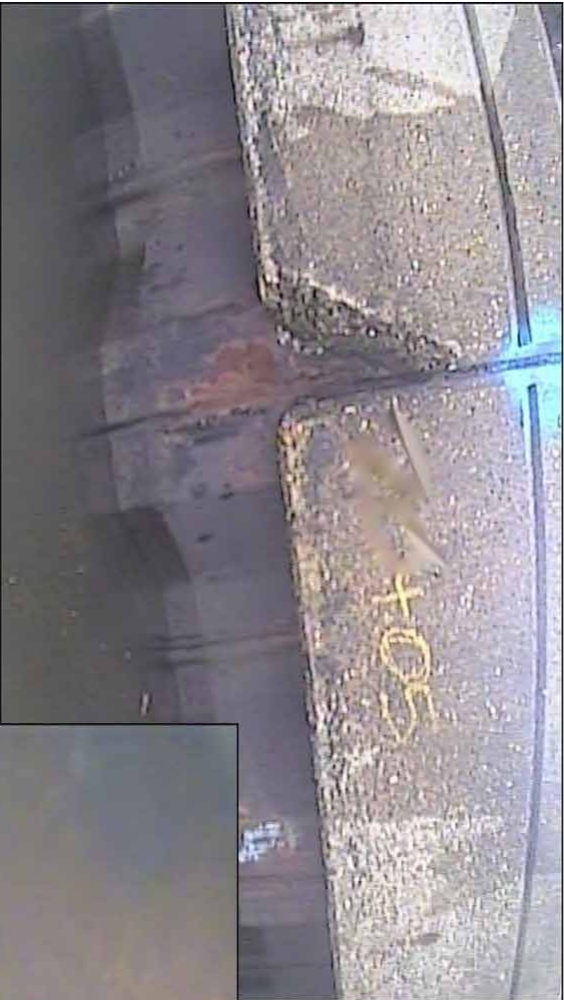
Heavy Spalling at joint
1' 5" x 10" exposing top of
sheet pile causing heavy corrosion
and deterioration.
Fig. 16

Heavy corrosion and deterioration of sea wall at the joint
approximately 2' x 2' exposed and continuing below natural bottom.
Hardware are missing at bottom with a slight bow outward
at the joint.
Fig. 16

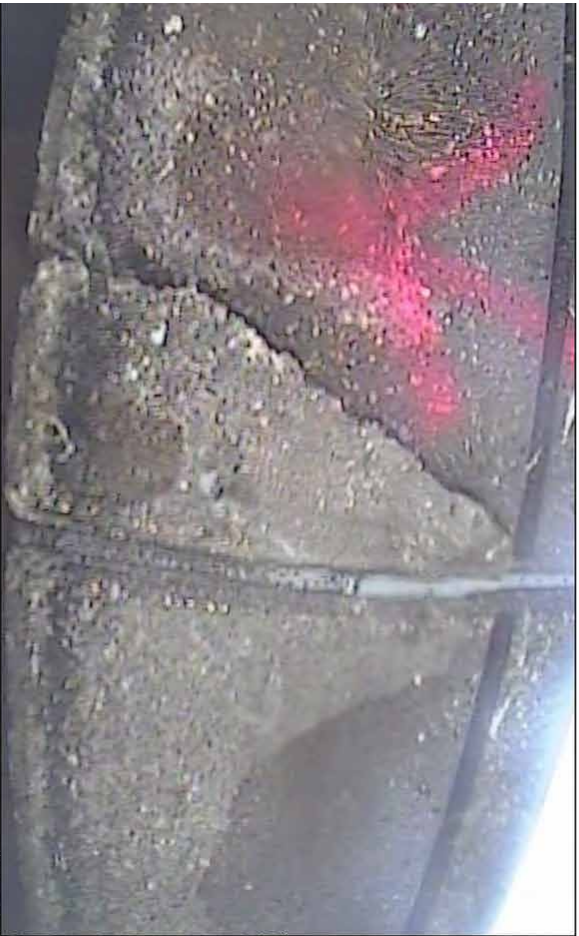
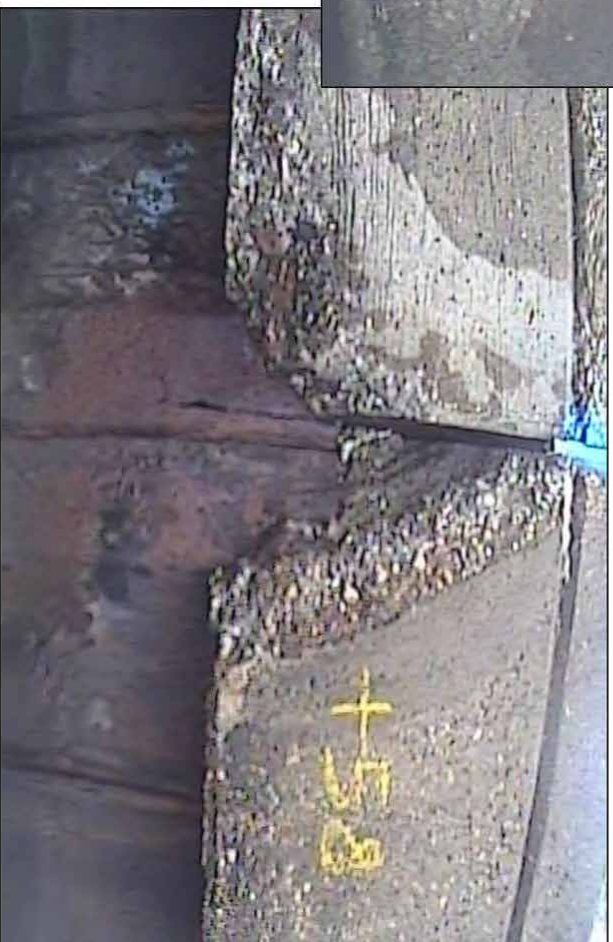
Area beginning to spall at joint 1' x 8" Fig. 17

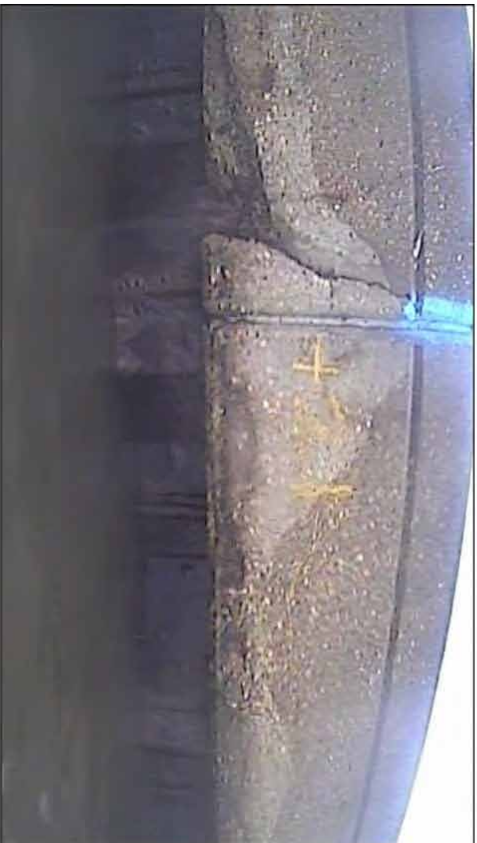
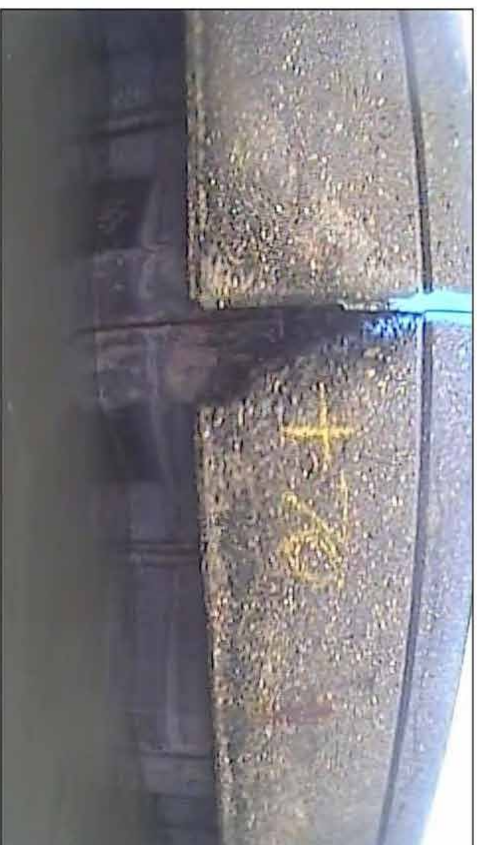
Heavy spalling at joint 1' 10" x 2' exposing top of sheet pile causing heavy corrosion and deterioration Fig. 18

Heavy spalling at the joint 1' 1 1/2" x 9" exposing top of sheet pile causing heavy corrosion and deterioration Fig. 18

Heavy corrosion and deterioration on sheet pile at bottom of joint approximately 8" x 11" with hardware missing. Fig. 18

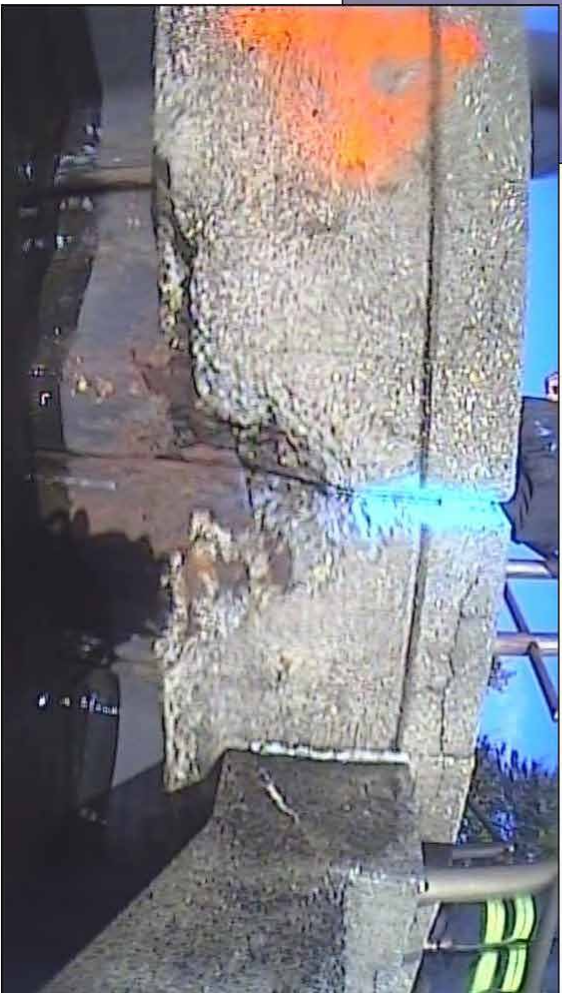
Heavy corrosion and deterioration on joint bracket and hardware. Approximately 2' section separated from sheet piles and 9" section missing at bottom.

Heavy spalling at joint 3' x 1' 6" exposing top of sheet pile causing heavy corrosion and deterioration Fig.20

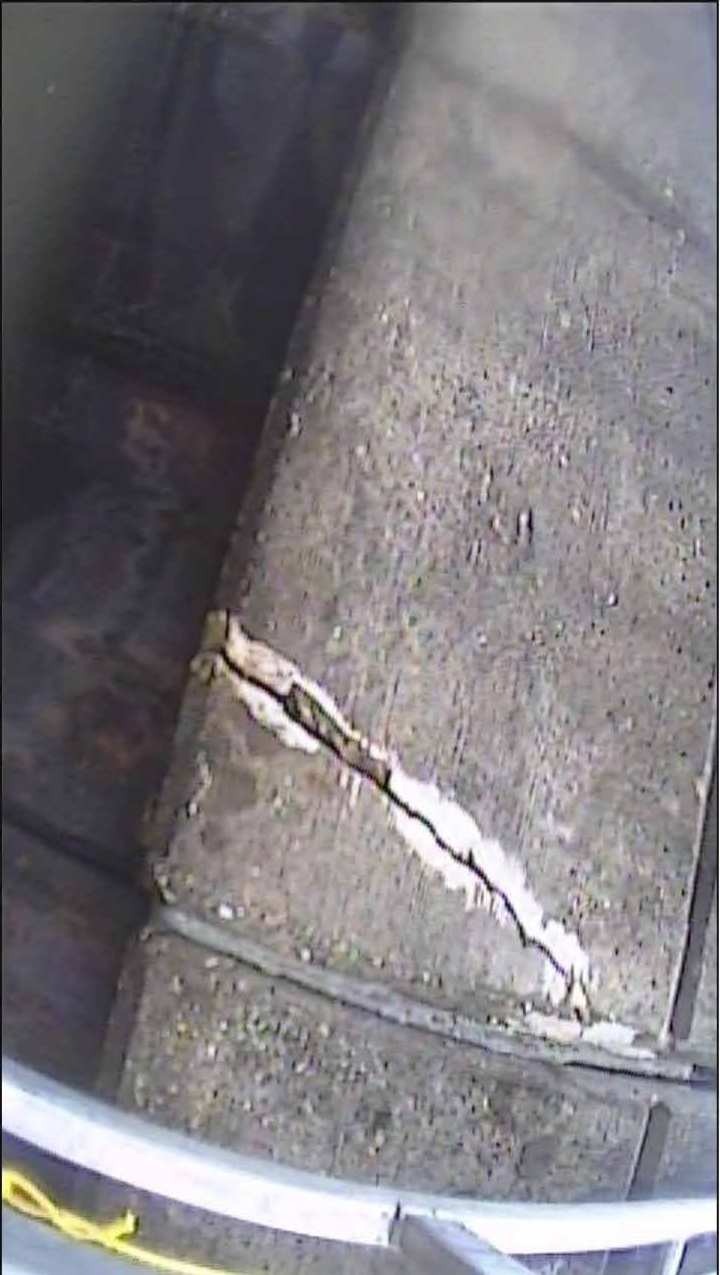
Area beginning to spall
1' 9" x 8" Fig.22

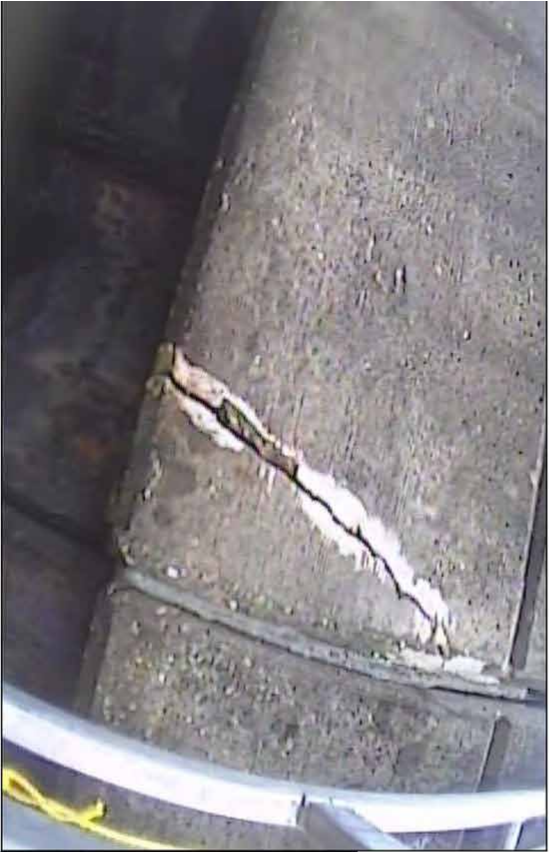
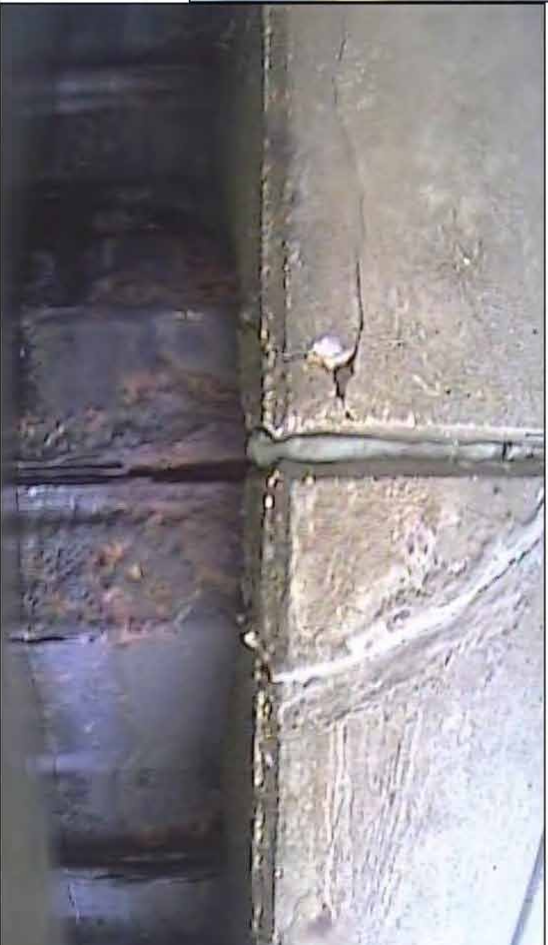
Fig.23

Area beginning to spall
1' 8" x 8" Fig:23

Area beginning to spall
1' 8" x 10" with exposed top of sheet pile
Fig:23

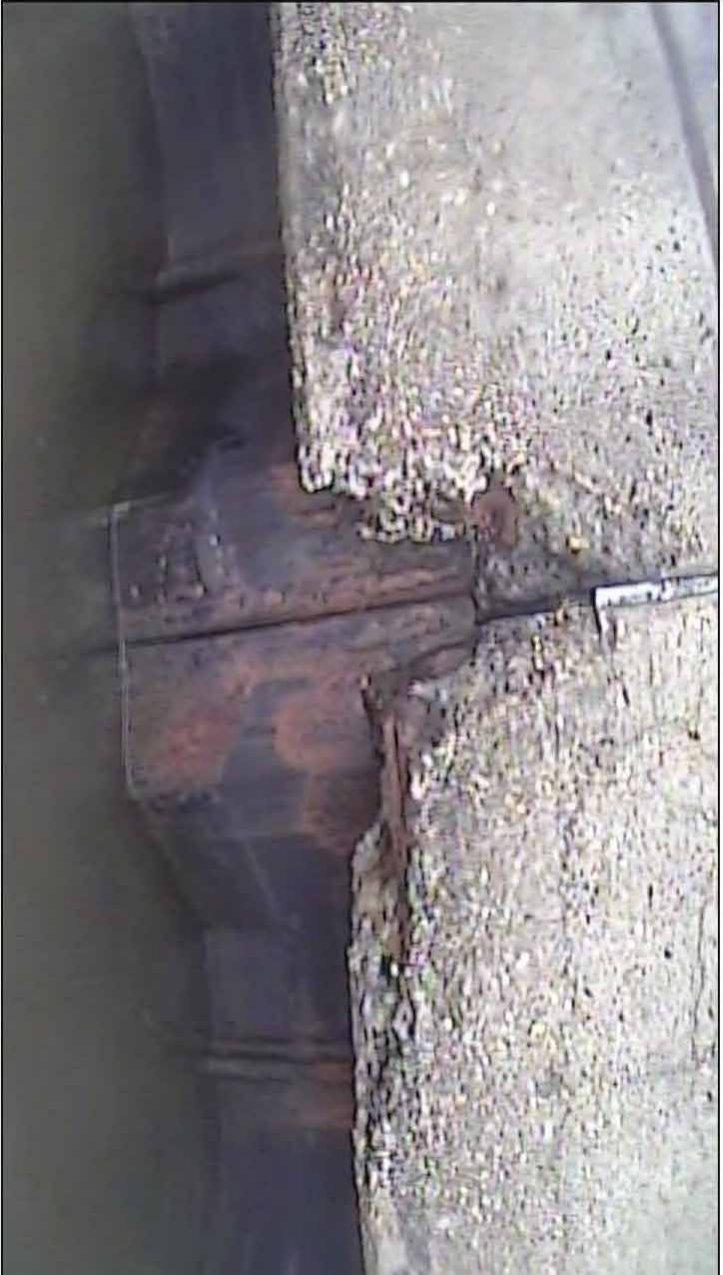
Heavy spalling at joint
2' 5" x 1' 9" exposing top of sheet pile causing heavy corrosion and deterioration
Fig.24

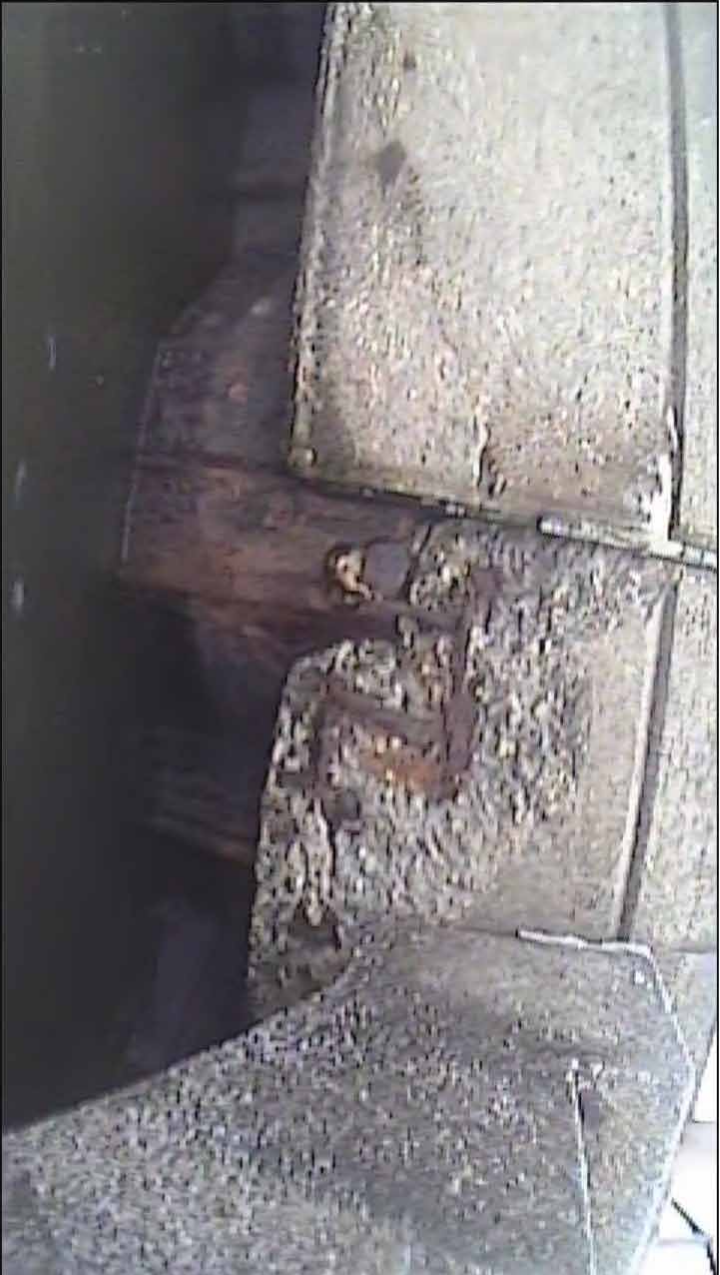
Heavy spalling at joint
4' 1" x 2' 1" exposing top of sheet pile
causing heavy corrosion and deterioration
Fig.25

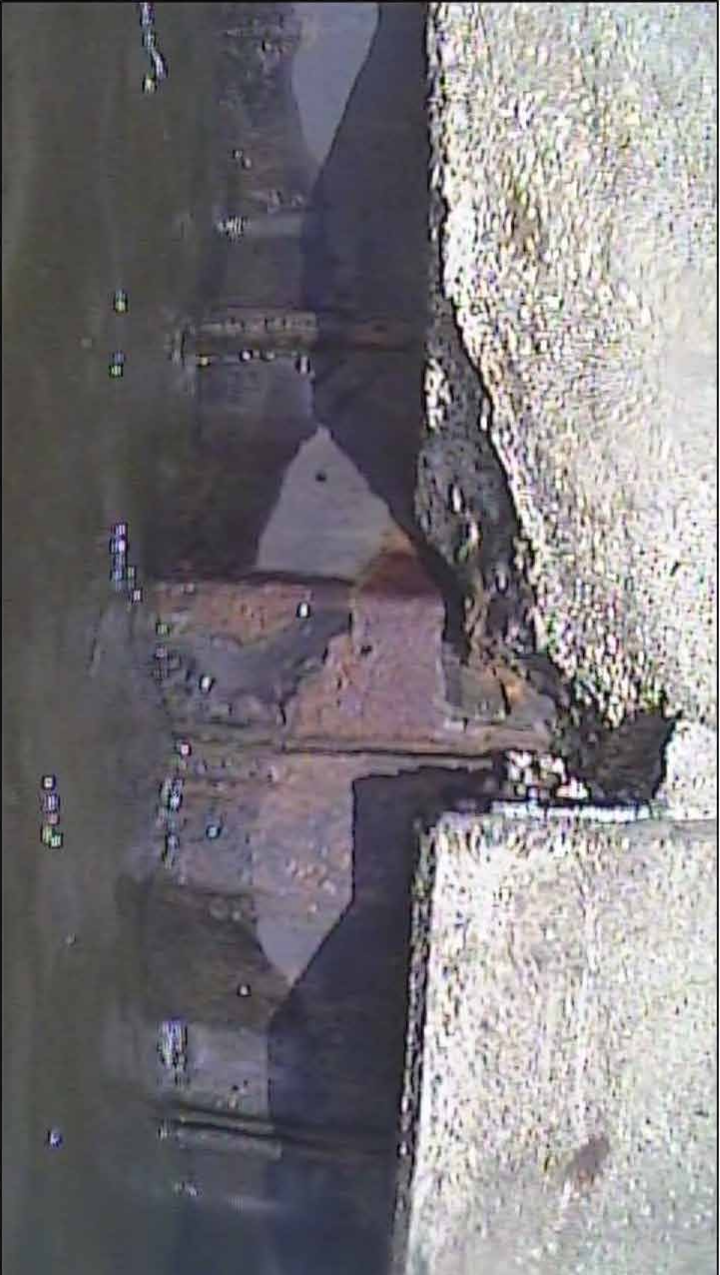
Heavy spalling at the joint
2' x 1' 2" exposing top of sheet pile
causing heavy corrosion and deterioration
Fig.26

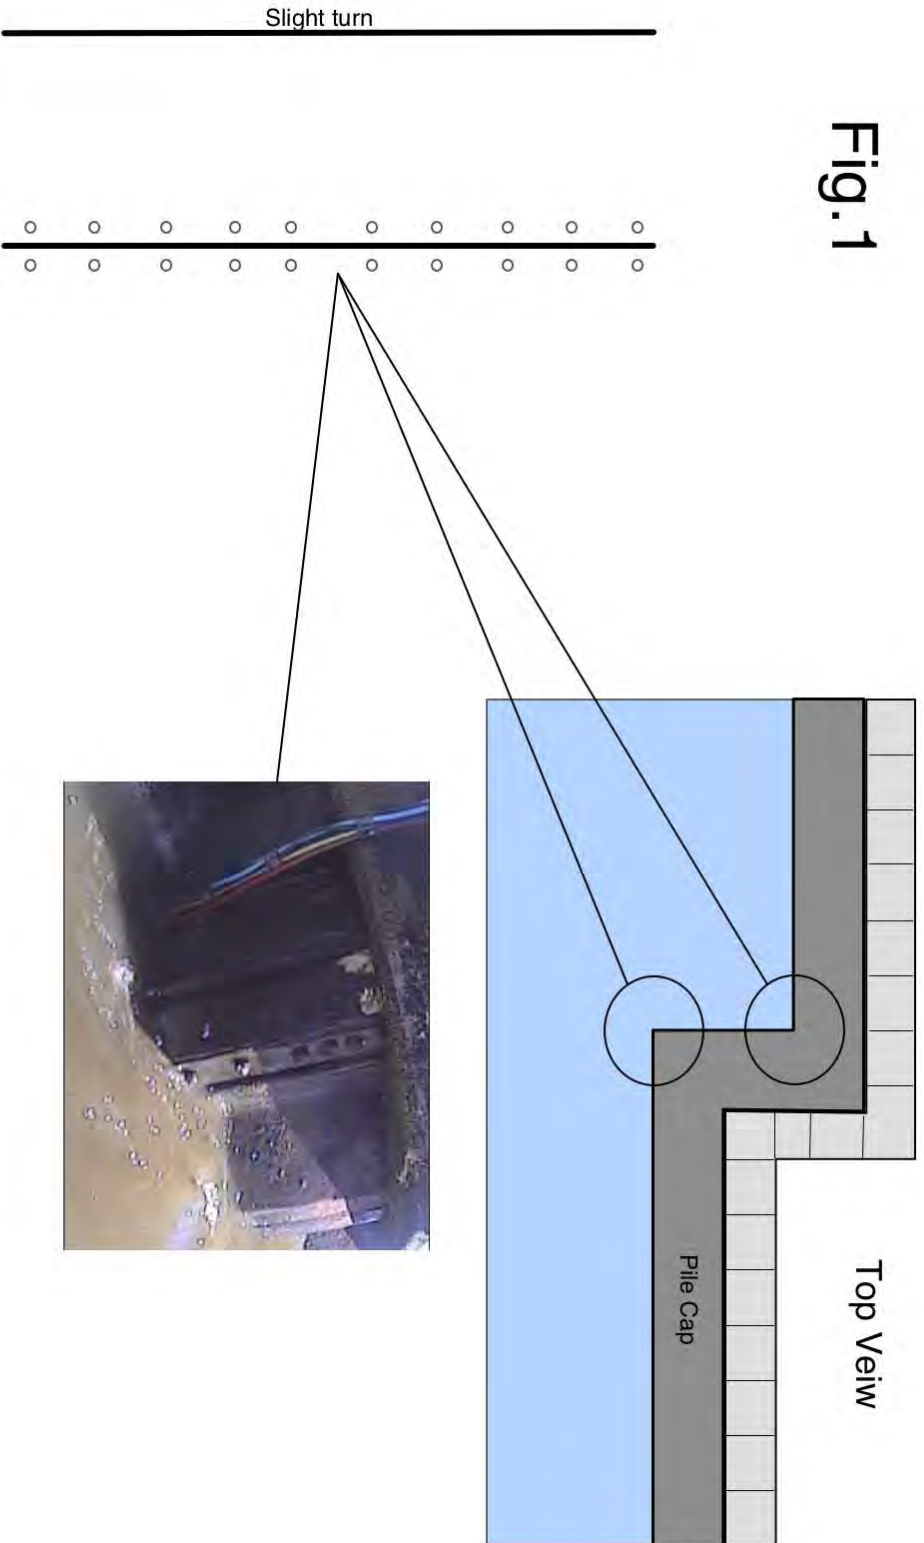
Heavy corrosion on all hardware at joint Fig. 1

Heavy corrosion on all hardware Fig. 1

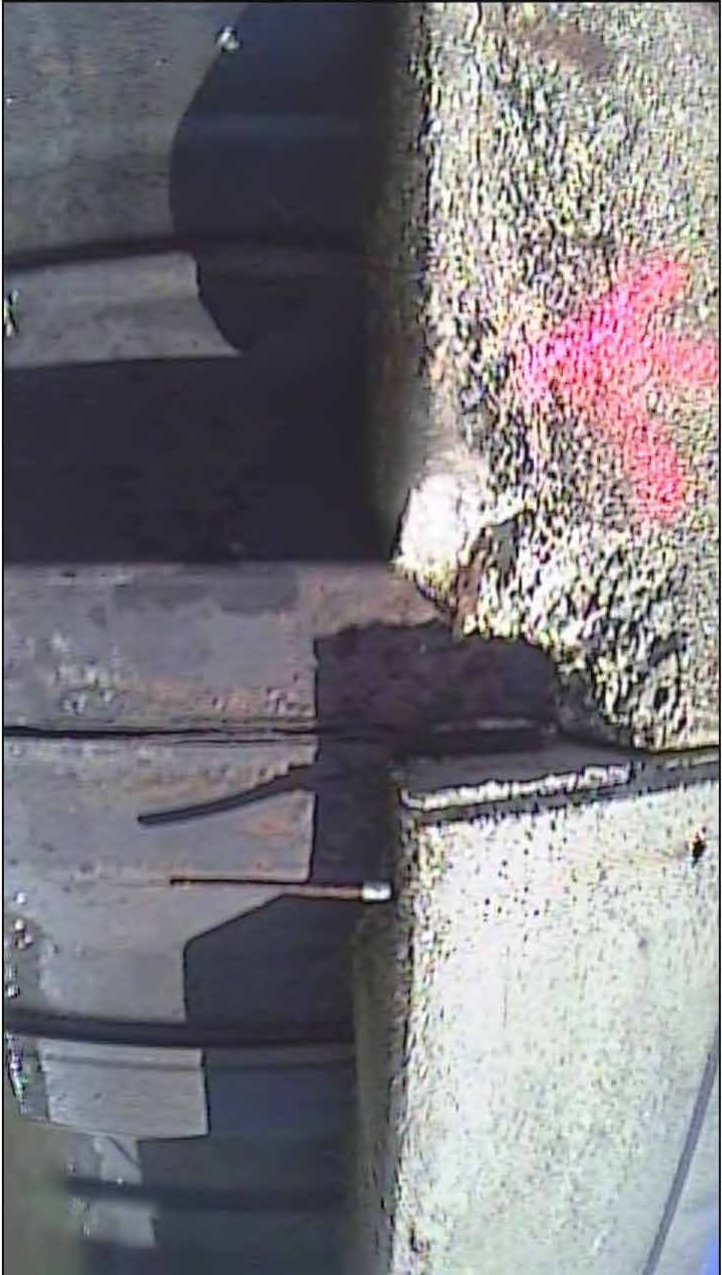
Fig.29

Heavy spalling at the joint 4' 5" x 1' 10" exposing the top of sheet pile causing heavy corrosion and deterioration Fig. 29

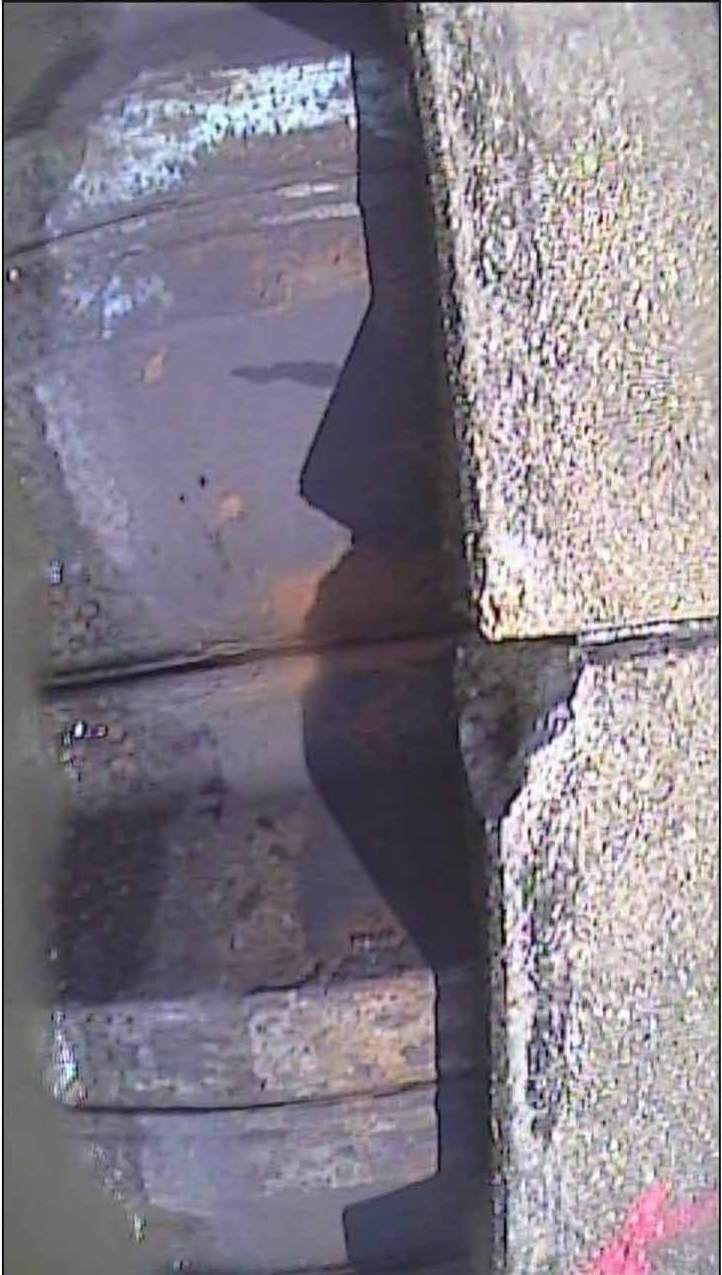
Heavy corrosion and deterioration at the joint approximately 3' x 8" Fig.31

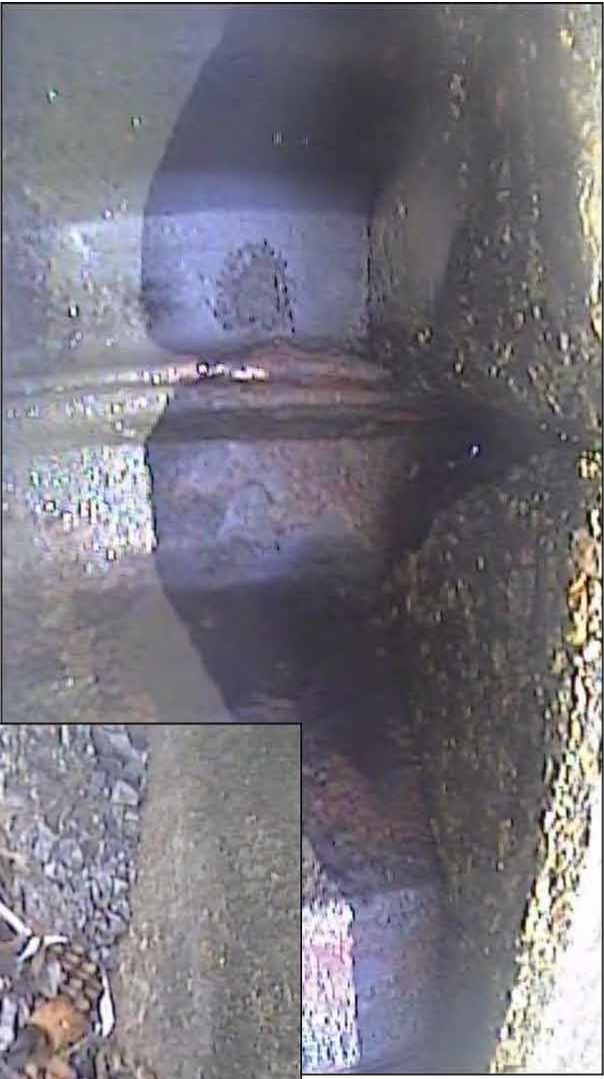
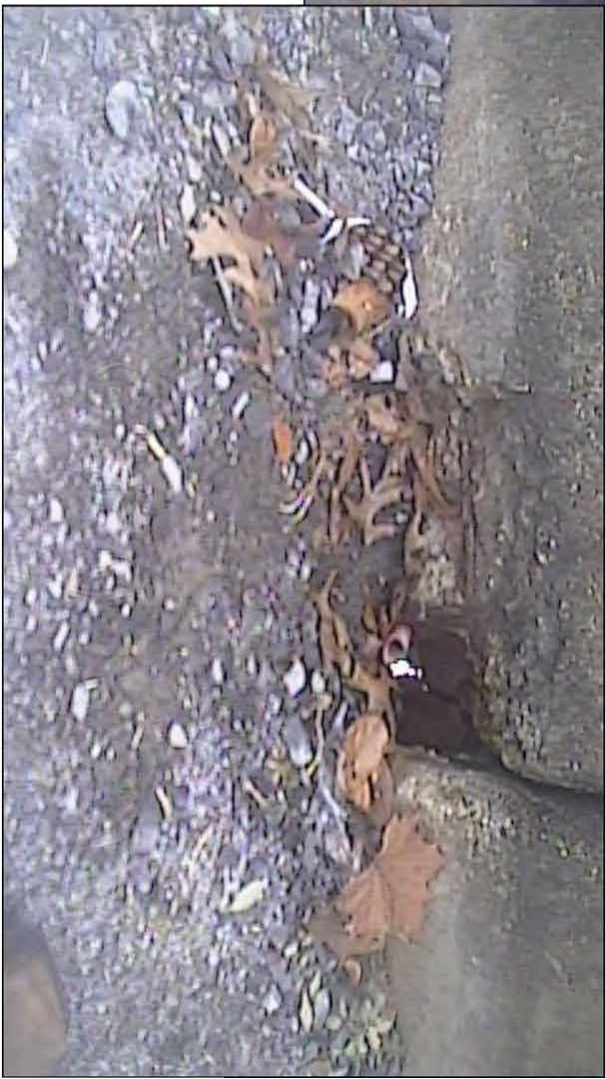
Heavy corrosion and deterioration on sheet pile wall at knuckle 11" x 7" Fig.32

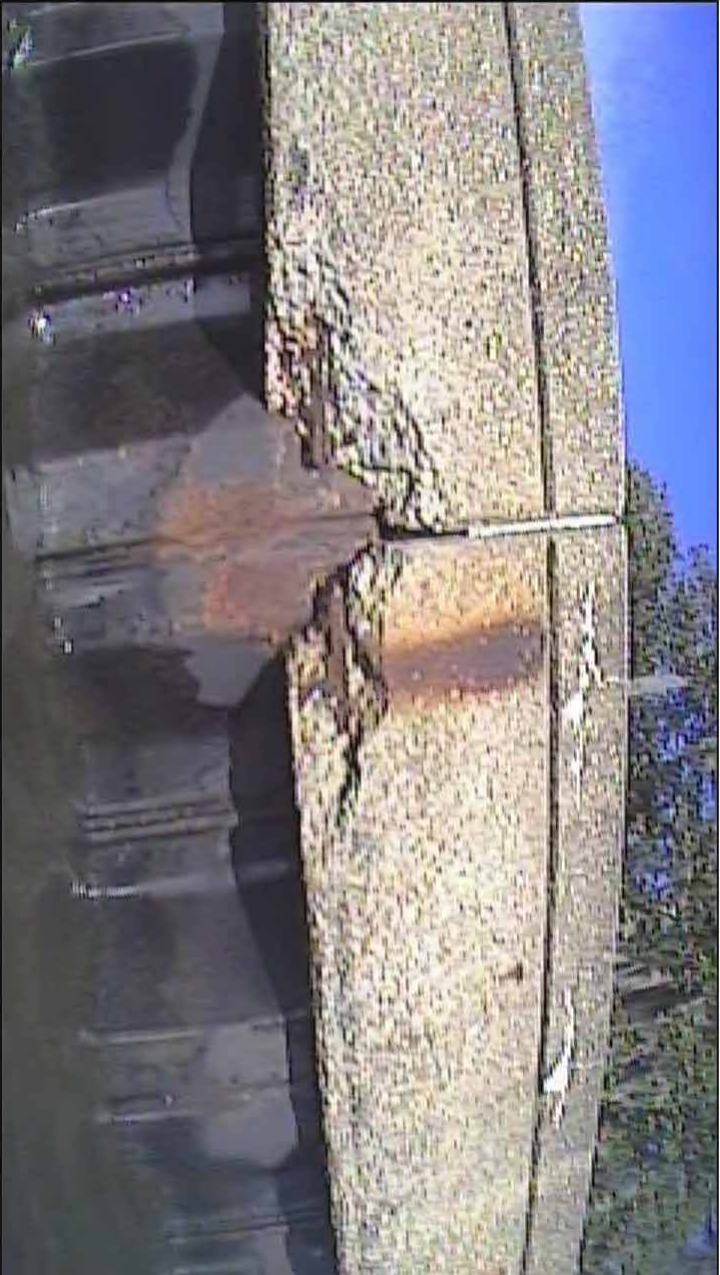
Fig.34

Heavy spalling at joint
3' 4" x 1' 3" exposing top of sheet pile wall causing heavy corrosion and deterioration
Fig. 34

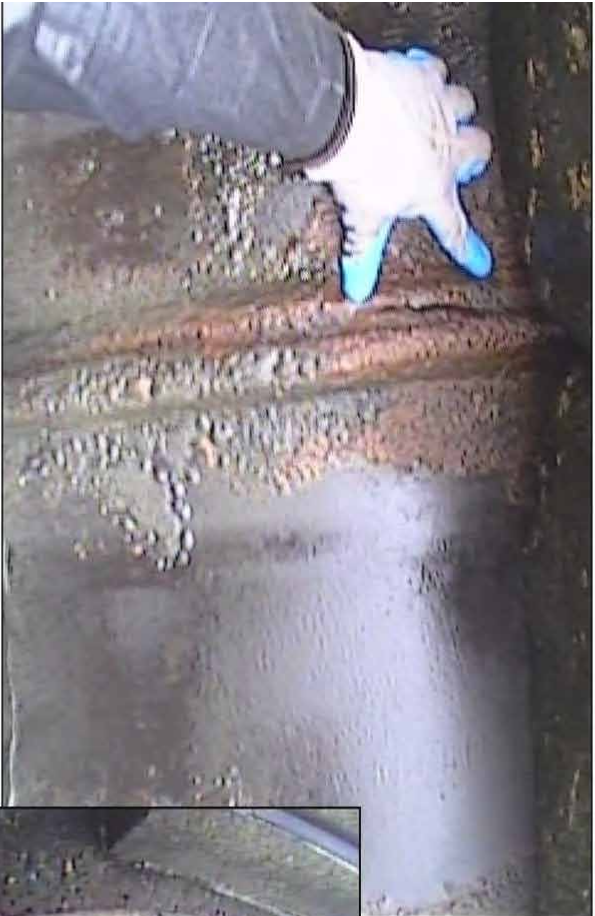
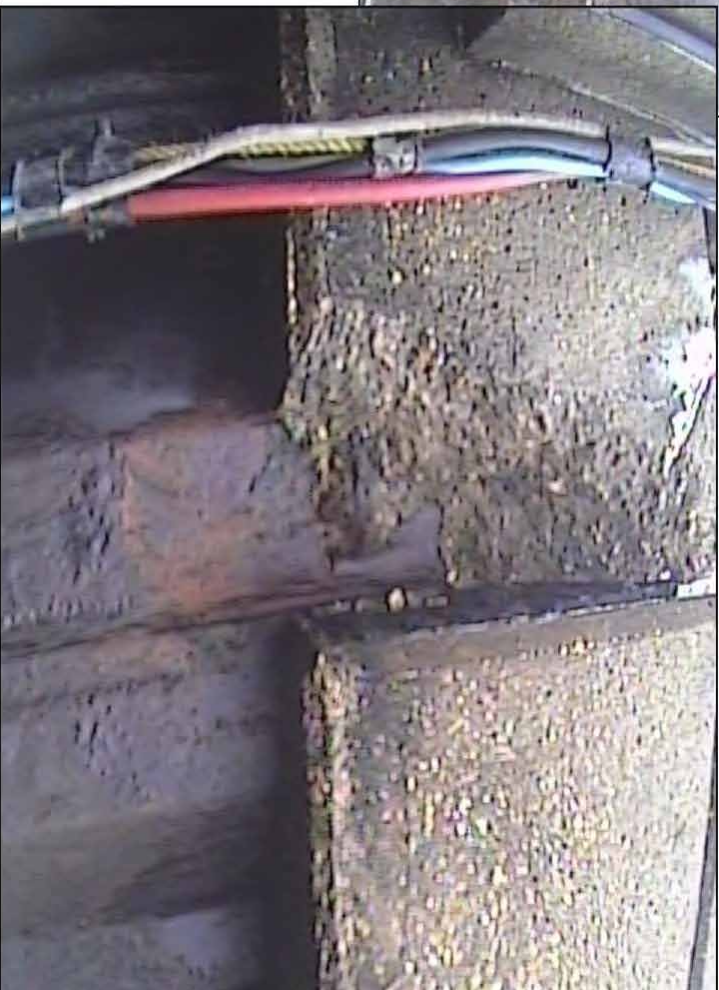
UT .365
Cracking on the sheet pile wall at the knuckle below pile cap 5" x 1/4"
Fig.35

Heavy Spalling at the joint 1' x 10" exposing top of sheet pile wall causing heavy corrosion and deterioration.
Fig.35

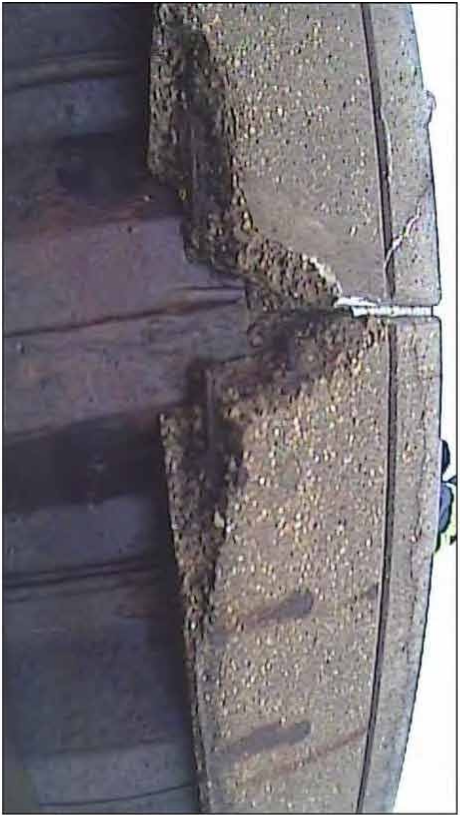
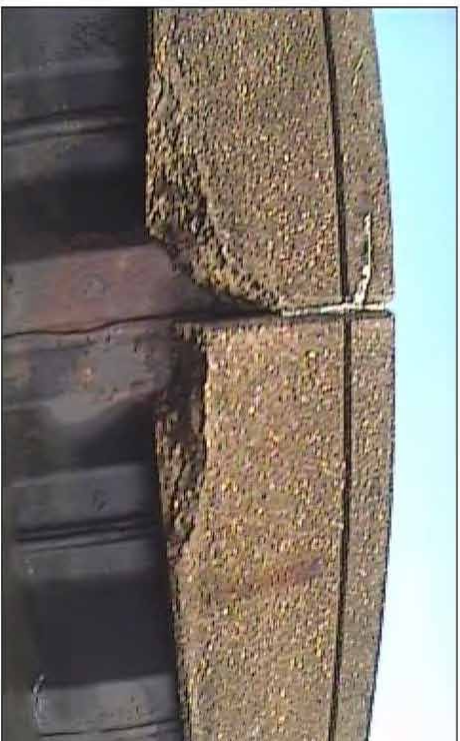
Heavy spalling at joint
3' 10" x 2' exposing top of sheet pile wall causing heavy corrosion and deterioration.
Fig.36

Heavy spalling at joint
3' 11" x 1' 4" exposing top of sheet pile wall causing heavy corrosion and deterioration
Fig.36

Moderate to heavy corrosion in splash zone
Heavy corrosion and deterioration on sheeppile wall 7" x 7" on left of break wall and 9" x 8" on right.
Fig.36

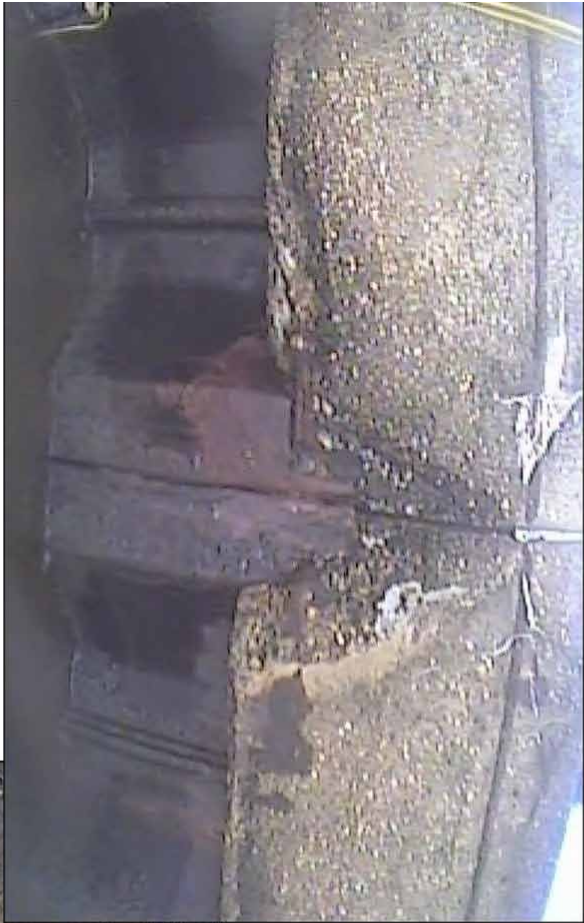
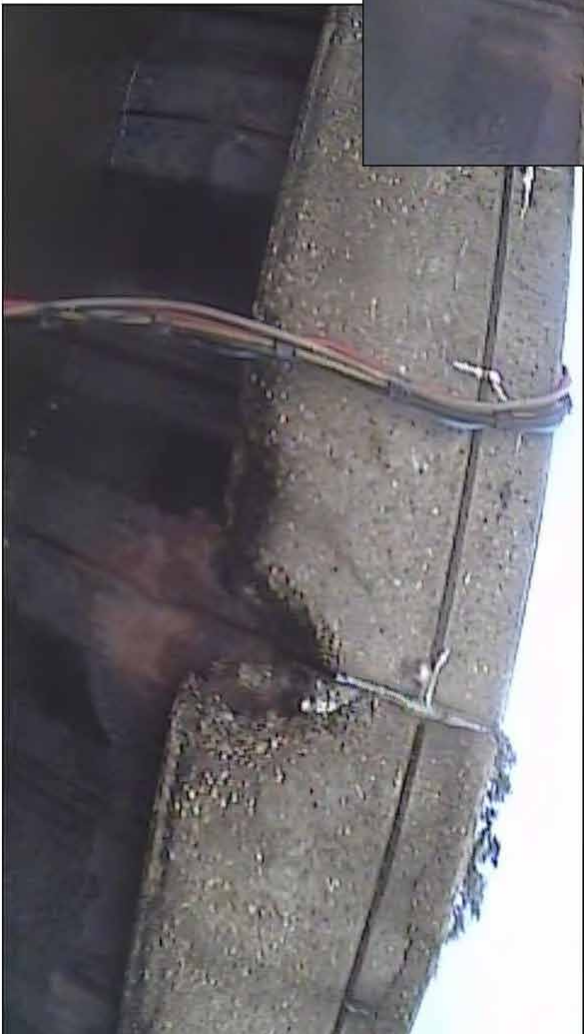
Heavy Spalling at joint
3' x 1' 10" exposing top of sheet pile wall causing heavy corrosion and deterioration
Fig.38

Heavy spalling at joint
2' 8" x 1' 6" exposing top of sheet pile wall causing heavy corrosion and deterioration
Fig.38
