**COM PROJ. NO. 100.21.019
SEAWALL REPAIR (INSPECTION PROJECT)
FINAL FINDINGS/ASSESSMENT REPORT**

The City of Mandeville
1100 Mandeville High Blvd.
Mandeville, LA 70471

Prepared by
BURK-KLEINPETER, INC.
4176 Canal Street
New Orleans, LA 70119

APRIL 2023

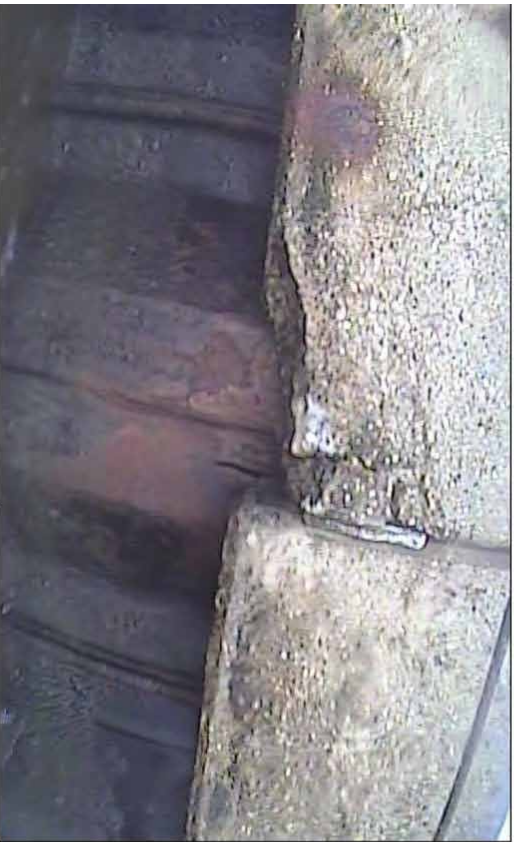
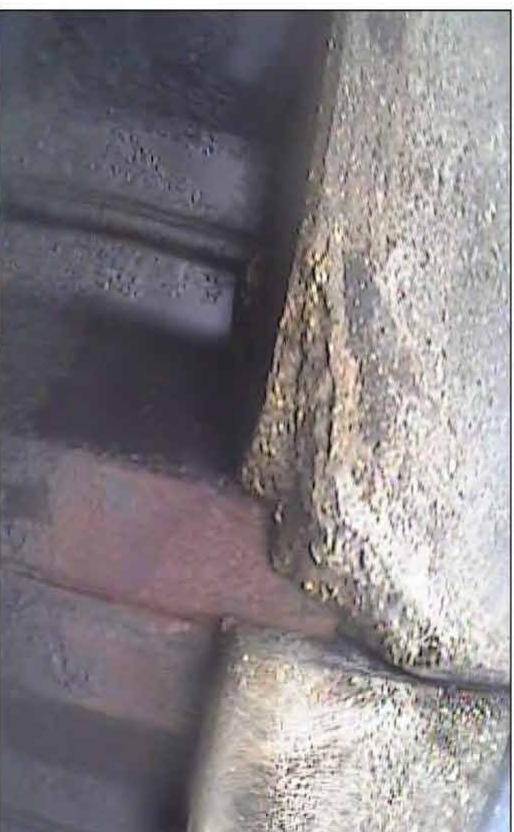
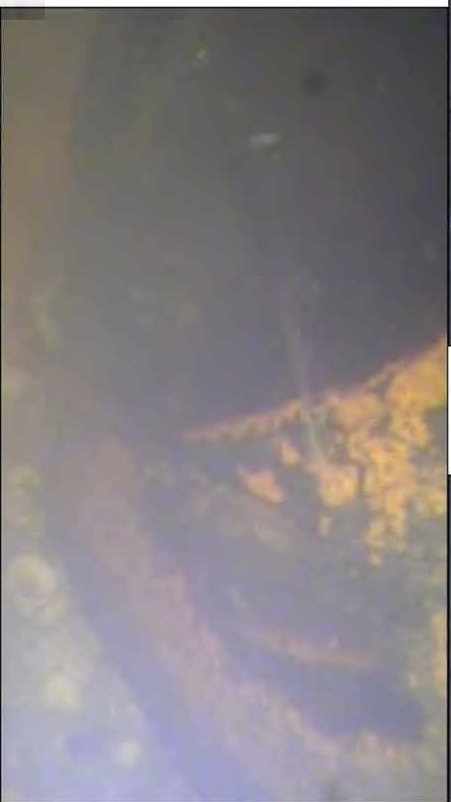
UT .375
Heavy spalling at joint
1' 6" x 1' exposing top of sheet pile wall
causing heavy corrosion and deterioration
Fig.39

Heavy spalling at joint
2' x 1' exposing top of sheet pile wall
causing heavy corrosion and deterioration
Fig.39

Multiple areas with heavy corrosion and deterioration around drain pipe
Fig.39

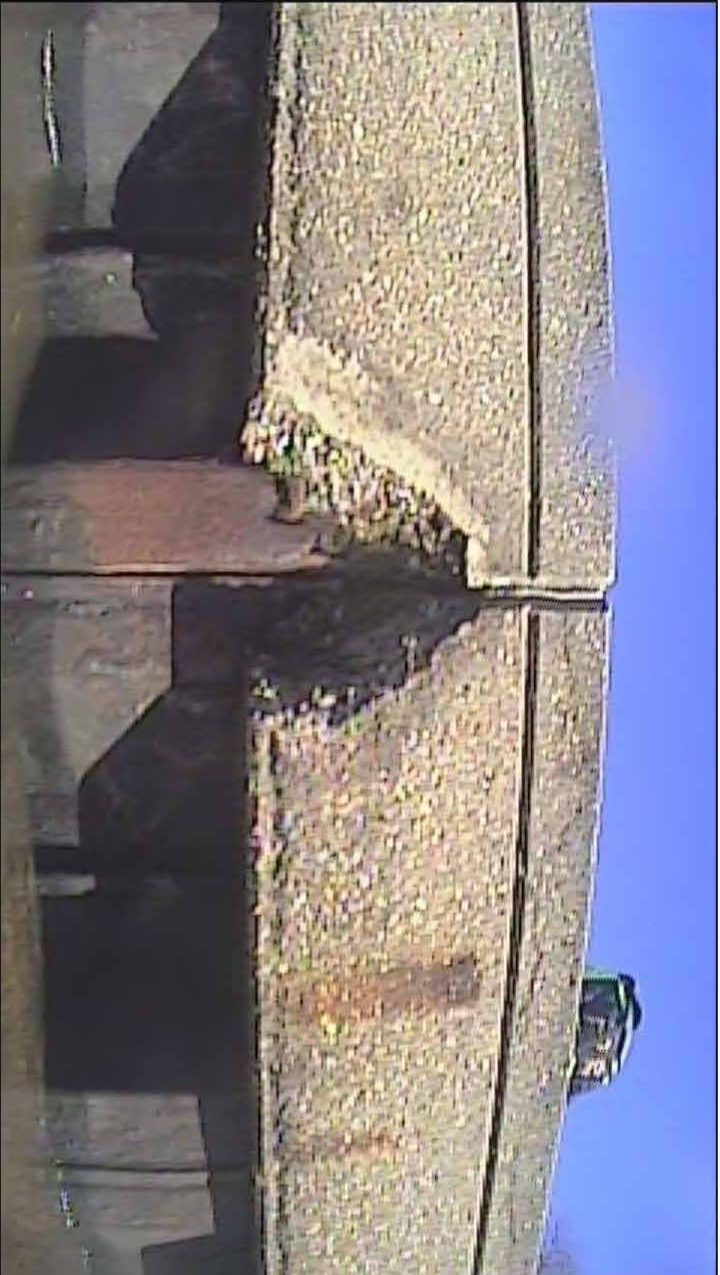
Fig.40

Heavy spalling at joint
1' 8" x 1' 7" exposing top of sheet pile wall
causing heavy corrosion and deterioration.
Fig. 40

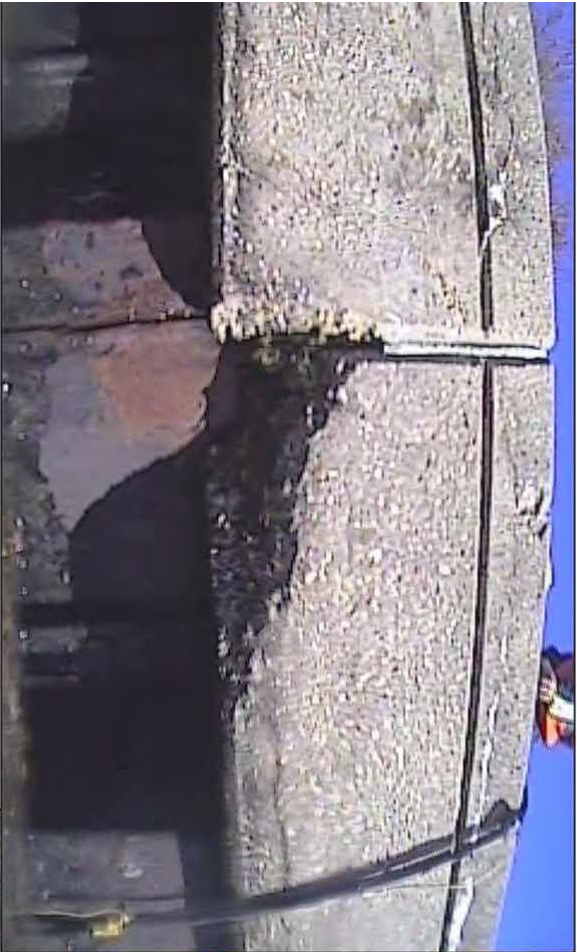
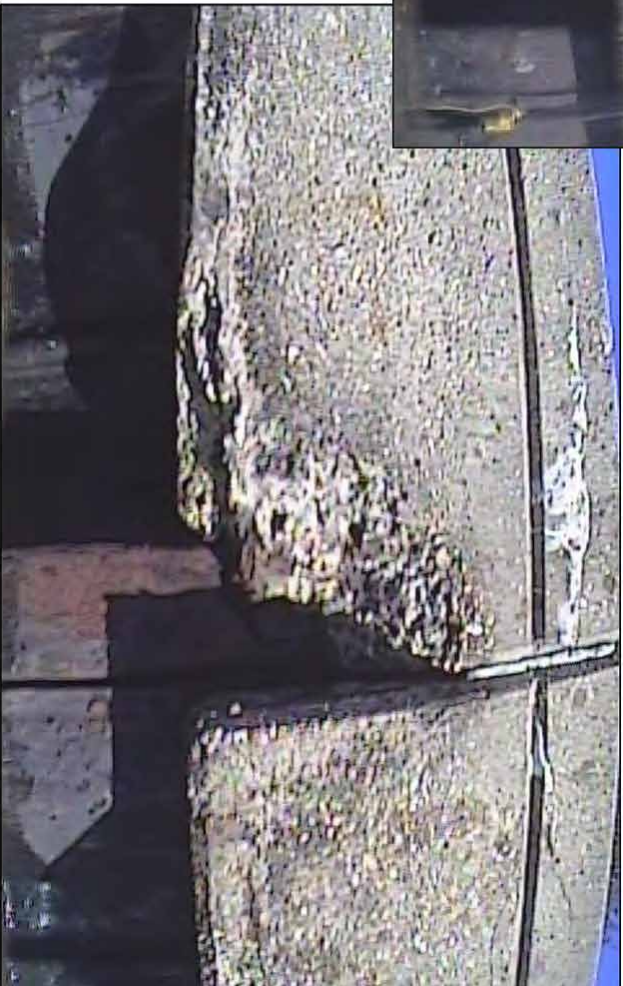
UT .365
Heavy spalling at joint
2' x 1' 2" exposing top of sheet pile wall causing heavy corrosion and deterioration.
Fig.41

UT .365
Heavy spalling at joint
1' 9" x 1' 7" exposing sheet pile wall causing heavy corrosion and deterioration.
Fig.41

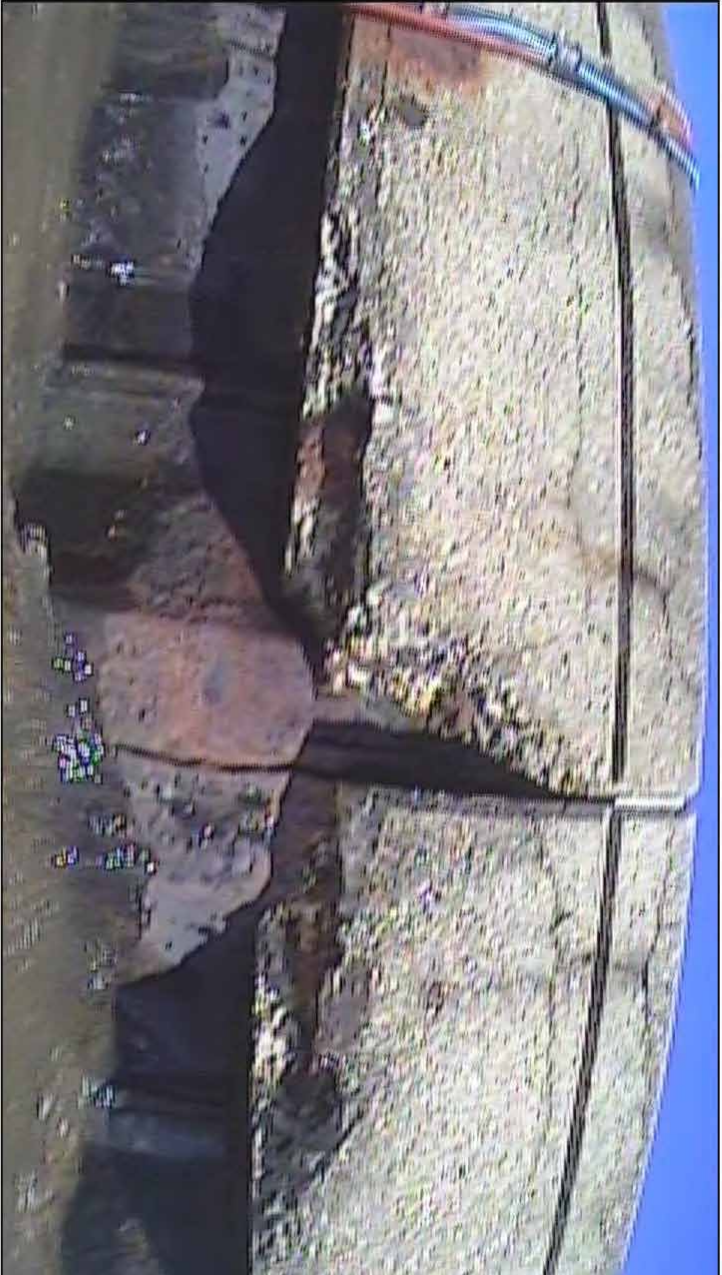
Heavy spalling at joint
3' 6" x 2' exposing top of sheet pile wall causing heavy corrosion and deterioration
Fig.42

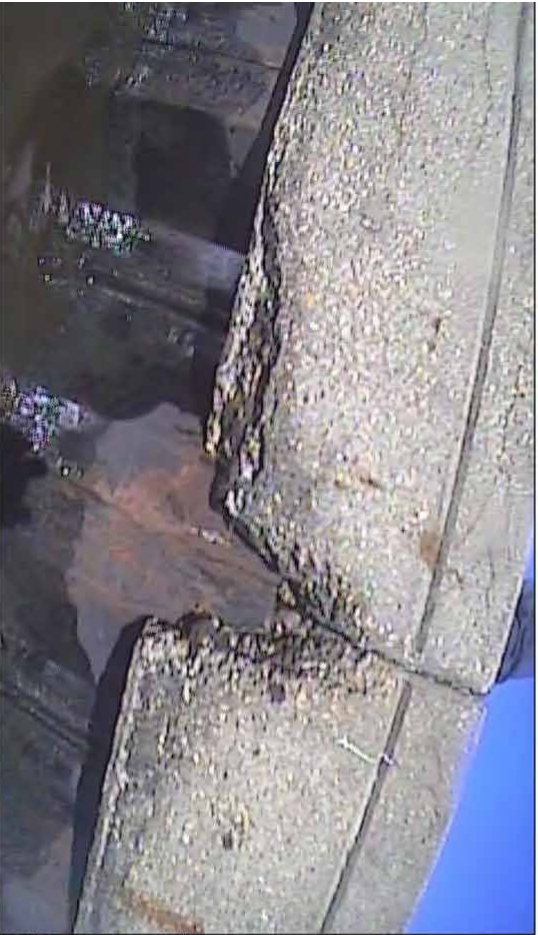
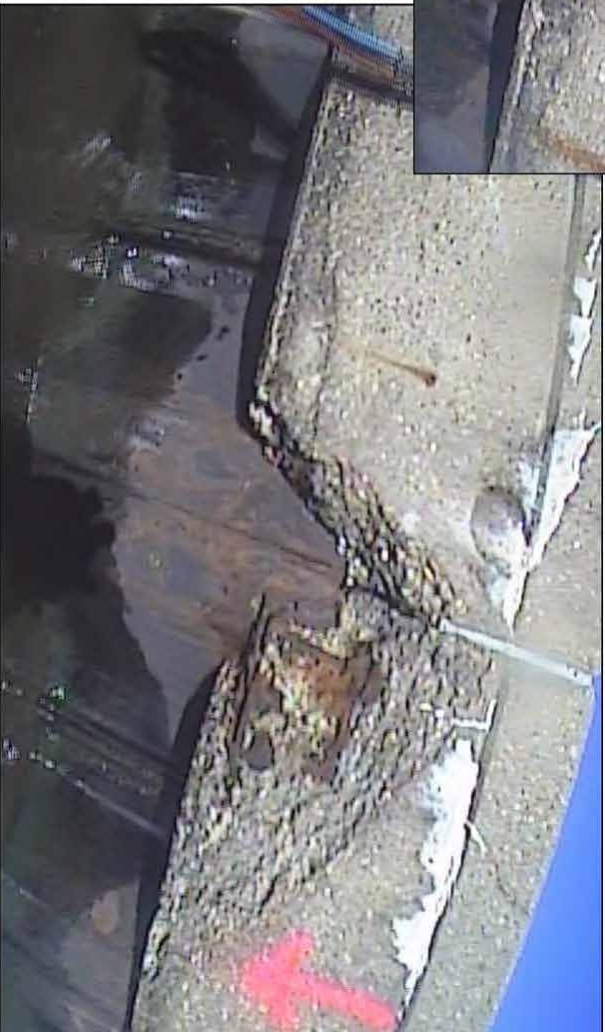
Fig.43

Heavy spalling at joint
3' 3" x 2' exposing top of sheet pile wall causing heavy corrosion and deterioration.
Fig. 43

Heavy spalling at joint
3' 5" x 2' exposing top of sheet pile wall causing heavy corrosion and deterioration.
Fig. 43

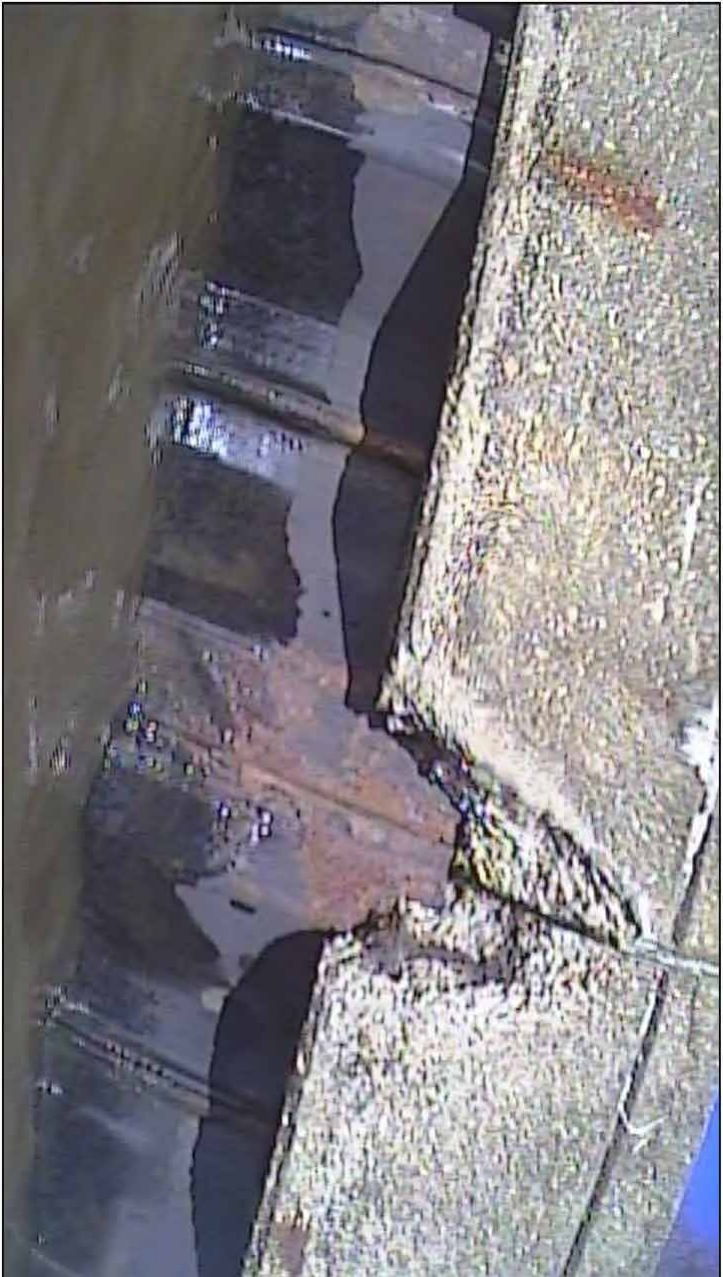
Fig.44

Heavy spalling at joint
1' 10" x 1' 4" exposing top of sheet pile wall causing heavy corrosion and deterioration.
Fig. 44

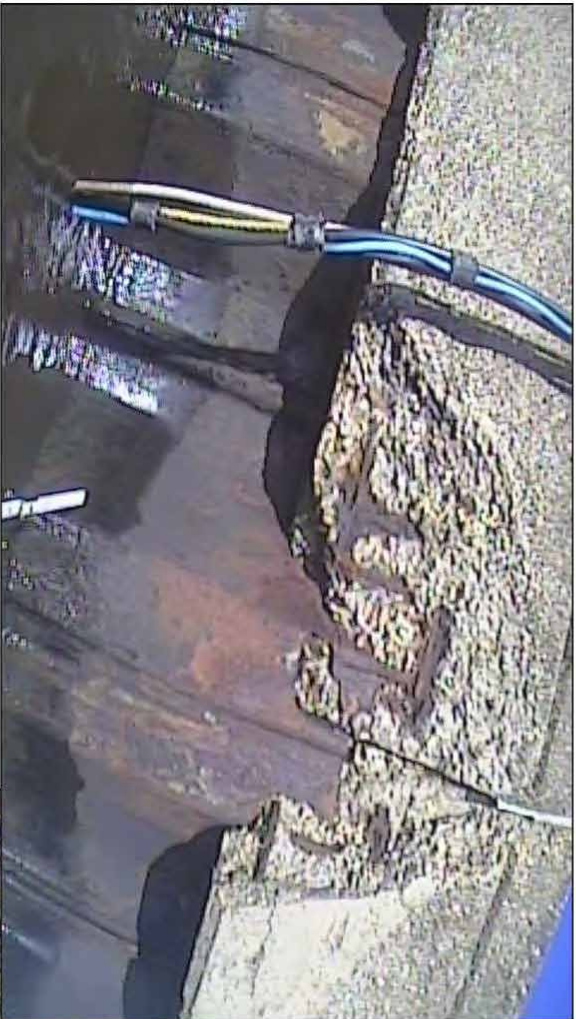
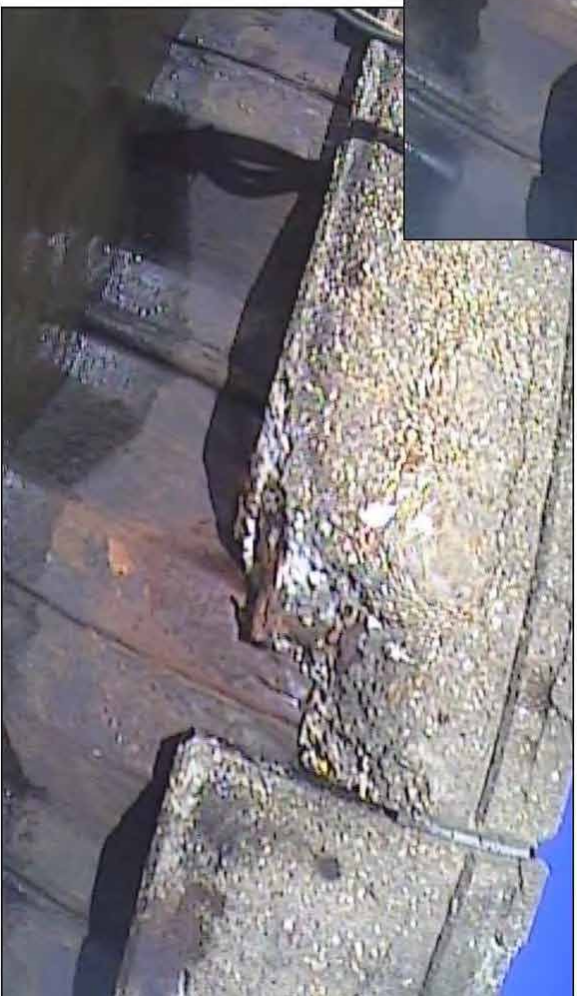
Fig.45

Heavy spalling at joint
3' x 2' 4" exposing top of sheet pile wall
causing heavy corrosion and deterioration
Fig. 45

Heavy spalling at joint
1' 8" x 1' 7" exposing top of sheet pile wall
causing heavy corrosion and deterioration.
Fig. 45

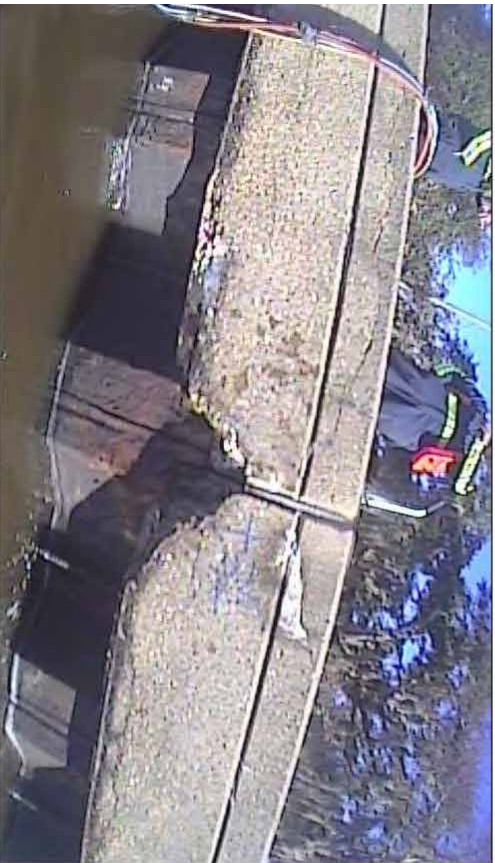
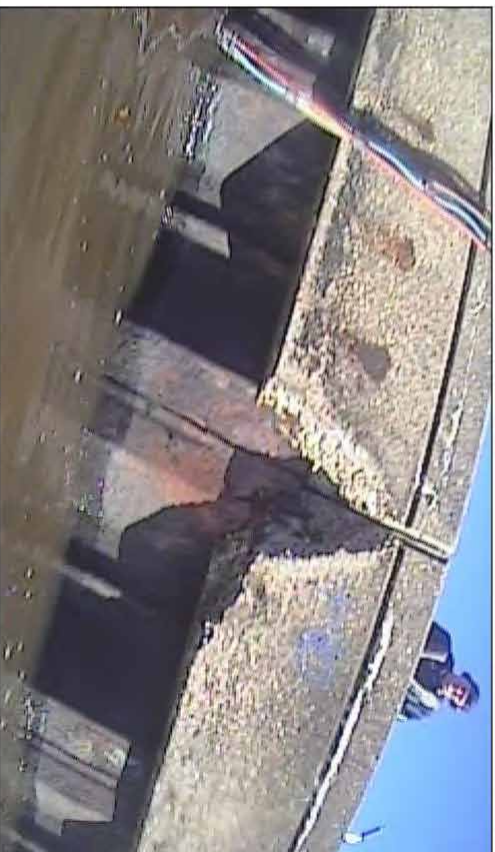
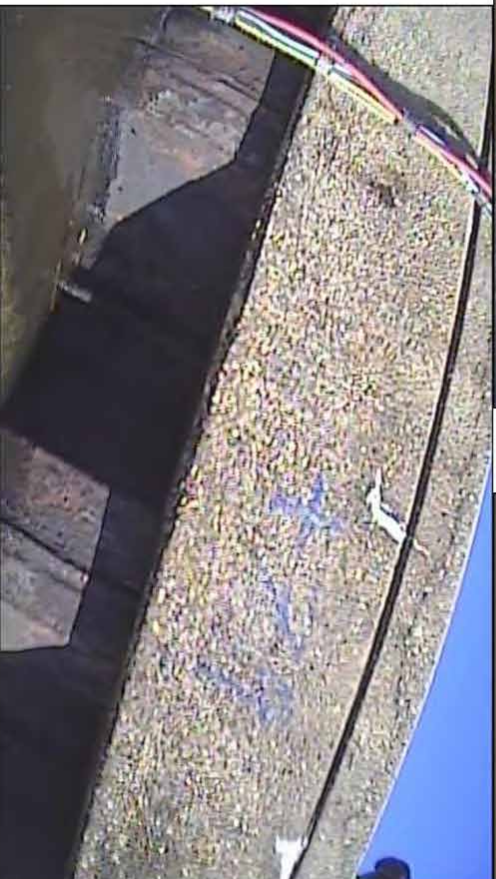
Heavy spalling at joint
4' 3" x 1' 7" exposing top of sheet pile wall
causing heavy corrosion and deterioration.
Fig.46

Heavy spalling at joint
2' 4" x 2' exposing top of sheet pile wall
causing heavy corrosion and deterioration.
Fig.46

Heavy corrosion and deterioration
at bottom of sheet pile wall directly behind
break wall 1' 3" x 8"
Fig.46

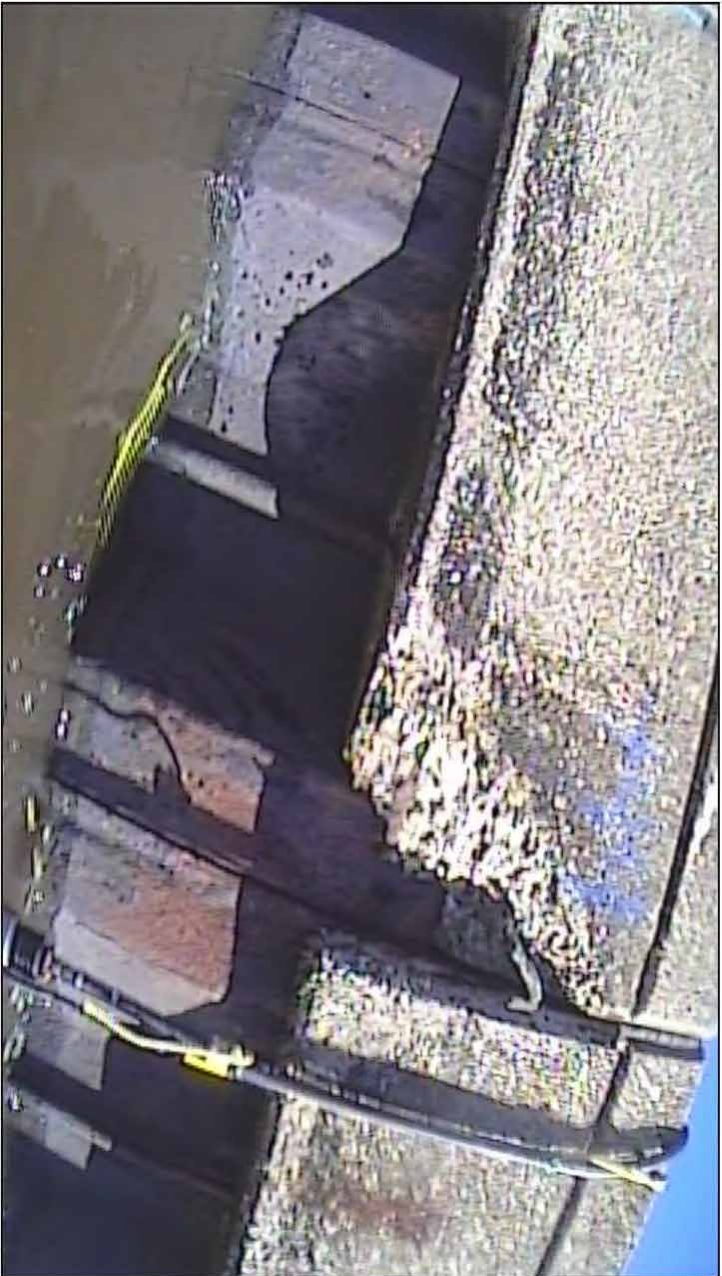
Heavy spalling at joint
1' 8" x 1' 4" exposing top of sheet pile wall causing heavy corrosion and deterioration.
Fig.47

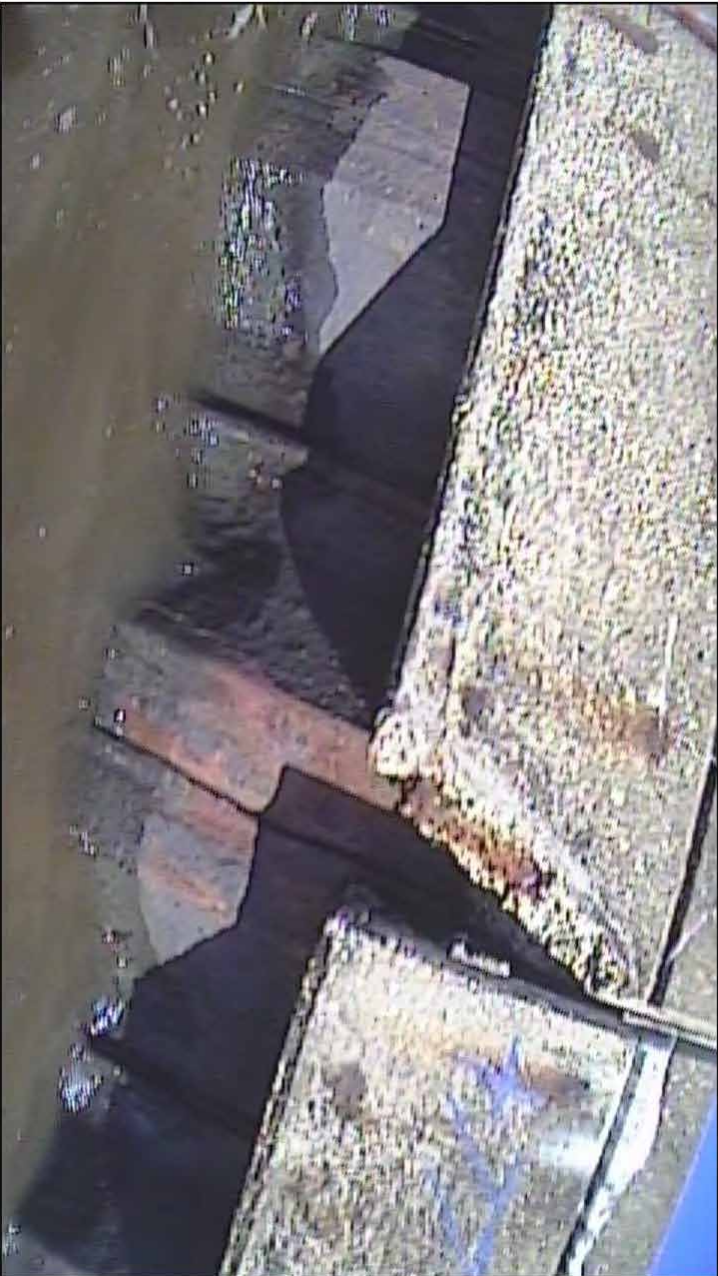
Heavy spalling at joint
1' 8" x 10" exposing top of sheet pile wall causing heavy corrosion and deterioration.
Fig.48

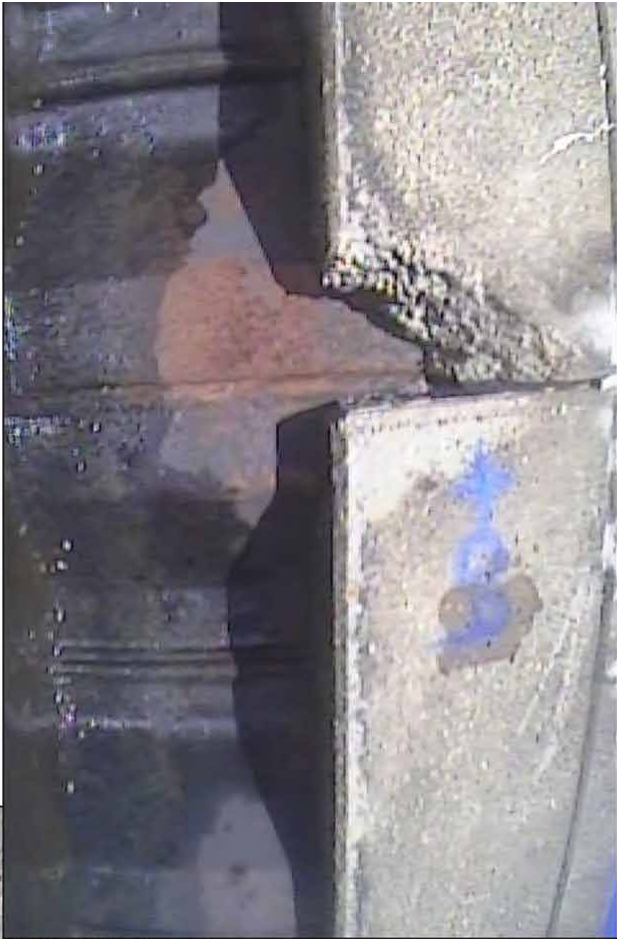
Heavy spalling at joint
2' 4" x 1' 9" exposing top of sheet pile wall causing heavy corrosion and deterioration.
Fig.51

Heavy spalling at joint
1' 9" x 10" exposing top of sheet pile wall causing heavy corrosion and deterioration.
Fig.51

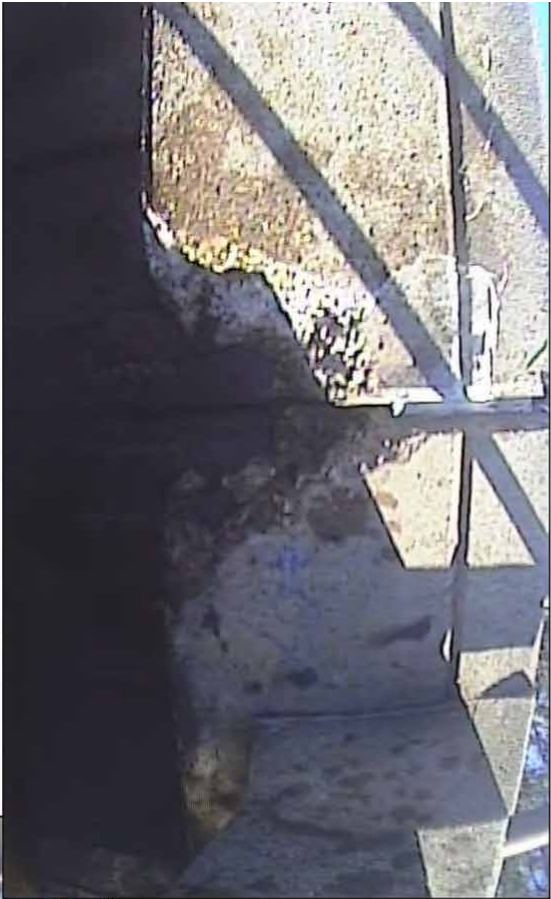
Fig.53

Heavy spalling at joint
2' 5" x 1' 8" exposing top of sheet pile wall causing heavy corrosion and deterioration.
Fig. 53

Heavy spalling at joint
2' 7" x 2' exposing top of sheet pile wall causing heavy corrosion and deterioration.
Fig. 53

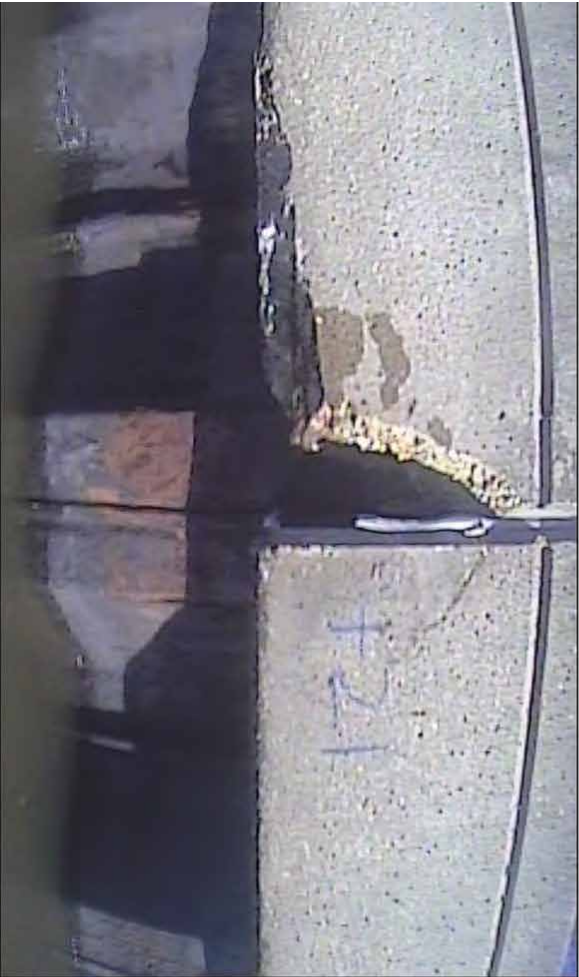
Heavy spalling at joint
2' 5" x 2' exposing top of sheet pile wall
causing heavy corrosion and deterioration.
Fig.54

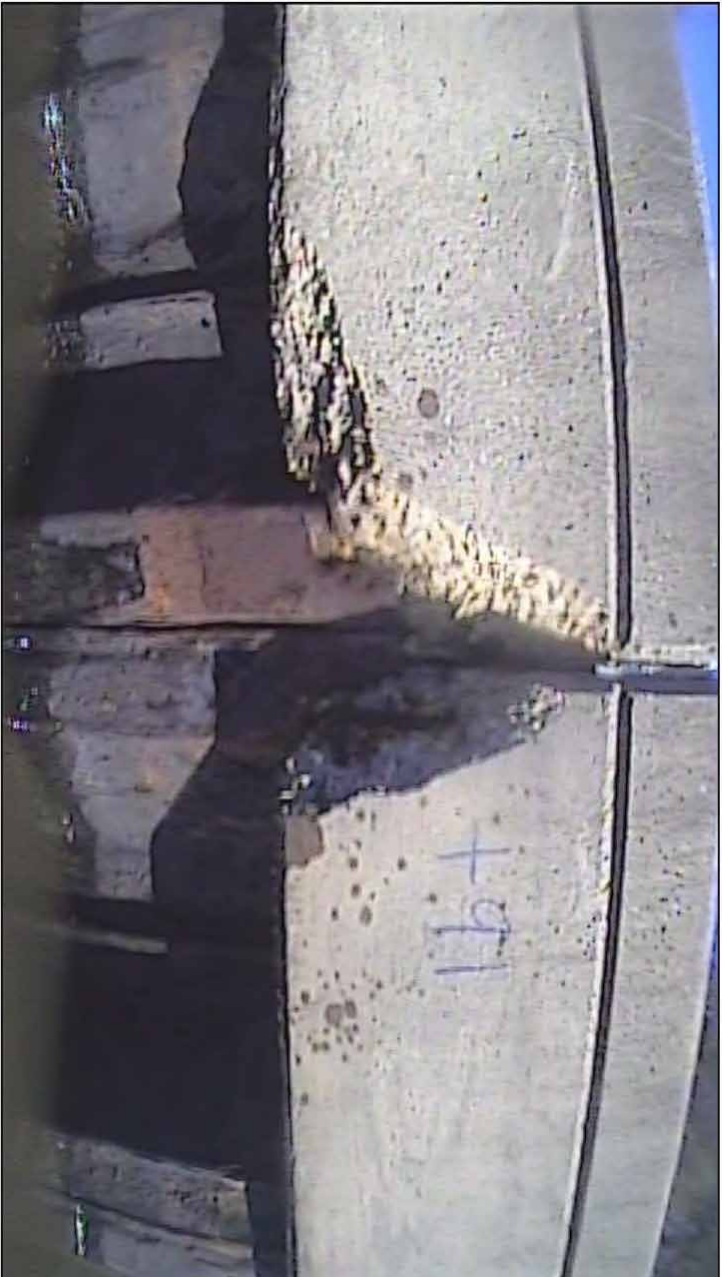
Area beginning to spall at joint
1' 5" x 1' 2" Fig.55

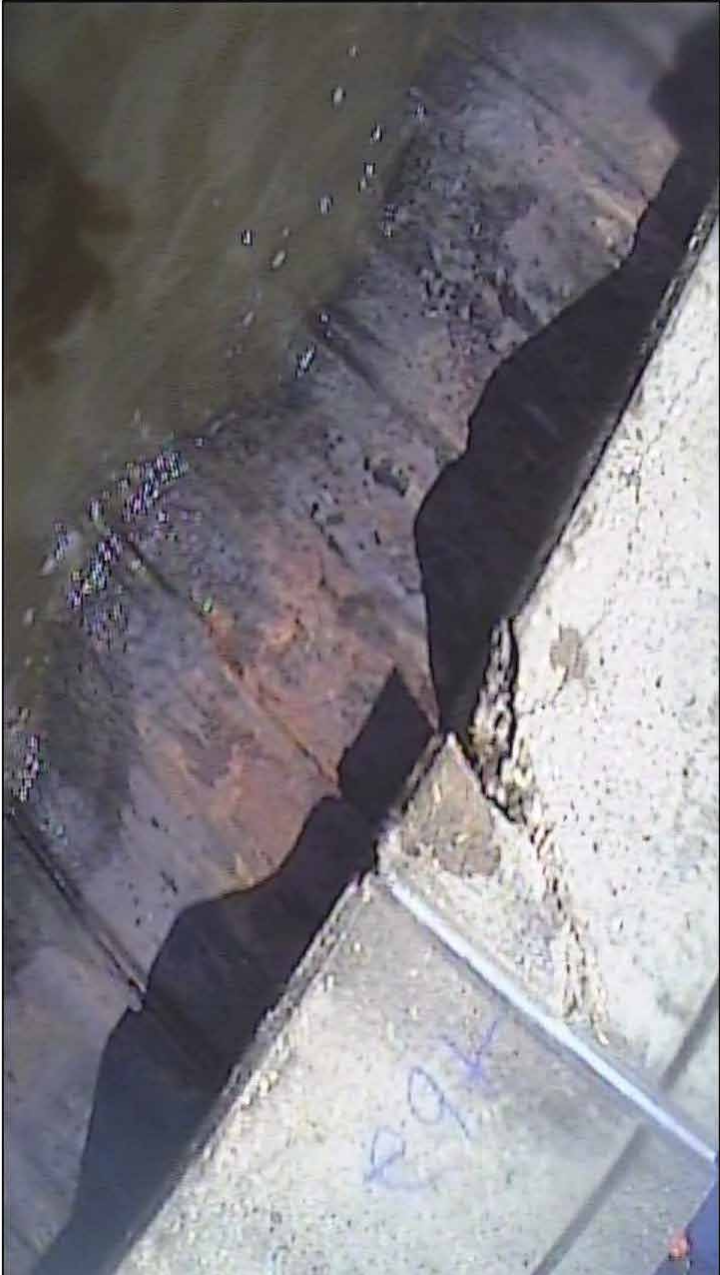
U/T .375
Heavy spalling at joint
3' x 1' 6" exposing top of sheet pile wall causing heavy corrosion and deterioration
Fig.56

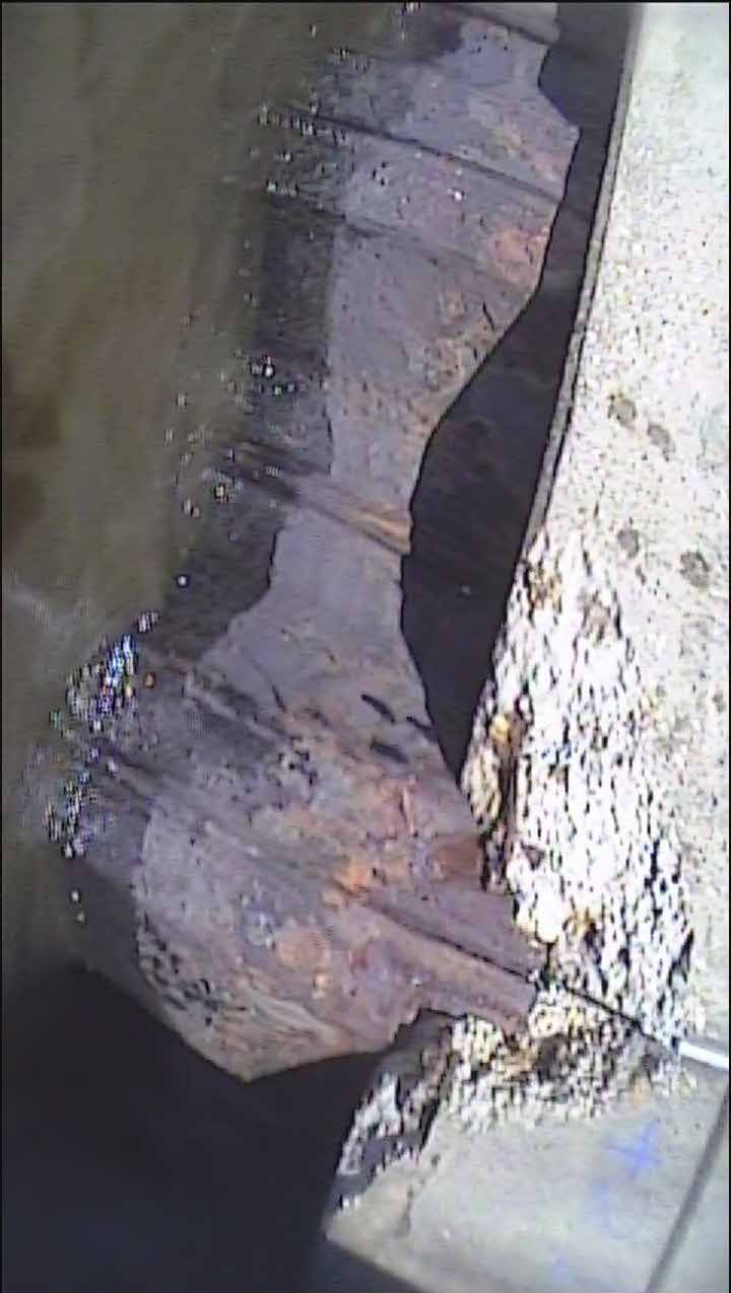
Area beginning to spall at joint 2' x 9" Fig.57

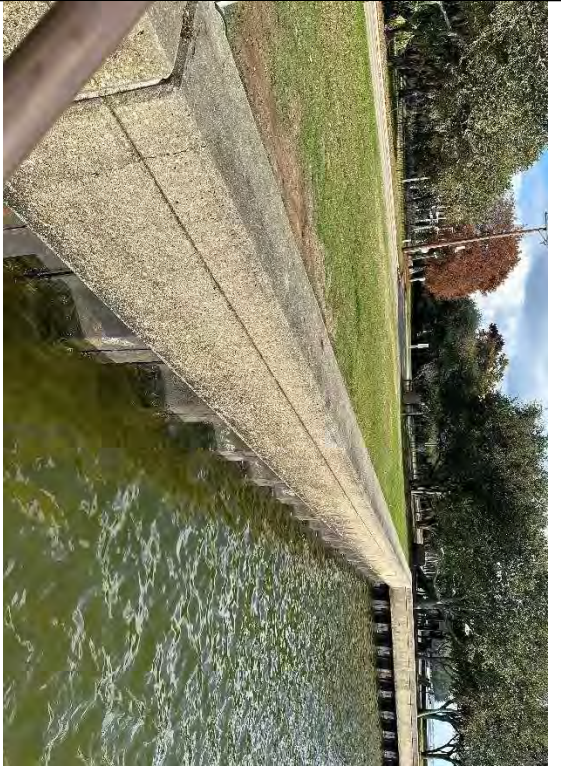
<p>Photo Name: IMG_0067 Inspection Field Notes Photo # : 18 Date: 12-12-22 Approximate Station: Station 4+30 to 4+90 Description: Lake Side of wall Coordinates: Latitude: 30 ; 21 ; 33.2599 Longitude: 90 ; 4 ; 54.710</p>

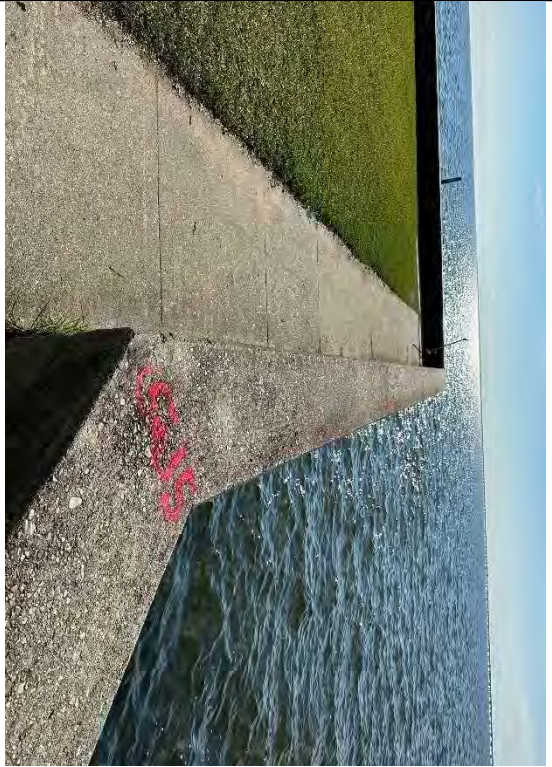
<p>Photo Name: IMG_0071 Inspection Field Notes Photo # : 22 Date: 12-12-22 Approximate Station: Station 5+35 to 5+42 Description: Minor Vertical cracks Coordinates: Latitude: 30 ; 21 ; 32.6199 Longitude: 90 ; 4 ; 53.9699</p>

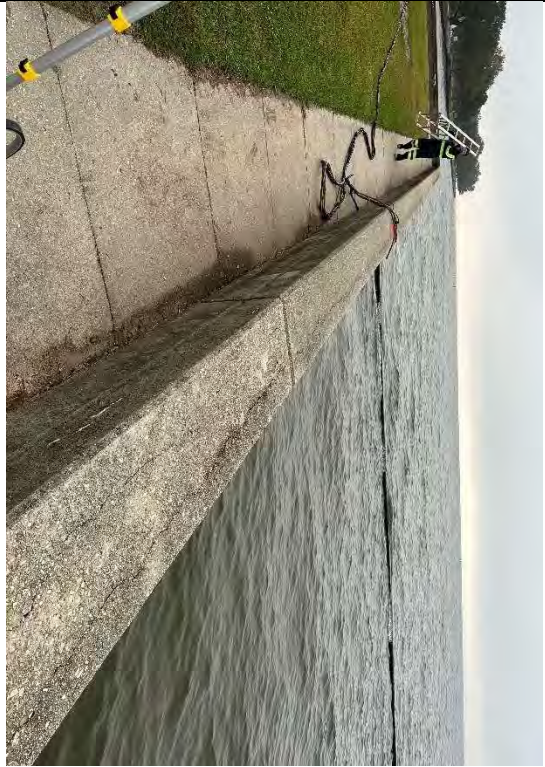
<p>Photo Name: IMG_0074 Inspection Field Notes Photo # : 23 Date: 12-13-22 Approximate Station: Station 5+47 to 6+00 Description: Horizontal cracks on top of seawall. Minor horizontal cracks on land face side of seawall Coordinates: Latitude: 30 ; 21 ; 32.25 Longitude: 90 ; 4 ; 54.19</p>

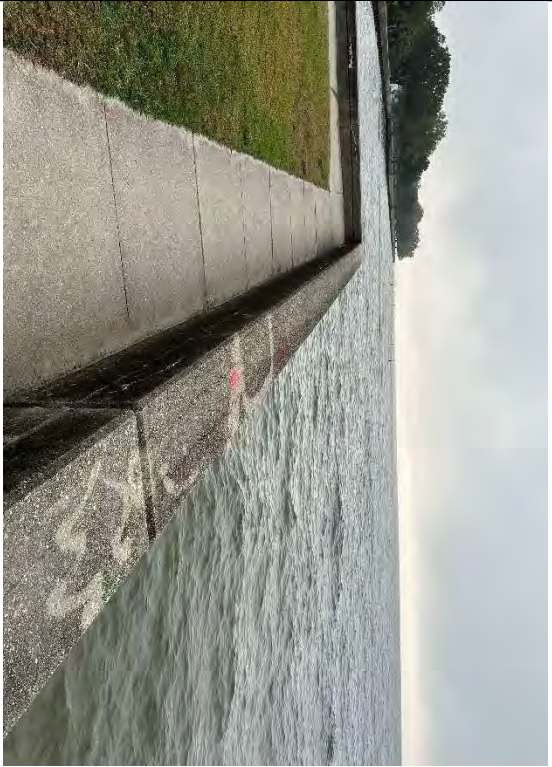
<p>Photo Name: IMG_0075 Inspection Field Notes Photo # : 24 Date: 12-13-22 Approximate Station: Station 6+00 to 6+15 Description: Top of seawall contains horizontal cracks reflective of the sheet pile. Land face side contains horizontal cracks with minor vertical cracks as well Coordinates: Latitude: 30 ; 21 ; 31.899 Longitude: 90 ; 4 ; 53.5499</p>

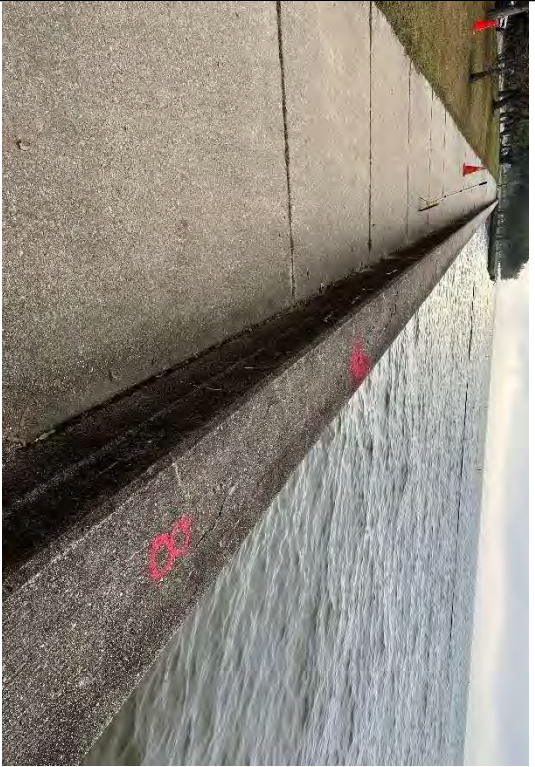
<p>Photo Name: IMG_0079 Inspection Field Notes Photo # : 28 Date: 12-13-22 Approximate Station: Station 8+00 to 8+25 Description: Heavy cracks at top of seawall. Concrete spall on the seaside of expansion joint. Landside face contains minor horizontal cracks Coordinates: Latitude: 30 ; 21 ; 32.100 Longitude: 90 ; 4 ; 52.1799</p>

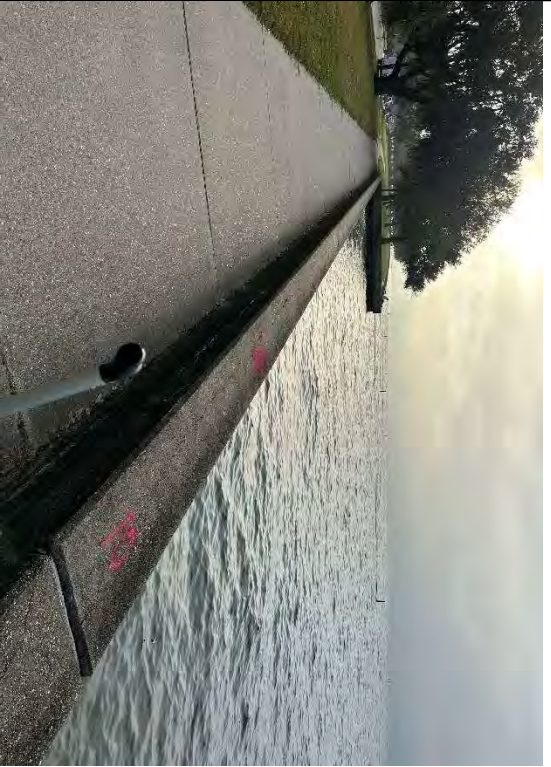
<p>Photo Name: IMG_0081 Inspection Field Notes Photo # : 30 Date: 12-13-22 Approximate Station: Station 10+00 to 11+00 Description: Top of seawall contains horizontal cracks that are reflective of the sheet pile. The land side face contains minor vertical and horizontal cracks as well Coordinates: Latitude: 30 ; 21 ; 31.1499 Longitude: 90 ; 4 ; 50.26</p>

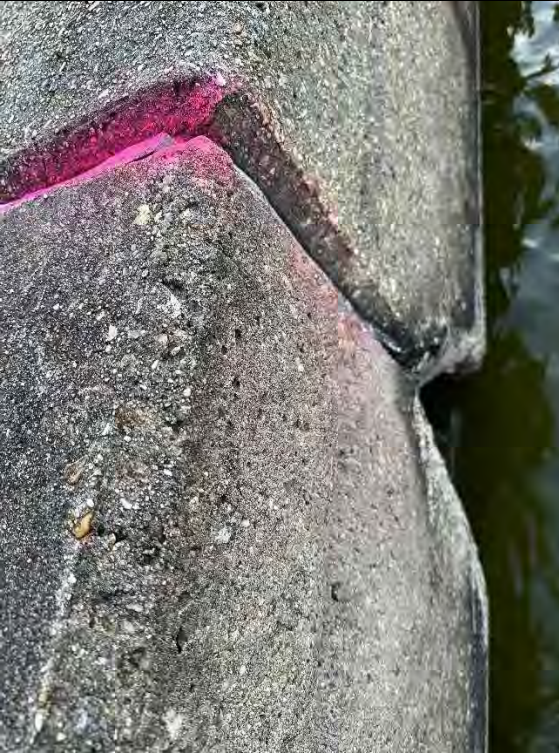
<p>Photo Name: IMG_0082 Inspection Field Notes Photo # : 31 Date: 12-13-22 Approximate Station: Station 10+57 Description: Concrete spall at expansion joint Coordinates: Latitude: 30 ; 21 ; 30.82 Longitude: 90 ; 4 ; 49.5399</p>

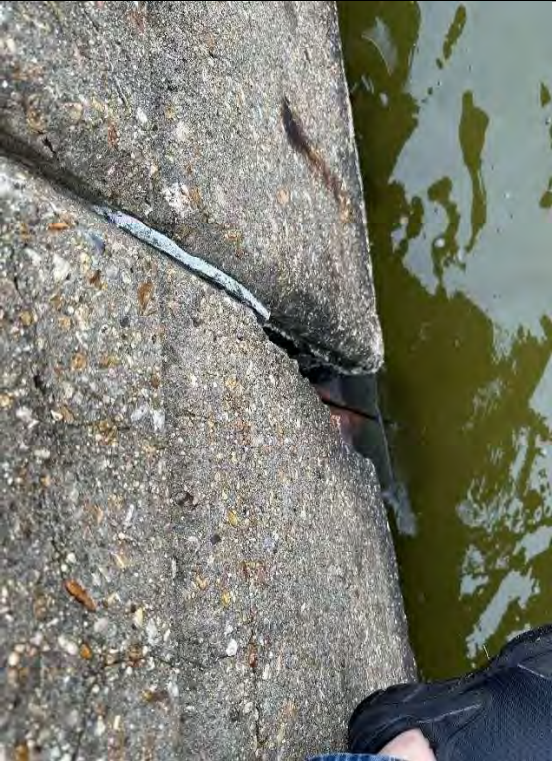
<p>Photo Name: IMG_0087 Inspection Field Notes Photo # : 37 Date: 12-13-22 Approximate Station: Station 12+93 Description: Large concrete spall on seaside of expansion joint Coordinates: Latitude: 30 ; 21 ; 29.399 Longitude: 90 ; 4 ; 47.70</p>

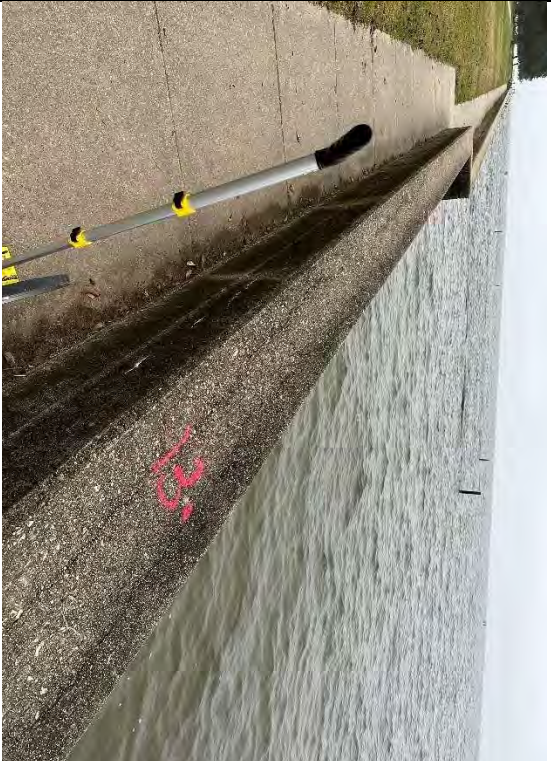
<p>Photo Name: IMG_0088 Inspection Field Notes Photo # : 38 Date: 12-13-22 Approximate Station: Station 13+00 to 13+42 Description: Minor horizontal on top side of seawall Coordinates: Latitude: 30 ; 21 ; 29.36 Longitude: 90 ; 4 ; 47.9199</p>

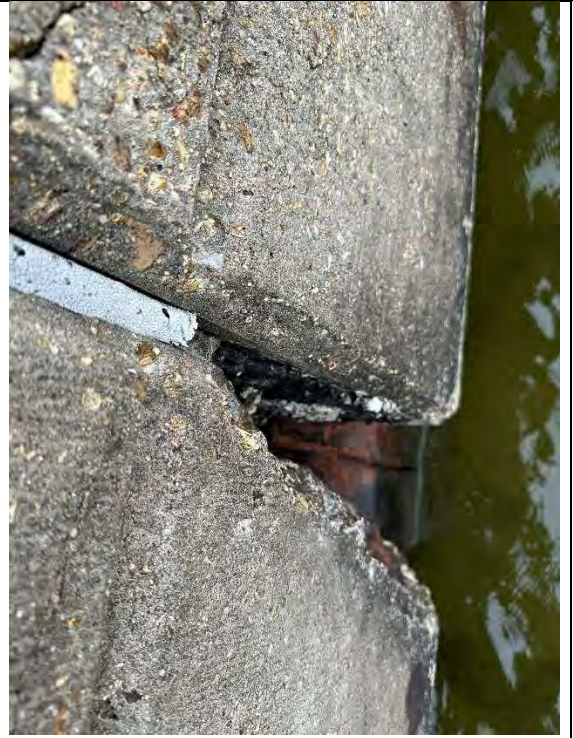
<p>Photo Name: IMG_0090 Inspection Field Notes Photo # : 37.2 Date: 12-13-22 Approximate Station: Station 13+50 Description: Concrete spall on seaside of expansion joint Coordinates: Latitude: 30 ; 21 ; 28.970 Longitude: 90 ; 4 ; 47.5399</p>

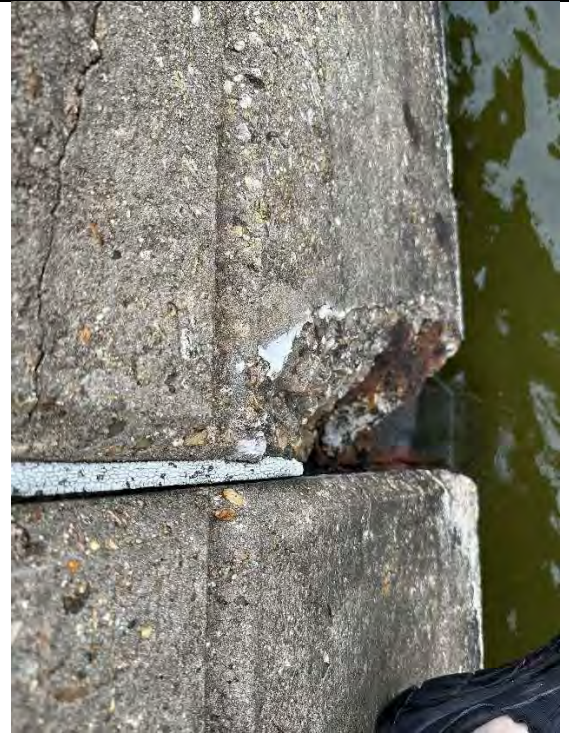
<p>Photo Name: IMG_0092 Inspection Field Notes Photo # : 39.2 Date: 12-13-22 Approximate Station: Station 14+07 Description: Concrete spall along seaside face of expansion joint Coordinates: Latitude: 30 ; 21 ; 28.6399 Longitude: 90 ; 4 ; 47.02</p>

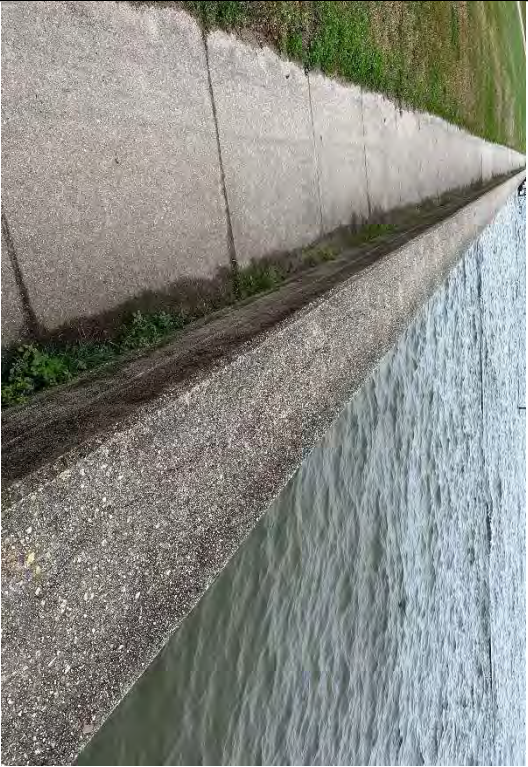
<p>Photo Name: IMG_0095 Inspection Field Notes Photo # : 41 Date: 12-13-22 Approximate Station: Station 14+67 to 15+00 Description: Horizontal cracks on top side of seawall Coordinates: Latitude: 30 ; 21 ; 28.46 Longitude: 90 ; 4 ; 46.7399</p>

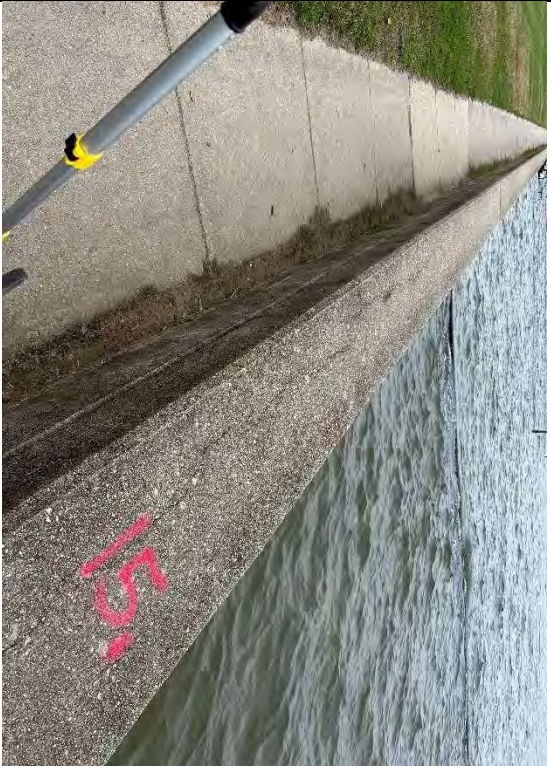
<p>Photo Name: IMG_0096 Inspection Field Notes Photo # : 42 Date: 12-13-22 Approximate Station: Station 15+00 to 16+00 Description: Horizontal cracks on top side of seawall Coordinates: Latitude: 30 ; 21 ; 28.27 Longitude: 90 ; 4 ; 46.1099</p>

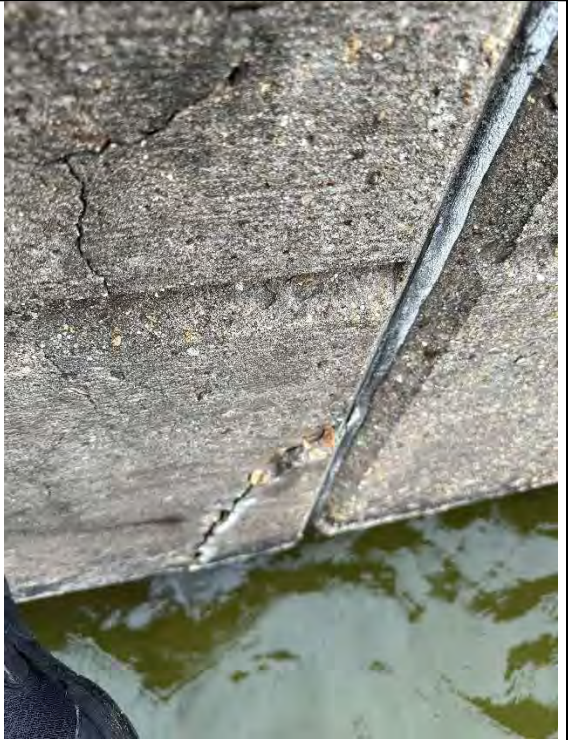
<p>Photo Name: IMG_0097 Inspection Field Notes Photo # : 43 Date: 12-13-22 Approximate Station: Station 15+24 Description: Concrete spall on seaside of expansion joint Coordinates: Latitude: 30 ; 21 ; 27.9199 Longitude: 90 ; 4 ; 45.9199</p>

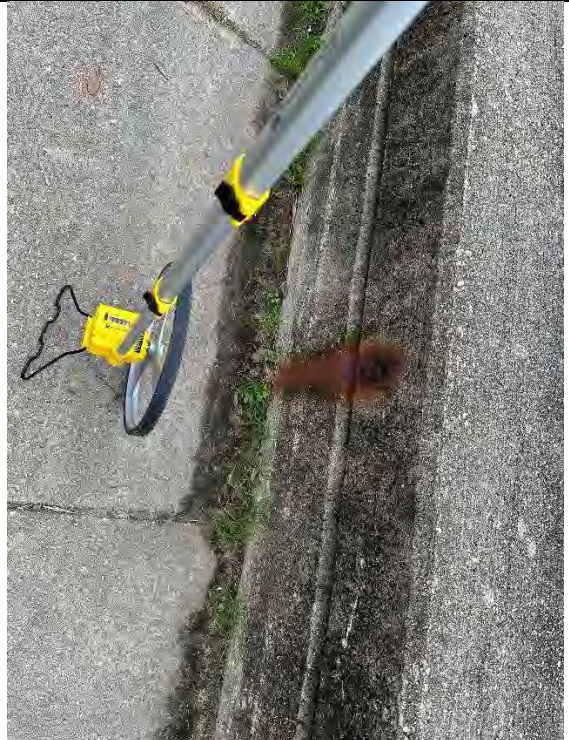
<p>Photo Name: IMG_0098 Inspection Field Notes Photo # : 44 Date: 12-13-22 Approximate Station: Station 15+73 Description: Rust spot on Land side of seawall Coordinates: Latitude: 30 ; 21 ; 28.41 Longitude: 90 ; 4 ; 44.63</p>
