**COM PROJ. NO. 100.21.019
SEAWALL REPAIR (INSPECTION PROJECT)
FINAL FINDINGS/ASSESSMENT REPORT**

The City of Mandeville
1100 Mandeville High Blvd.
Mandeville, LA 70471

Prepared by
BURK-KLEINPETER, INC.
4176 Canal Street
New Orleans, LA 70119

APRIL 2023

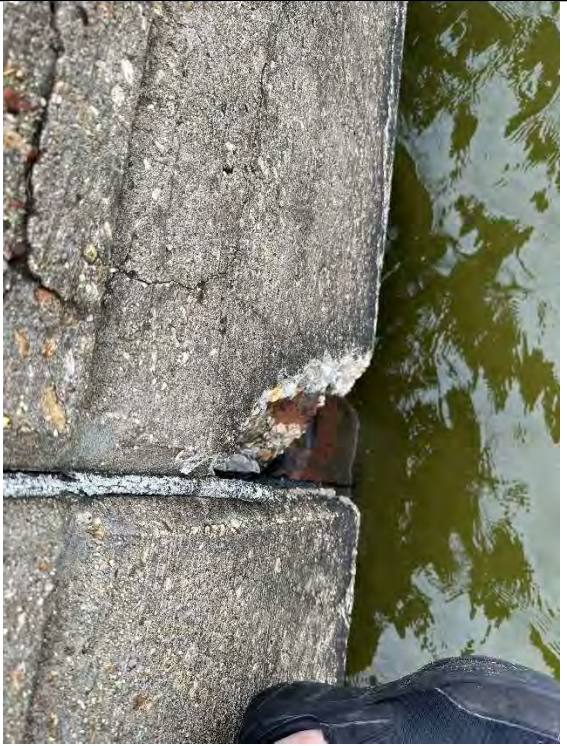
<p>Photo Name: IMG_0099 Inspection Field Notes Photo # : 45 Date: 12-13-22 Approximate Station: Station 15+84 Description: Concrete spall on seaside of expansion joint Coordinates: Latitude: 30 ; 21 ; 27.53999 Longitude: 90 ; 4 ; 45.34</p>

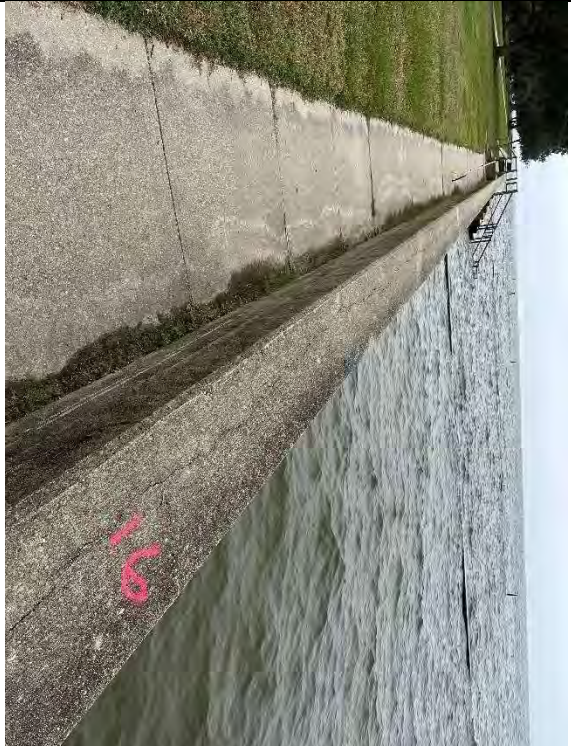
<p>Photo Name: IMG_0100 Inspection Field Notes Photo # : 46 Date: 12-13-22 Approximate Station: Station 16+00 to 16+42 Description: Horizontal cracks on top side of seawall. Minor horizontal cracks on the land side of the seawall as well Coordinates: Latitude: 30 ; 21 ; 27.5899 Longitude: 90 ; 4 ; 45.21</p>

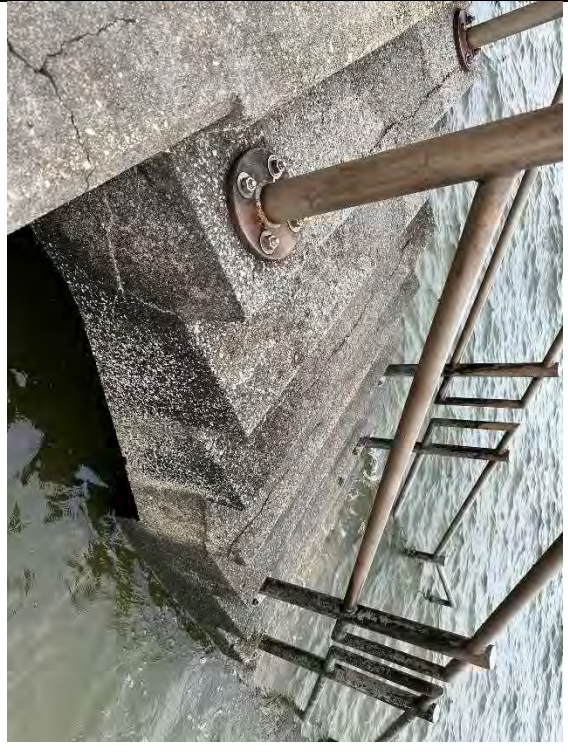
<p>Photo Name: IMG_0102 Inspection Field Notes Photo # : 48 Date: 12-13-22 Approximate Station: Station 16+98 Description: Stairway. Cracks in steps and on the sides of the steps as well. Rust is coming to surface Coordinates: Latitude: 30 ; 21 ; 27.10 Longitude: 90 ; 4 ; 44.38</p>

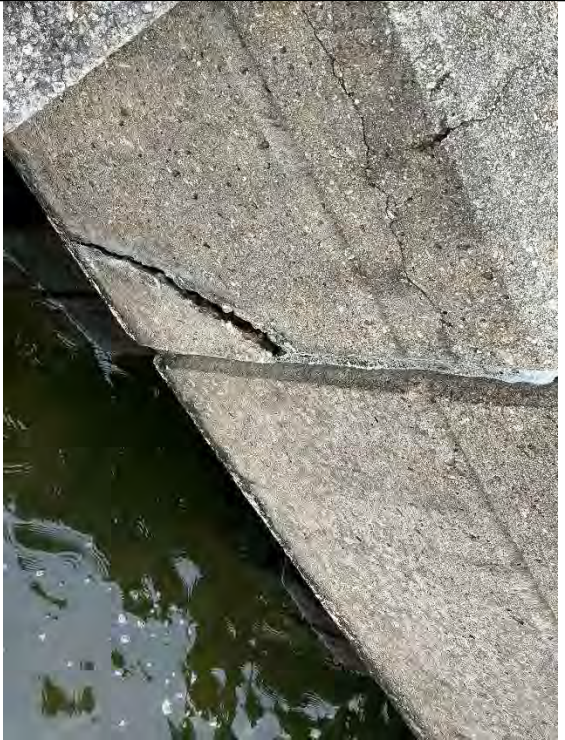
<p>Photo Name: IMG_0103 Inspection Field Notes Photo # : 49 Date: 12-13-22 Approximate Station: Station 17+00 Description: Concrete spall on seaside of expansion joint Coordinates: Latitude: 30 ; 21 ; 26.9199 Longitude: 90 ; 4 ; 44.44</p>

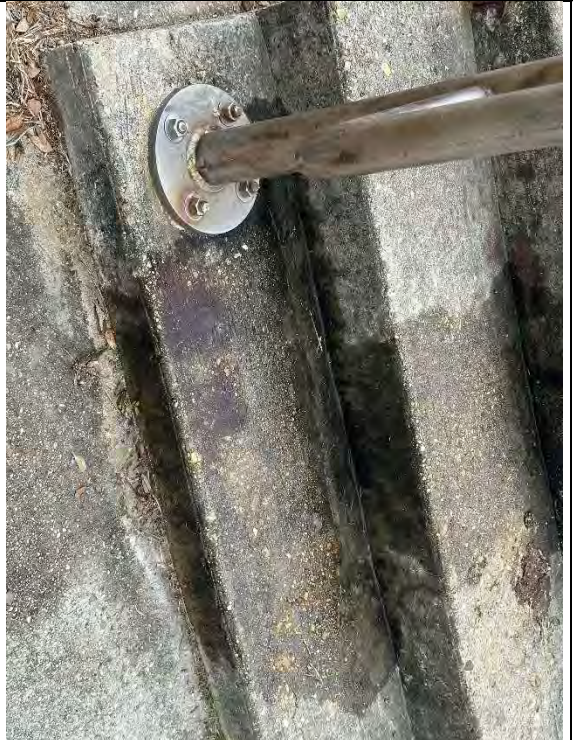
<p>Photo Name: IMG_0104 Inspection Field Notes Photo # : 50 Date: 12-13-22 Approximate Station: Station 17+00 Description: Bottom of the steps on the land face side shows signs of rust coming to the top Coordinates: Latitude: 30 ; 21 ; 26.94 Longitude: 90 ; 4 ; 44.27</p>

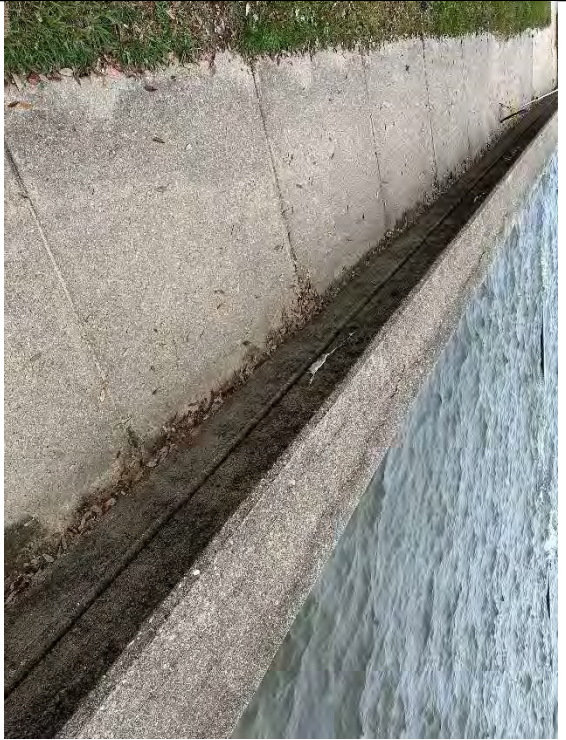
<p>Photo Name: IMG_0105 Inspection Field Notes Photo # : 51 Date: 12-13-22 Approximate Station: Station 17+25 to 17+50 Description: Horizontal cracks that are reflective of the sheet pile on top side of seawall. Horizontal and vertical cracks along land face side Coordinates: Latitude: 30 ; 21 ; 26.8399 Longitude: 90 ; 4 ; 44.1099</p>

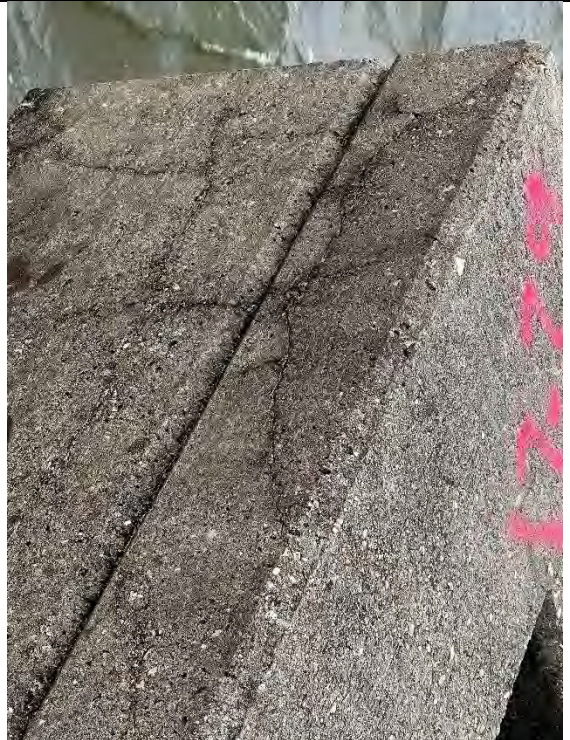
<p>Photo Name: IMG_0106 Inspection Field Notes Photo # : 52 Date: 12-13-22 Approximate Station: Station 17+79 to 17+89 Description: Vertical and horizontal cracks at seaside face of seawall Coordinates: Latitude: 30 ; 21 ; 26.4299 Longitude: 90 ; 4 ; 43.6099</p>

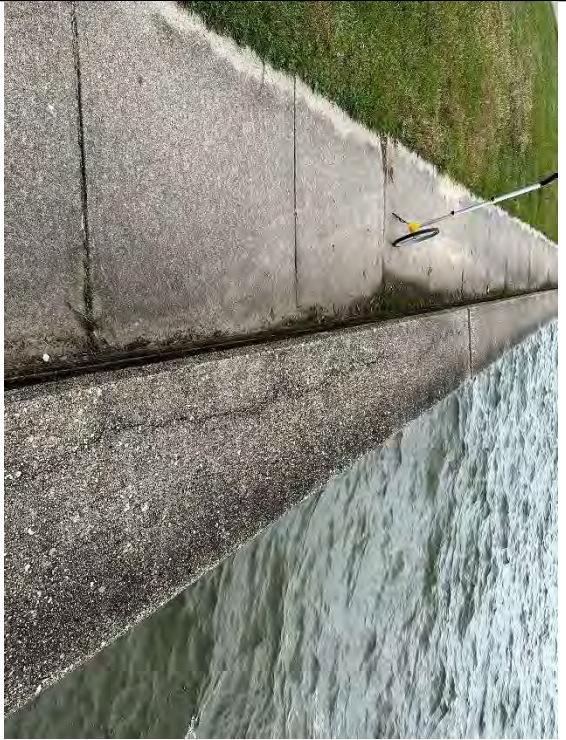
<p>Photo Name: IMG_0109 Inspection Field Notes Photo # : 55 Date: 12-13-22 Approximate Station: Station 18+70 to 18+80 Description: Horizontal and vertical cracks on top side of seawall Coordinates: Latitude: 30 ; 21 ; 25.96 Longitude: 90 ; 4 ; 42.84</p>

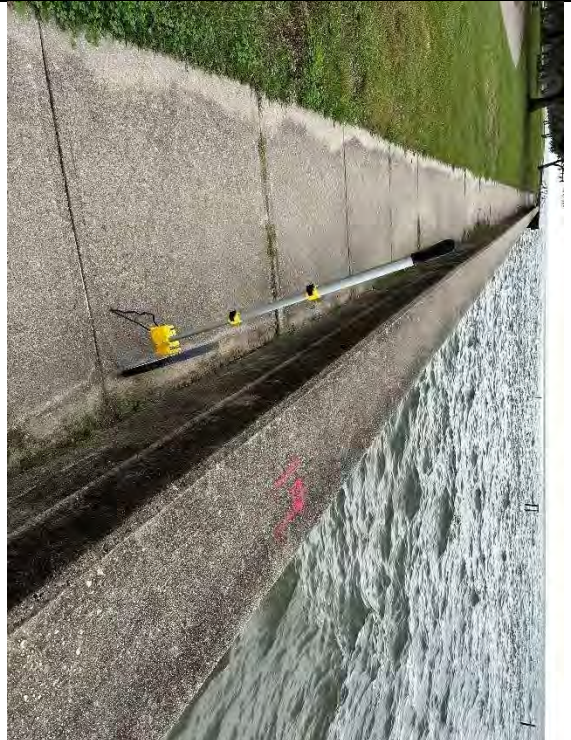
<p>Photo Name: IMG_0110 Inspection Field Notes Photo # : 56 Date: 12-13-22 Approximate Station: Station 19+00 to 19+40 Description: Minor cracks on top side of seawall Coordinates: Latitude: 30 ; 21 ; 25.91 Longitude: 90 ; 4 ; 42.84</p>

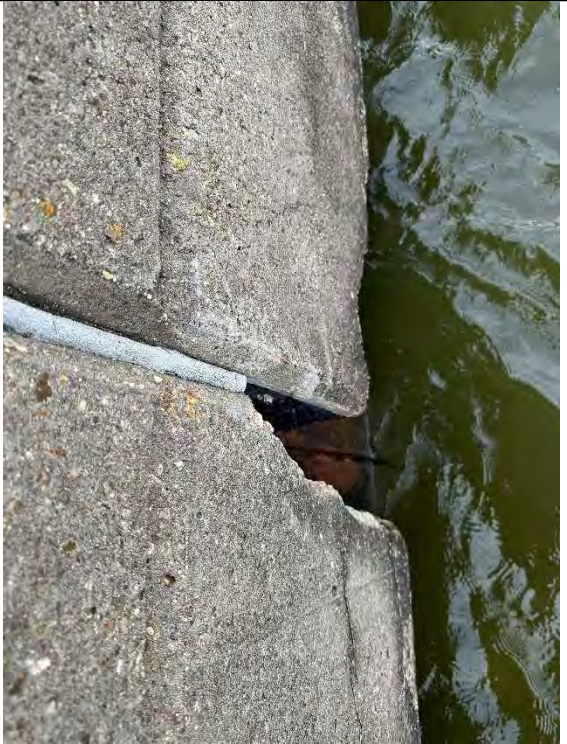
<p>Photo Name: IMG_0111 Inspection Field Notes Photo # : 57 Date: 12-13-22 Approximate Station: Station 19+40 Description: Concrete spall in seaside of expansion joint Coordinates: Latitude: 30 ; 21 ; 25.52 Longitude: 90 ; 4 ; 42.21</p>

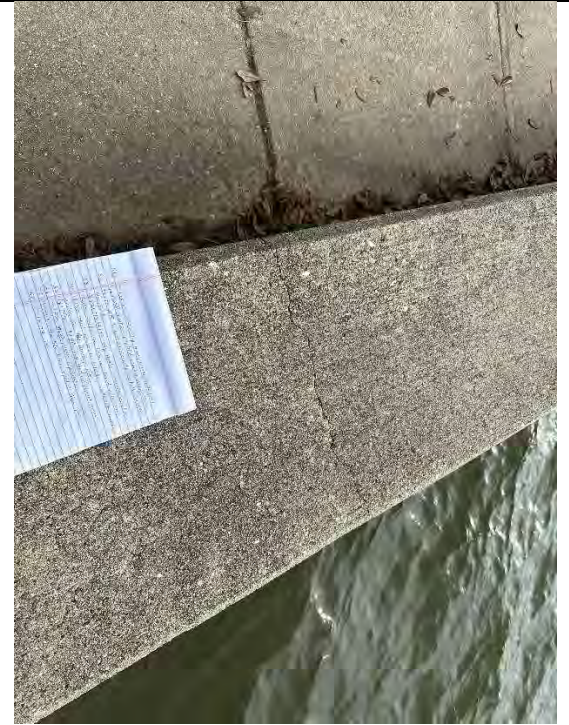
<p>Photo Name: IMG_0112 Inspection Field Notes Photo # : 58 Date: 12-13-22 Approximate Station: Station 19+90 to 20+00 Description: Vertical crack on top side of seawall Coordinates: Latitude: 30 ; 21 ; 25.38 Longitude: 90 ; 4 ; 41.20</p>

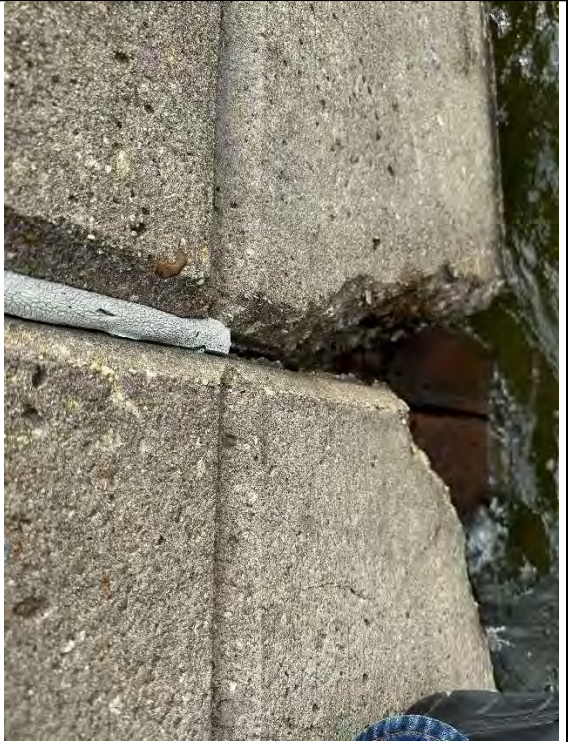
<p>Photo Name: IMG_0113 Inspection Field Notes Photo # : 59 Date: 12-13-22 Approximate Station: Station 19+98 Description: Concrete spall in seaside of expansion side Coordinates: Latitude: 30 ; 21 ; 25.1699 Longitude: 90 ; 4 ; 41.7399</p>

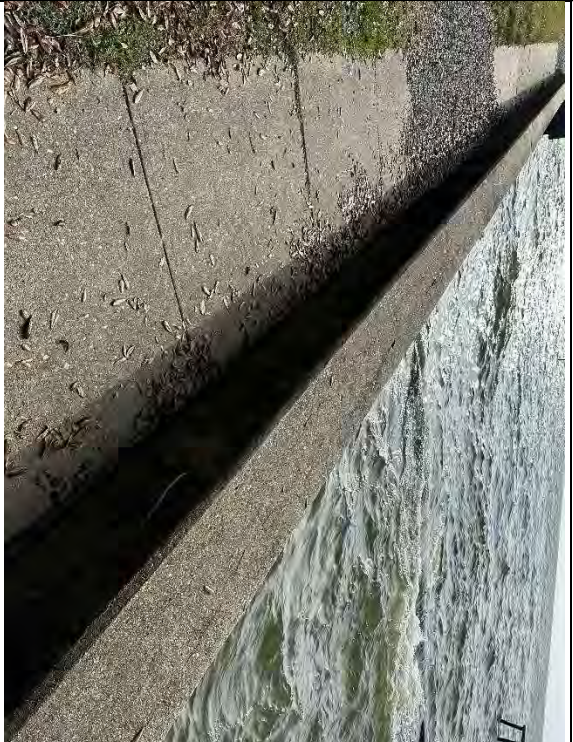
<p>Photo Name: IMG_0114 Inspection Field Notes Photo # : 60 Date: 12-13-22 Approximate Station: Station 20+22 to 20+50 Description: Horizontal cracks along top side of seawall. Horizontal cracks along land face side of seawall Coordinates: Latitude: 30 ; 21 ; 25.0599 Longitude: 90 ; 4 ; 41.3599</p>

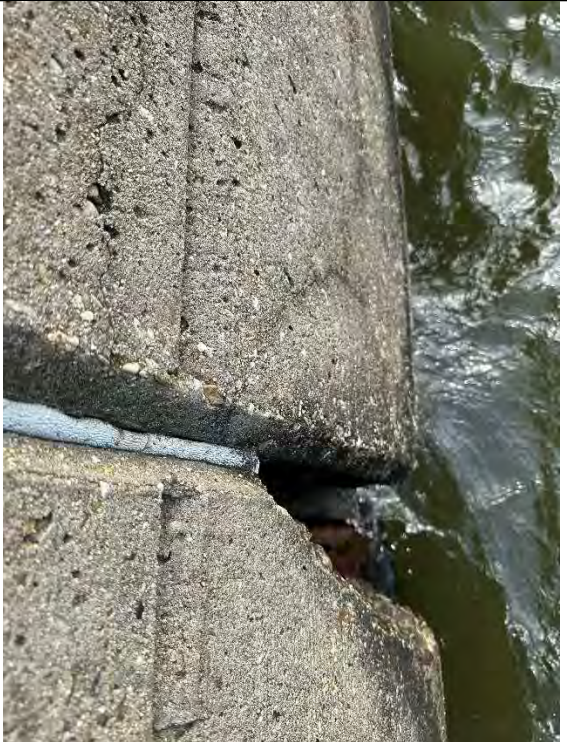
<p>Photo Name: IMG_0115 Inspection Field Notes Photo # : 61 Date: 12-13-22 Approximate Station: Station 20+57 Description: Concrete spall on seaside of expansion joint Coordinates: Latitude: 30 ; 21 ; 24.820 Longitude: 90 ; 4 ; 41.1699</p>

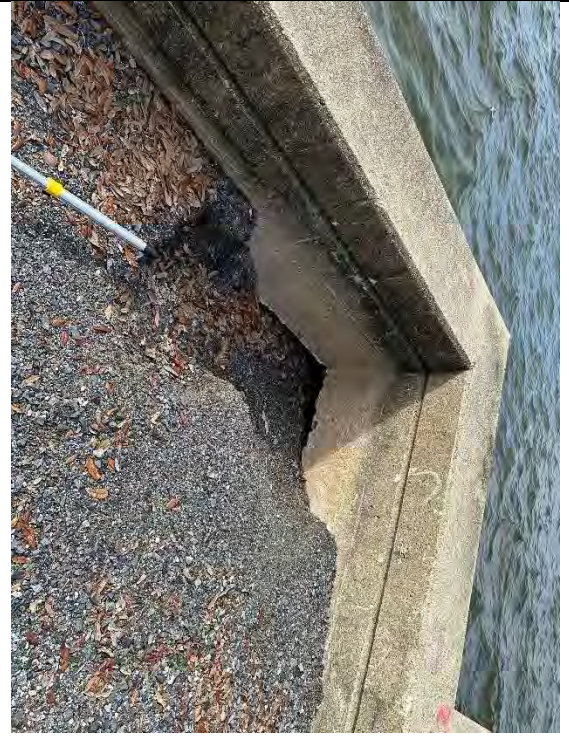
<p>Photo Name: IMG_0116 Inspection Field Notes Photo # : 63 Date: 12-13-22 Approximate Station: Station 21+16 Description: Hole under concrete seawall on land face side at repair area Coordinates: Latitude: 30 ; 21 ; 24.4499 Longitude: 90 ; 4 ; 40.5599</p>

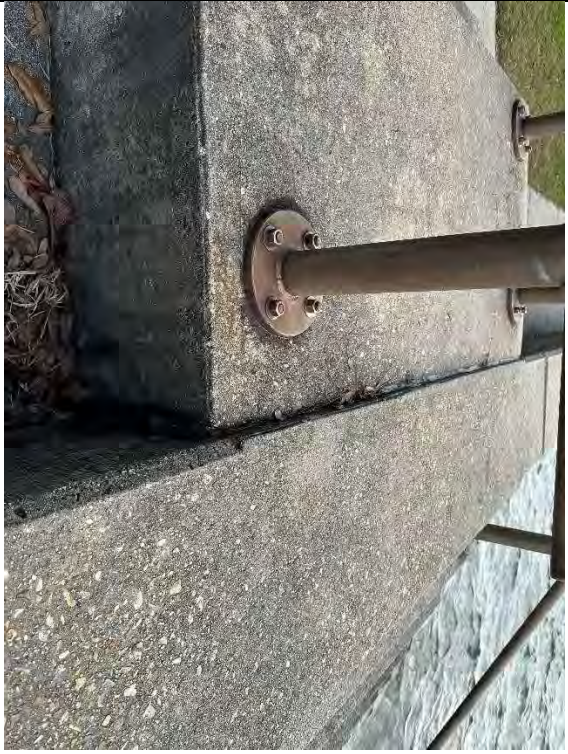
<p>Photo Name: IMG_0118 Inspection Field Notes Photo # : 65 Date: 12-13-22 Approximate Station: Station 22+08 Description: Step 3 on landside face of seawall settled 1 1/2 “ Coordinates: Latitude: 30 ; 21 ; 23.9499 Longitude: 90 ; 4 ; 39.4899</p>

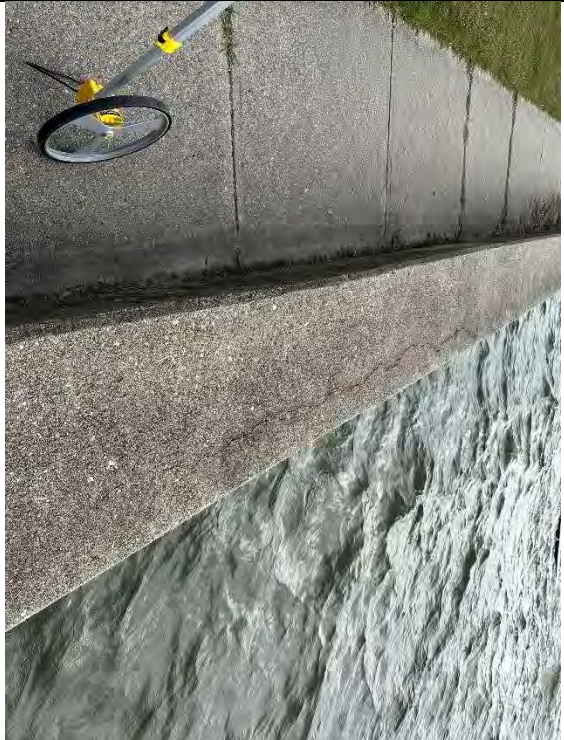
<p>Photo Name: IMG_0120 Inspection Field Notes Photo # : 67 Date: 12-13-22 Approximate Station: Station 22+45 to 22+50 Description: Horizontal and vertical cracks along top side of seawall Coordinates: Latitude: 30 ; 21 ; 23.809 Longitude: 90 ; 4 ; 39.800</p>

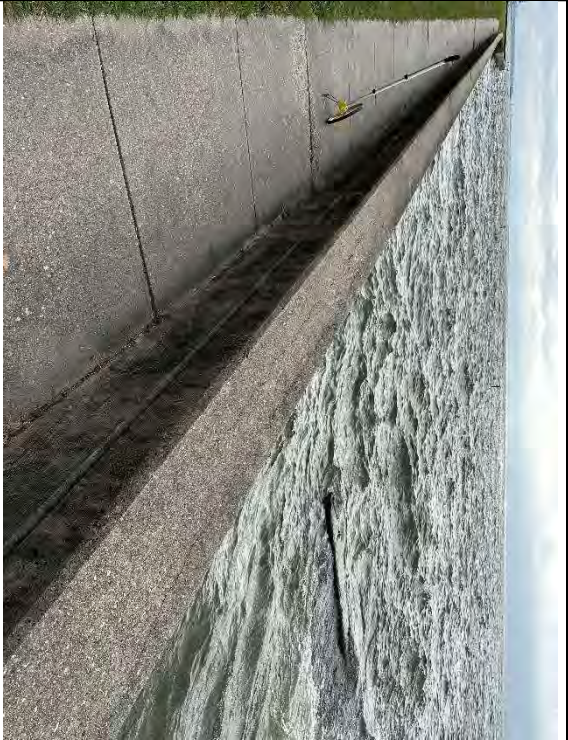
<p>Photo Name: IMG_0121 Inspection Field Notes Photo # : 68 Date: 12-13-22 Approximate Station: Station 22+66 to 22+88 Description: Horizontal cracks along top side of seawall. 2 vertical cracks Coordinates: Latitude: 30 ; 21 ; 23.6199 Longitude: 90 ; 4 ; 39.0499</p>

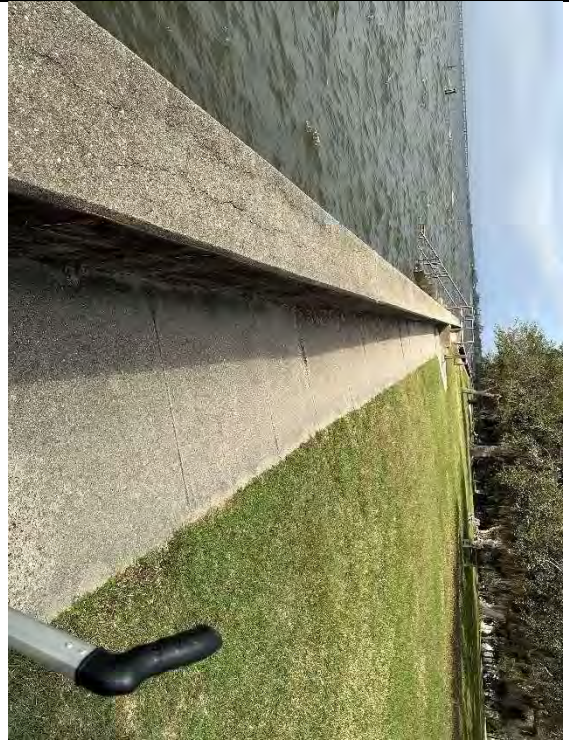
<p>Photo Name: IMG_0122 Inspection Field Notes Photo # : 69 Date: 12-13-22 Approximate Station: Station 23+00 to 24+00 Description: Horizontal cracks along top side of seawall. Horizontal cracks along land face side of seawall. Sidewalk is settling along wall Coordinates: Latitude: 30 ; 21 ; 24.74 Longitude: 90 ; 4 ; 36.2</p>

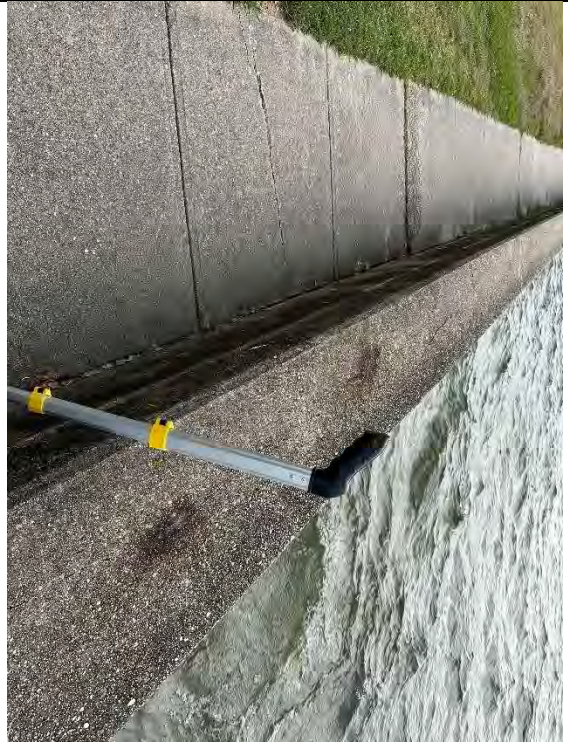
<p>Photo Name: IMG_0125 Inspection Field Notes Photo # : 71 Date: 12-13-22 Approximate Station: Station 23+57 Description: Rust spots on top side of seawall. Coordinates: Latitude: 30 ; 21 ; 23.16 Longitude: 90 ; 4 ; 38.09</p>

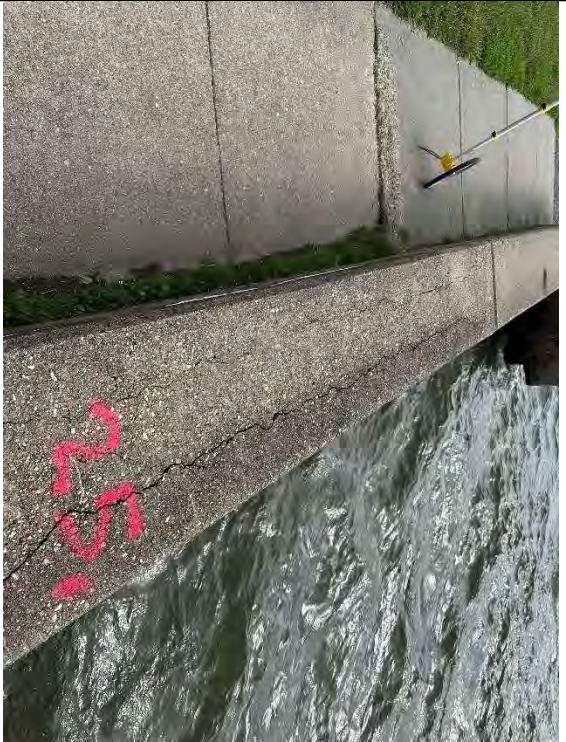
<p>Photo Name: IMG_0128 Inspection Field Notes Photo # : 73.2 Date: 12-13-22 Approximate Station: Station 25+00 to 25+09 Description: Horizontal cracks along top side of seawall. Horizontal cracks with rust coming out on the land face side of the seawall as well Coordinates: Latitude: 30 ; 21 ; 22.5599 Longitude: 90 ; 4 ; 36.7499</p>

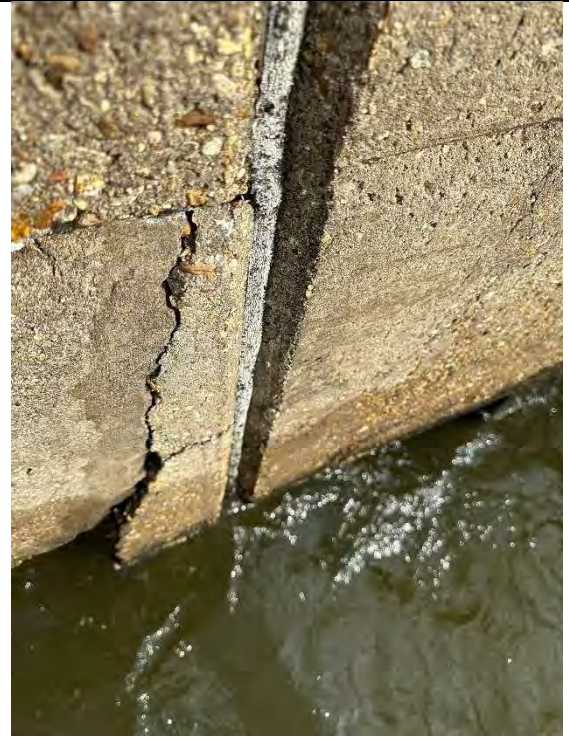
<p>Photo Name: IMG_0129 Inspection Field Notes Photo # : 74 Date: 12-13-22 Approximate Station: Station 25+09 Description: Concrete spall along seaside of expansion joint. Sidewalk is sunken in this area as well Coordinates: Latitude: 30 ; 21 ; 22.2799 Longitude: 90 ; 4 ; 36.799</p>

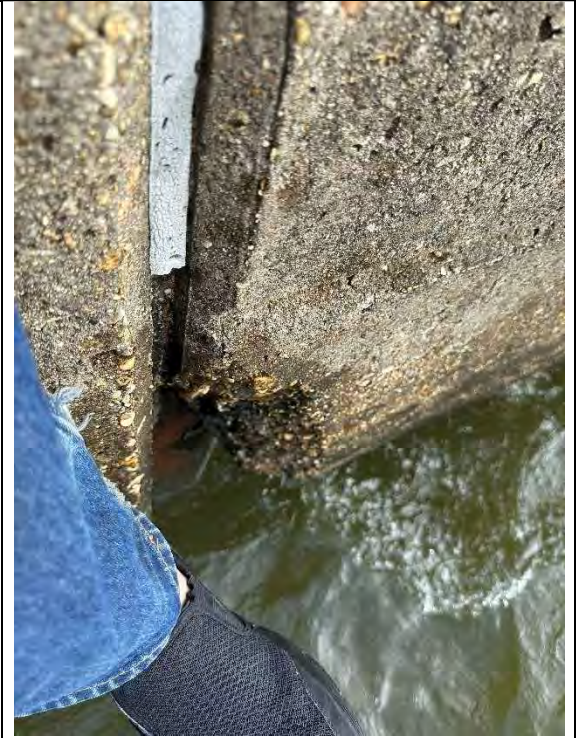
<p>Photo Name: IMG_0132 Inspection Field Notes Photo # : 79 Date: 12-13-22 Approximate Station: Station 26+32 Description: Concrete spall along seaside of expansion joint Coordinates: Latitude: 30 ; 21 ; 21.57 Longitude: 90 ; 4 ; 35.89</p>

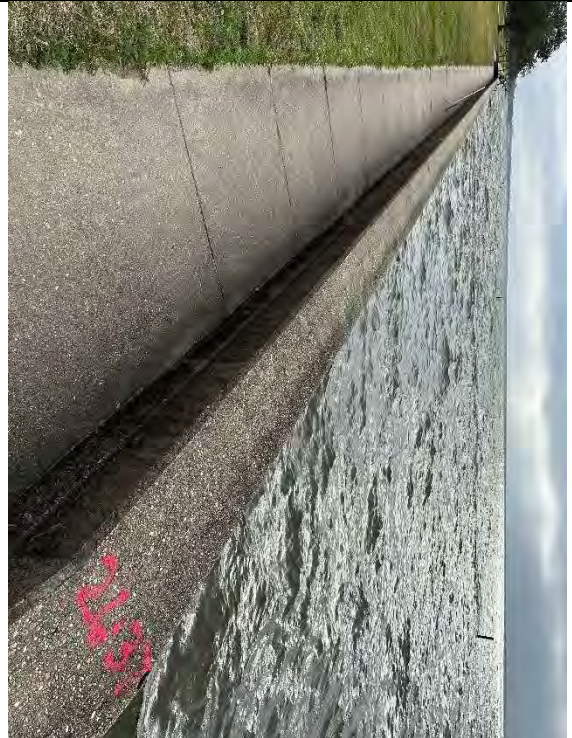
<p>Photo Name: IMG_0133 Inspection Field Notes Photo # : 80 Date: 12-13-22 Approximate Station: Station 26+37 to 27+00 Description: Horizontal cracks along top side of seawall. Coordinates: Latitude: 30 ; 21 ; 21.72 Longitude: 90 ; 4 ; 35.84</p>

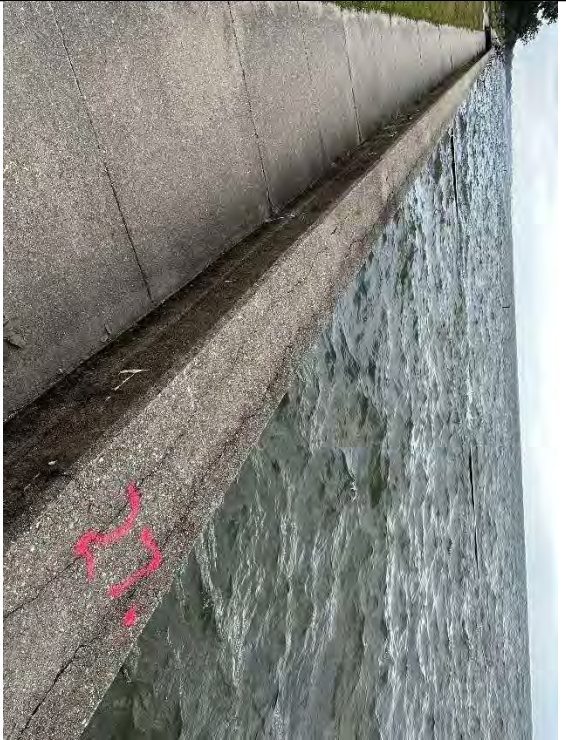
<p>Photo Name: IMG_0135 Inspection Field Notes Photo # : 81 Date: 12-13-22 Approximate Station: Station 27+00 to 28+00 Description: Horizontal cracks on top side of seawall. Horizontal and vertical cracks along the land face side of the seawall as well. Coordinates: Latitude: 30 ; 21 ; 21.699 Longitude: 90 ; 4 ; 35.2299</p>

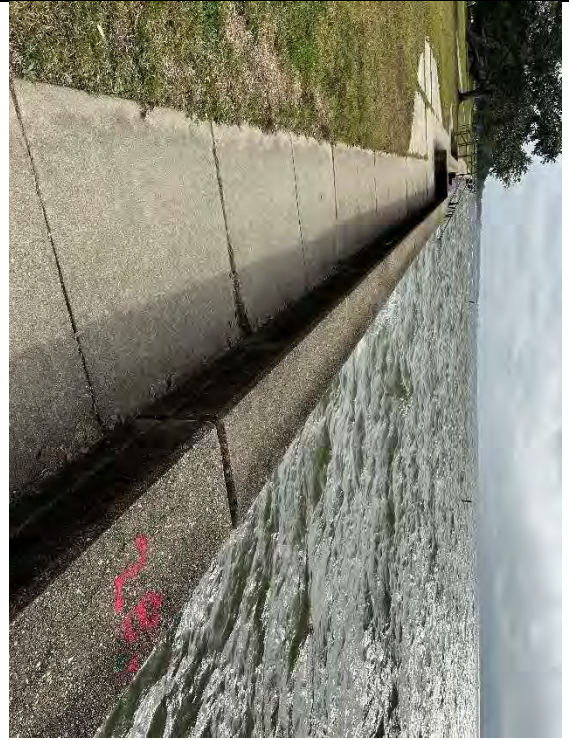
<p>Photo Name: IMG_0136 Inspection Field Notes Photo # : 82 Date: 12-13-22 Approximate Station: Station 28+00 to 28+63 Description: Horizontal cracks along the top side of seawall. A few horizontal cracks along the land face side of the seawall as well. Coordinates: Latitude: 30 ; 21 ; 20.99 Longitude: 90 ; 4 ; 34.19</p>

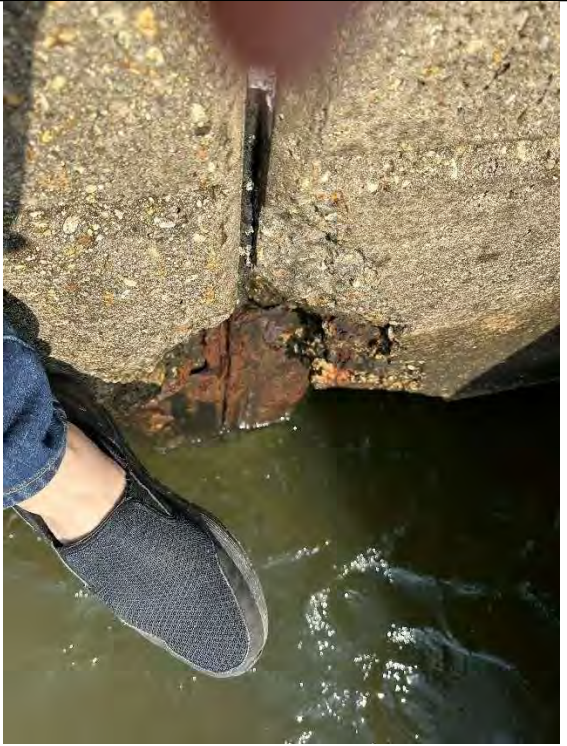
<p>Photo Name: IMG_0137 Inspection Field Notes Photo # : 83 Date: 12-13-22 Approximate Station: Station 28+68 Description: Concrete spall along seaside of expansion joint Coordinates: Latitude: 30 ; 21 ; 20.63 Longitude: 90 ; 4 ; 33.010</p>

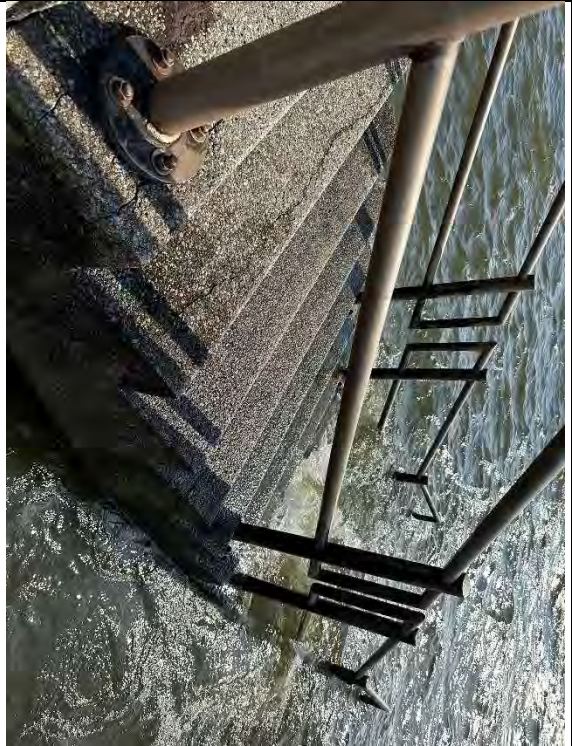
<p>Photo Name: IMG_0138 Inspection Field Notes Photo # : 84 Date: 12-13-22 Approximate Station: Station 28+76 Description: Stairway. Steps have cracks on them along the seaside Coordinates: Latitude: 30 ; 21 ; 20.4799 Longitude: 90 ; 4 ; 33.1199</p>

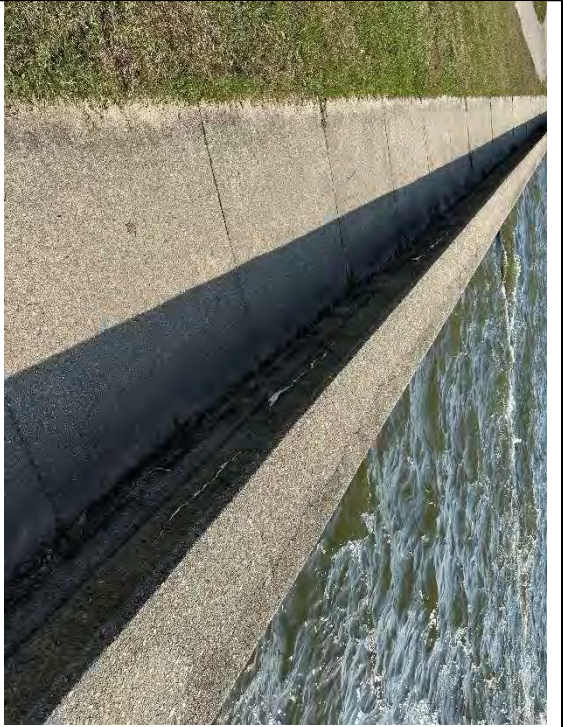
<p>Photo Name: IMG_0141 Inspection Field Notes Photo # : 88 Date: 12-13-22 Approximate Station: Station 29+72 to 30+00 Description: Horizontal cracks along the top side of the seawall. Horizontal cracks along the land face side of the seawall as well. Coordinates: Latitude: 30 ; 21 ; 19.91 Longitude: 90 ; 4 ; 32.099</p>

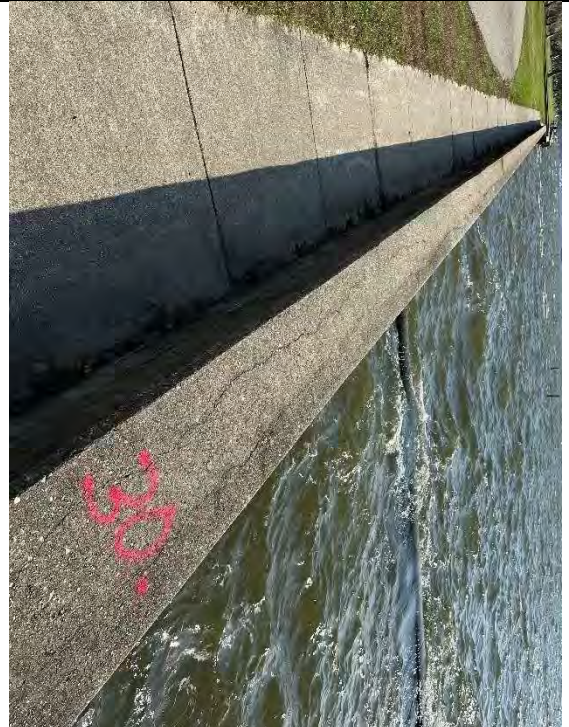
<p>Photo Name: IMG_0142 Inspection Field Notes Photo # : 89 Date: 12-13-22 Approximate Station: Station 30+00 to 31+00 Description: Horizontal cracks along the top side of the seawall. Horizontal cracks along the land face side of the seawall. Some rust spots as well. Coordinates: Latitude: 30 ; 21 ; 19.9299 Longitude: 90 ; 4 ; 31.75</p>

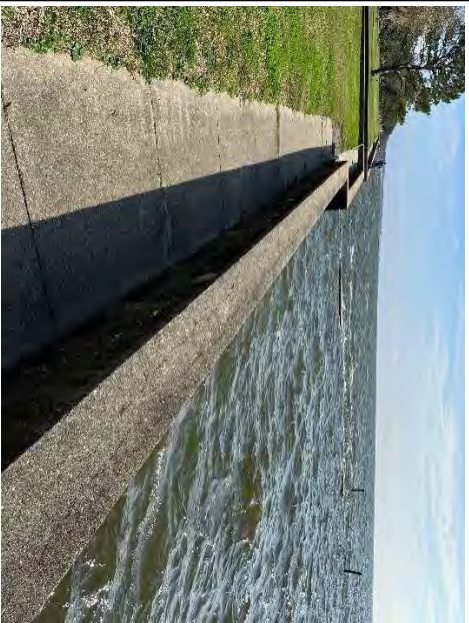
<p>Photo Name: IMG_0145 Inspection Field Notes Photo # : 92 Date: 12-13-22 Approximate Station: Station 32+18 to 32+30 Description: Horizontal cracks along the top side of the seawall. Horizontal cracks along the land face side of the seawall as well. Sidewalk is settling along with seawall. Coordinates: Latitude: 30 ; 21 ; 19.3899 Longitude: 90 ; 4 ; 30.1799</p>
	<p>Photo Name: IMG_0146 Inspection Field Notes Photo # : Date: 12-13-22 Approximate Station: Station Description: Coordinates: Longitude: Latitude: File is corrupted.</p>

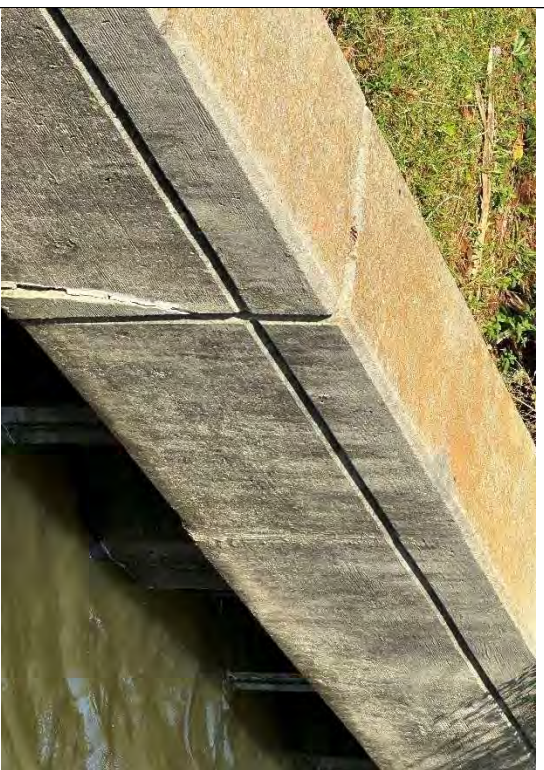
Photo Name: IMG_0147
Inspection Field Notes Photo # : 95
Date: 12-13-22
Approximate Station: Station 33+61
Description: Concrete Spall at Expansion Joint
Coordinates:
Latitude: 30 ; 21 ; 19.4299
Longitude: 90 ; 4 ; 28.89

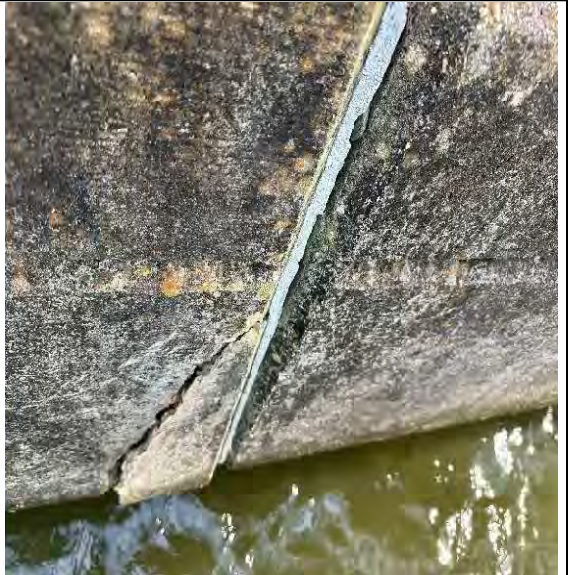
Photo Name: IMG_0152
Inspection Field Notes Photo # : 99
Date: 12-13-22
Approximate Station: Station 35+62
Description: Concrete Spall on East side of Expansion Joint
Coordinates:
Latitude: 30 ; 21 ; 19.7599
Longitude: 90 ; 4 ; 28.700

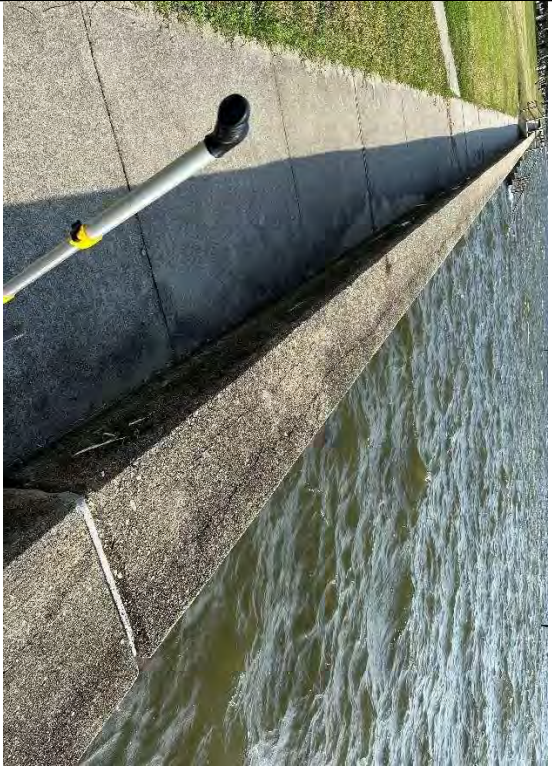
<p>Photo Name: IMG_0154 Inspection Field Notes Photo # : 101 Date: 12-13-22 Approximate Station: Station 37+32 to 37+77 Description: Horizontal cracks on top of seawall. Horizontal cracks on Land side of seawall Coordinates: Latitude: 30 ; 21 ; 18.66 Longitude: 90 ; 4 ; 28.619</p>

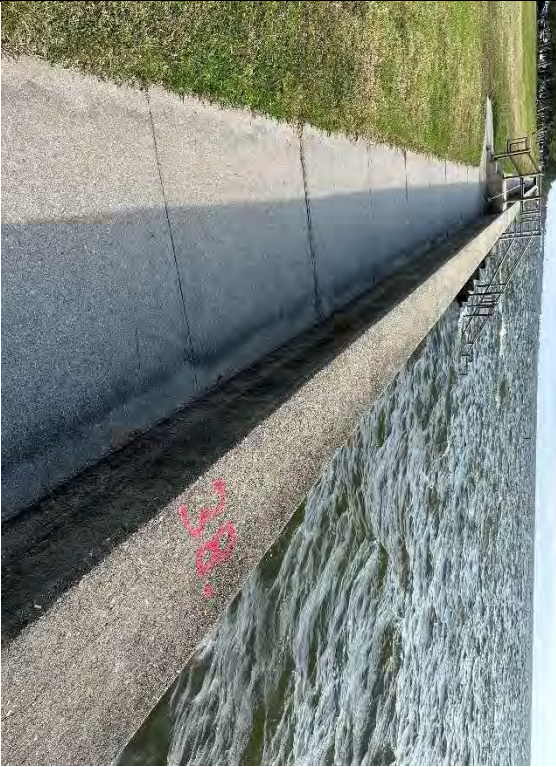
<p>Photo Name: IMG_0156 Inspection Field Notes Photo # : 102 Date: 12-13-22 Approximate Station: Station 38+00 to 38+49 Description: Minor horizontal cracks on top of seal wall Coordinates: Latitude: 30 ; 21 ; 18.38 Longitude: 90 ; 4 ; 27.8699</p>

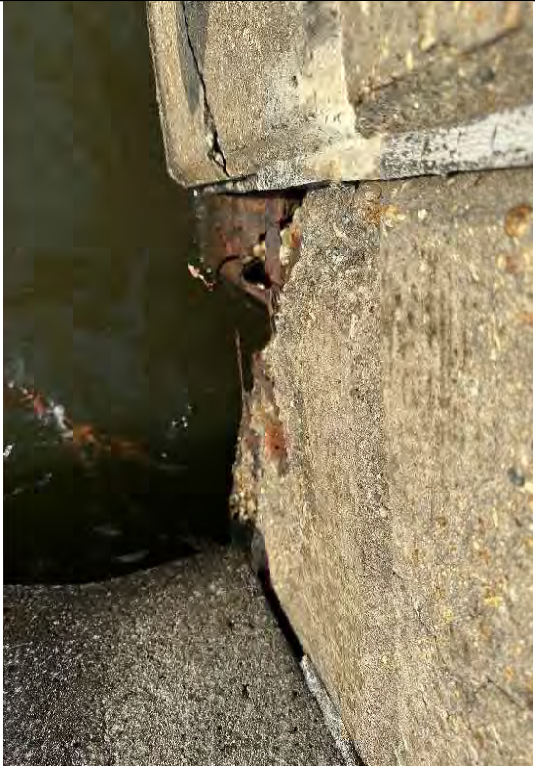
Photo Name: IMG_0157
Inspection Field Notes Photo # : 103
Date: 12-13-22
Approximate Station: Station 38+50
Description: Concrete spall at seaside of expansion joint
Coordinates:
Latitude: 30 ; 21 ; 18.1199
Longitude: 90 ; 4 ; 27.3800

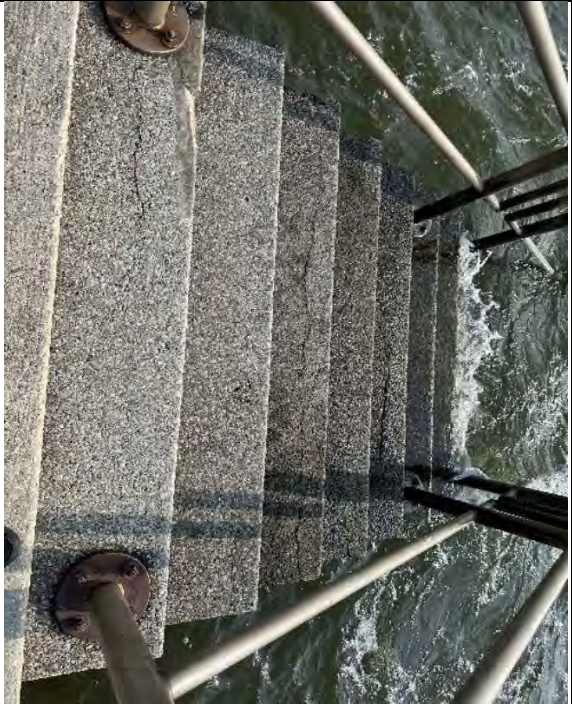
Photo Name: IMG_0158
Inspection Field Notes Photo # : 104
Date: 12-13-22
Approximate Station: Station 38+61
Description: Stairway. Step 7 is cracked on seaside face of seawall
Coordinates:
Latitude: 30 ; 21 ; 17.91
Longitude: 90 ; 4 ; 27.5399

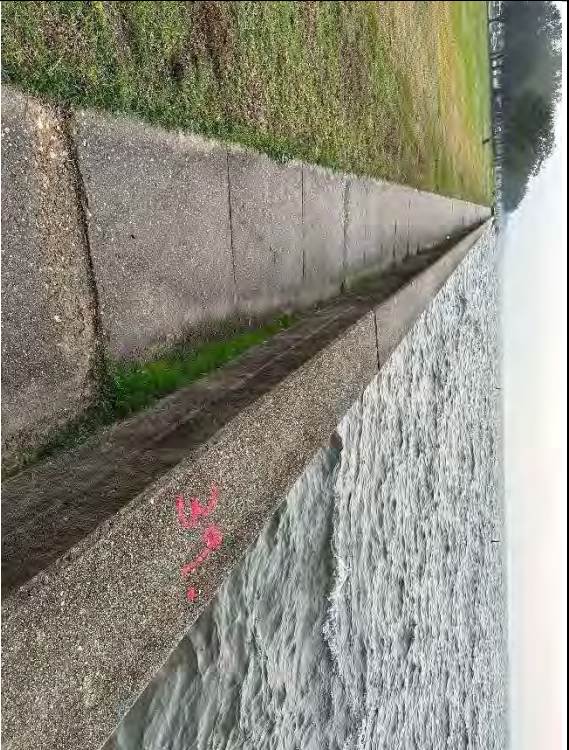
<p>Photo Name: IMG_0162 Inspection Field Notes Photo # : 108 Date: 12-14-22 Approximate Station: Station 39+00 to 40+00 Description: Minor hairline crack along the top side of the seawall. Sidewalk is setting along the wall as well Coordinates: Latitude: 30 ; 21 ; 17.83 Longitude: 90 ; 4 ; 27.02</p>

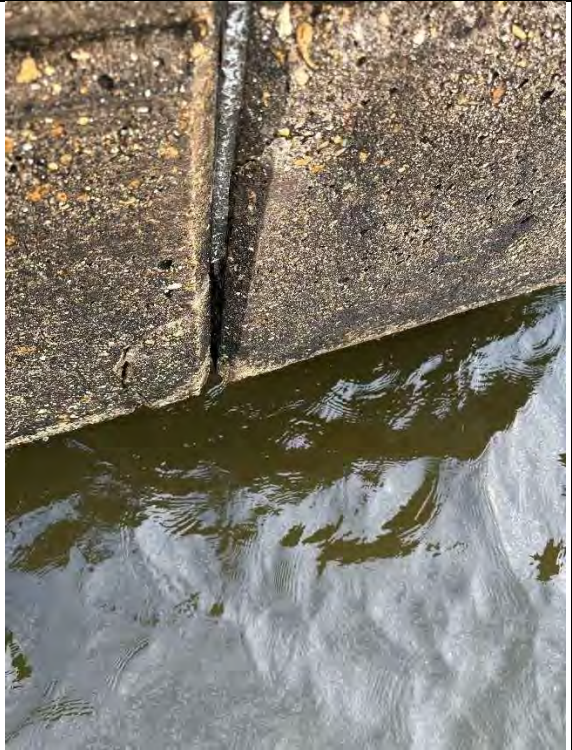
<p>Photo Name: IMG_0163 Inspection Field Notes Photo # : 109 Date: 12-14-22 Approximate Station: Station 39+68 Description: Concrete spall along seaside of expansion joint Coordinates: Latitude: 30 ; 21 ; 17.49 Longitude: 90 ; 4 ; 26.169</p>

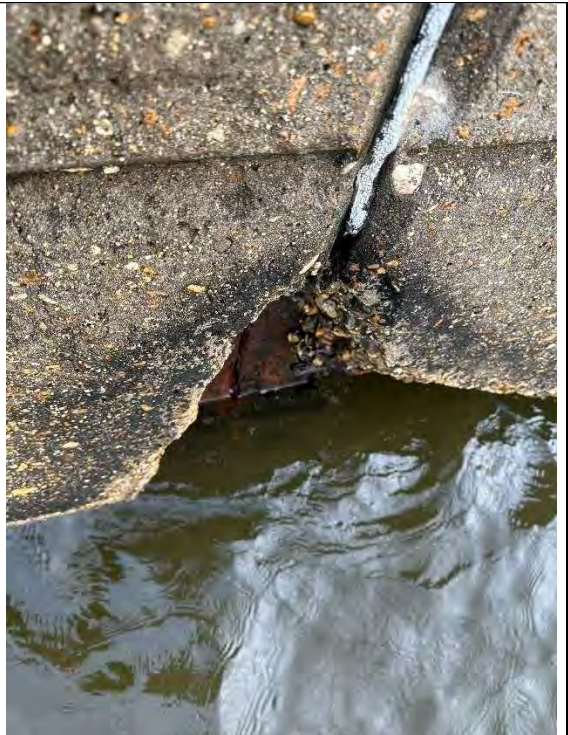
Photo Name: IMG_0166
Inspection Field Notes Photo # : 112
Date: 12-14-22
Approximate Station: Station 40+85
Description: Concrete spall along seaside of expansion joint
Coordinates:
Latitude: 30 ; 21 ; 16.899
Longitude: 90 ; 4 ; 25.02

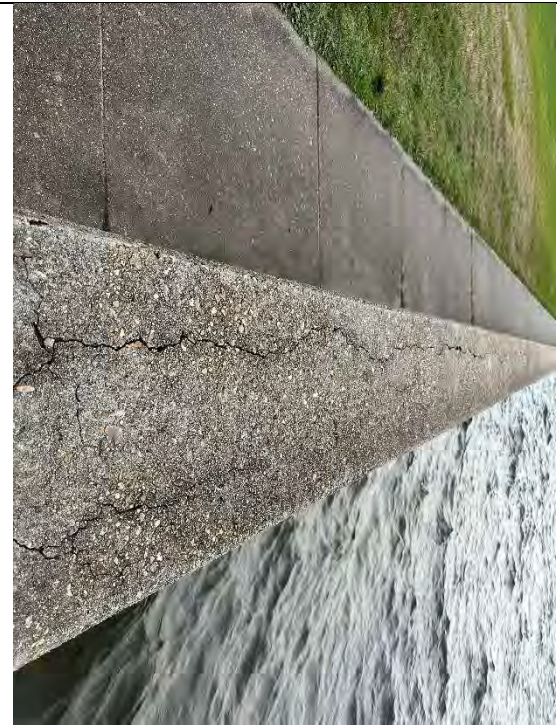
Photo Name: IMG_0167
Inspection Field Notes Photo # : 113
Date: 12-14-22
Approximate Station: Station 40+86 to 41+07
Description: Top side of seawall contains horizontal cracks that are reflective of the sheet pile
Coordinates:
Latitude: 30 ; 21 ; 17.00
Longitude: 90 ; 4 ; 24.94

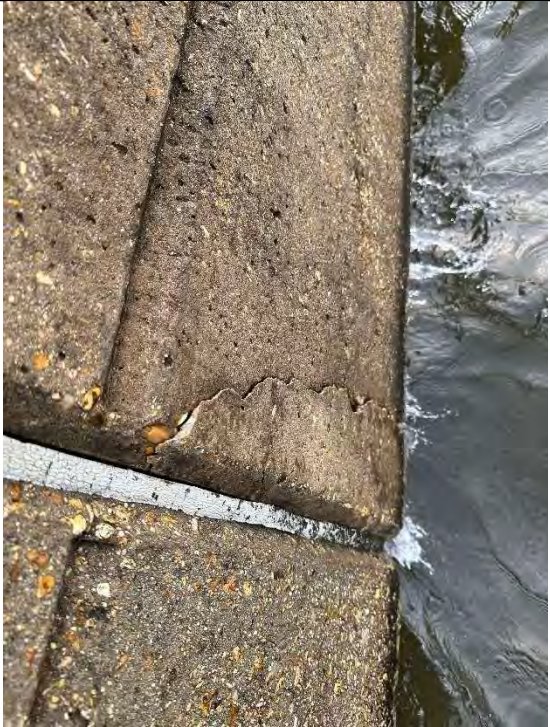
<p>Photo Name: IMG_0168 Inspection Field Notes Photo # : 114 Date: 12-14-22 Approximate Station: Station N/A Description: Concrete spall along seaside of expansion joint Coordinates: Latitude: 30 ; 21 ; 16.7899 Longitude: 90 ; 4 ; 24.3599</p>

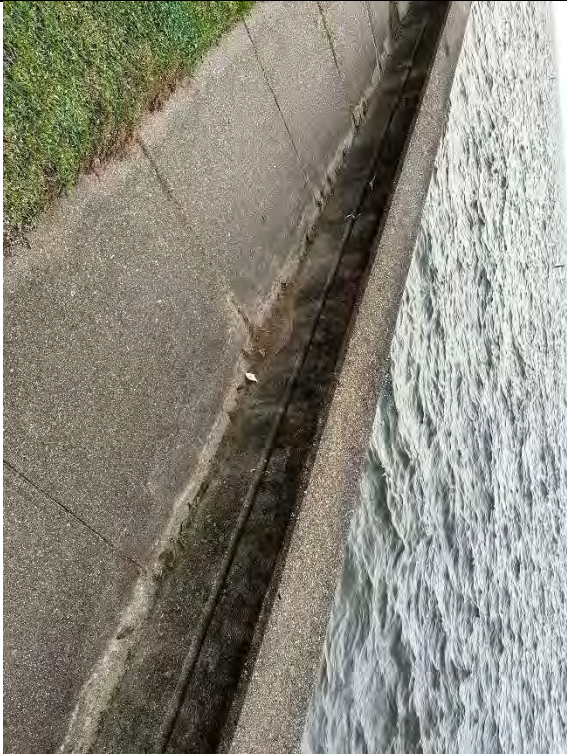
<p>Photo Name: IMG_0169 Inspection Field Notes Photo # : 116 Date: 12-14-22 Approximate Station: Station 41+60 to 42+10 Description: Horizontal cracks along land face side of seawall Coordinates: Latitude: 30 ; 21 ; 16.83 Longitude: 90 ; 4 ; 24.3599</p>

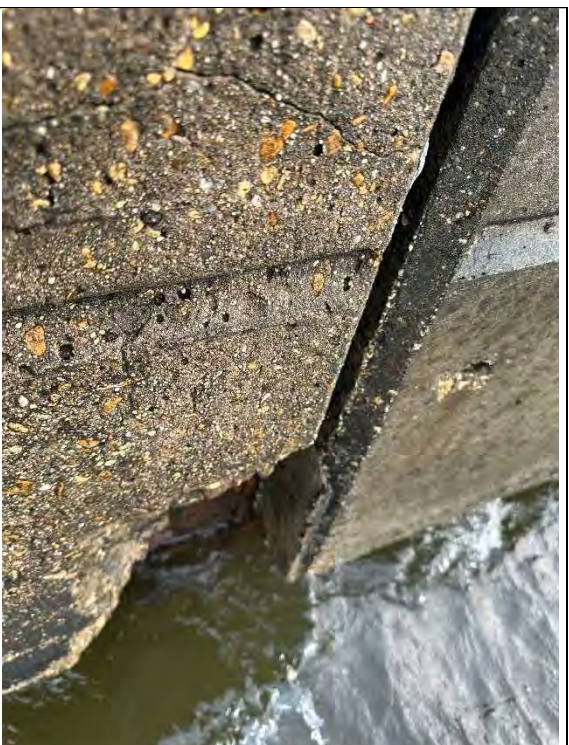
Photo Name: IMG_0170
Inspection Field Notes Photo # : 118
Date: 12-14-22
Approximate Station: Station 42+03 to 42+19
Description: Bottom edge of concrete wall needs repairing on seaside
Coordinates:
Latitude: 30 ; 21 ; 16.610
Longitude: 90 ; 4 ; 23.809

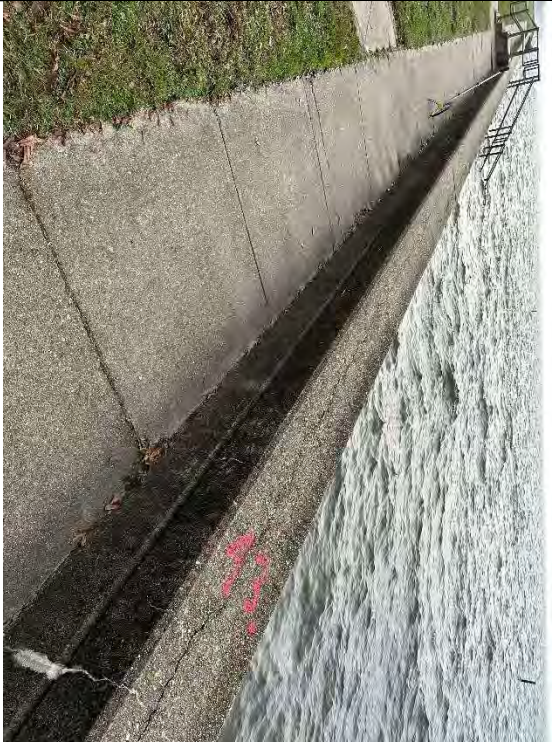
<p>Photo Name: IMG_0174 Inspection Field Notes Photo # : 122 Date: 12-14-22 Approximate Station: Station 43+00 to 43+24 Description: Horizontal cracks along the top side of the seawall that are reflective of sheet pile. Horizontal and vertical cracks along the land face side as well. Coordinates: Latitude: 30 ; 21 ; 16.32 Longitude: 90 ; 4 ; 22.9299</p>

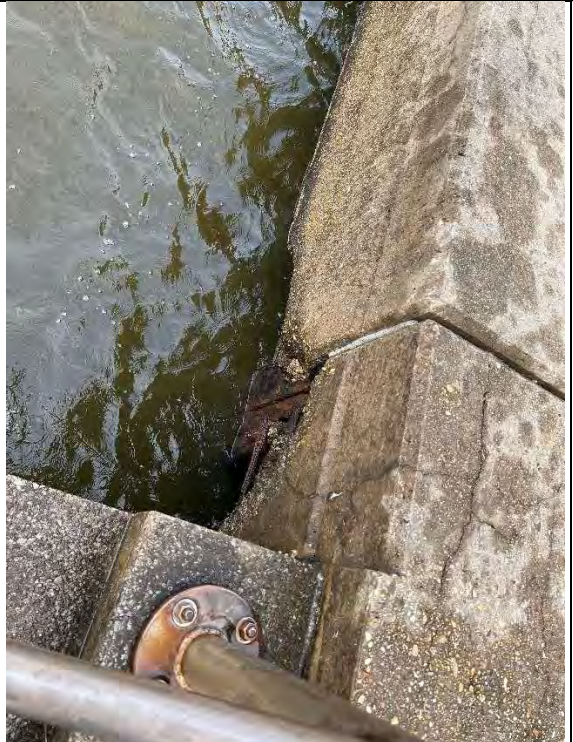
<p>Photo Name: IMG_0175 Inspection Field Notes Photo # : 123 Date: 12-14-22 Approximate Station: Station 43+68 Description: Concrete spall along the seaside of expansion joint Coordinates: Latitude: 30 ; 21 ; 15.85 Longitude: 90 ; 4 ; 22.38</p>
