**COM PROJ. NO. 100.21.019
SEAWALL REPAIR (INSPECTION PROJECT)
FINAL FINDINGS/ASSESSMENT REPORT**

The City of Mandeville
1100 Mandeville High Blvd.
Mandeville, LA 70471

Prepared by
BURK-KLEINPETER, INC.
4176 Canal Street
New Orleans, LA 70119

APRIL 2023

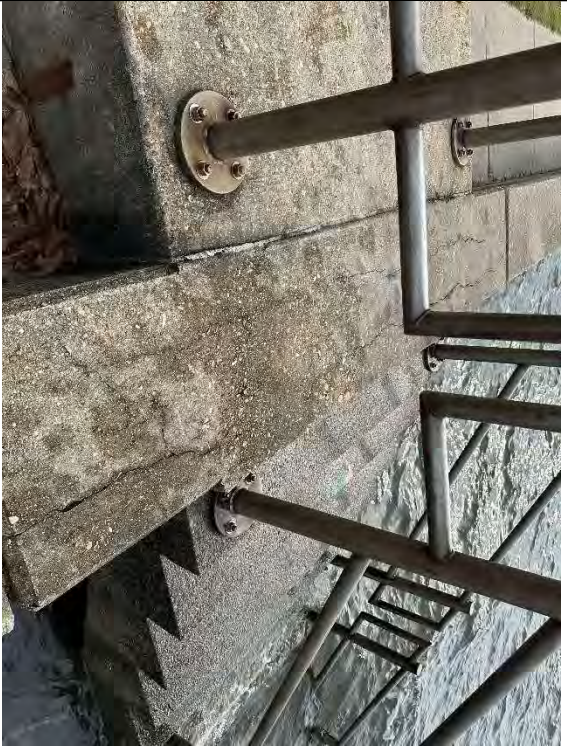
<p>Photo Name: IMG_0176 Inspection Field Notes Photo # : 125 Date: 12-14-22 Approximate Station: Station 43+73 Description: Stairway. Steps 5 and 6 on the seaside contains cracks Coordinates: Latitude: 30 ; 21 ; 15.899 Longitude: 90 ; 4 ; 22.08</p>

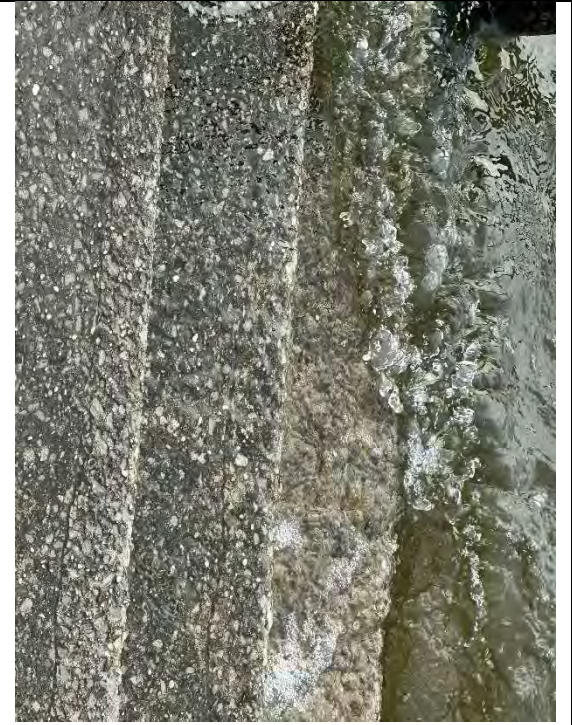
<p>Photo Name: IMG_0177 Inspection Field Notes Photo # : 125 Date: 12-14-22 Approximate Station: Station 43+73 Description: Stairway. Steps 5 and 6 on the seaside contains cracks Coordinates: Latitude: 30 ; 21 ; 15.8699 Longitude: 90 ; 4 ; 22.130</p>

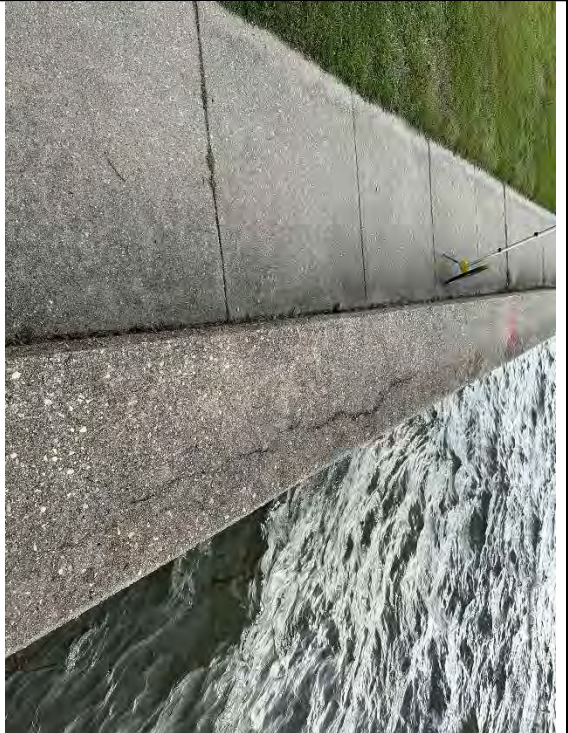
<p>Photo Name: IMG_0178 Inspection Field Notes Photo # : 126 Date: 12-14-22 Approximate Station: Station 43+68 to 44+00 Description: Minor horizontal cracks along the top side of the seawall Coordinates: Latitude: 30 ; 21 ; 16.1999 Longitude: 90 ; 4 ; 22.130</p>

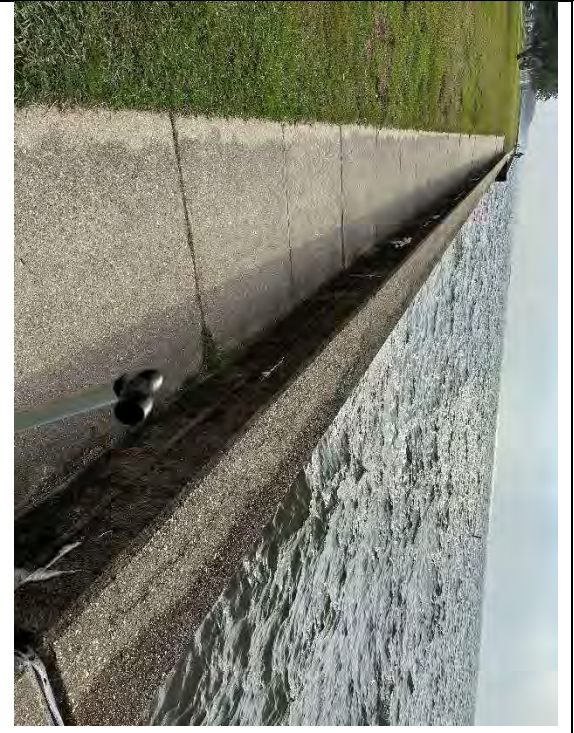
<p>Photo Name: IMG_0179 Inspection Field Notes Photo # : 127 Date: 12-14-22 Approximate Station: Station 44+16 to 4+38 Description: Cracks on the top side of the seawall that are reflective of sheet pile. Horizontal cracks along the land face side of the seawall. Coordinates: Latitude: 30 ; 21 ; 15.88 Longitude: 90 ; 4 ; 21.9099</p>

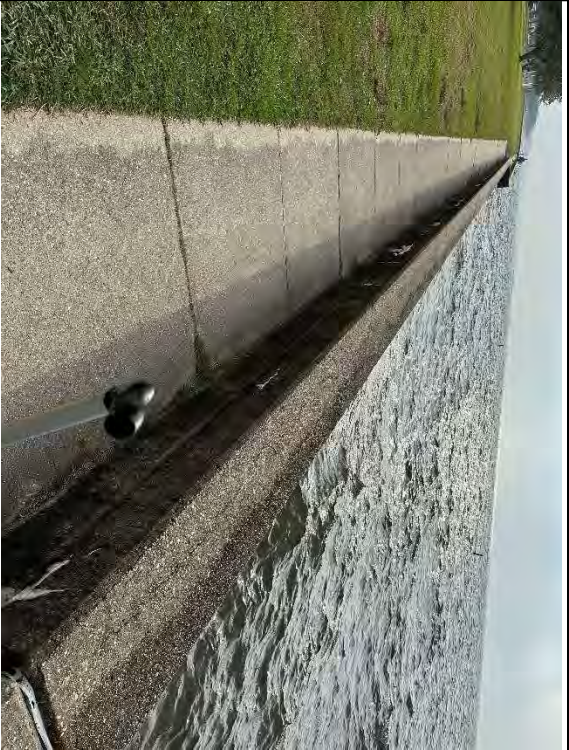
<p>Photo Name: IMG_0180 Inspection Field Notes Photo # : 128 Date: 12-14-22 Approximate Station: Station 44+38 to 45+00 Description: Horizontal cracks on the top side of the seawall that are reflective of sheet pile. Horizontal cracks along the land face side of the seawall as well Coordinates: Latitude: 30 ; 21 ; 15.60 Longitude: 90 ; 4 ; 21.53</p>

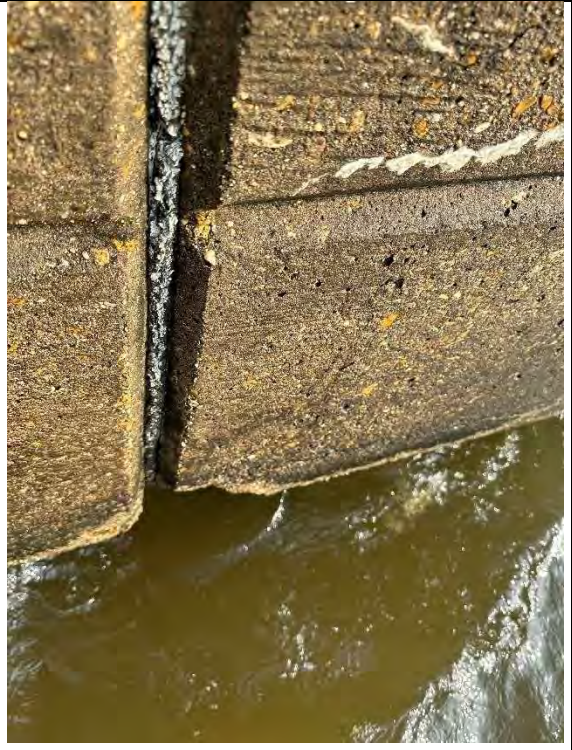
<p>Photo Name: IMG_0181 Inspection Field Notes Photo # : 129 Date: 12-14-22 Approximate Station: Station 44+97 Description: Concrete spall along seaside of expansion joint Coordinates: Latitude: 30 ; 21 ; 15.2899 Longitude: 90 ; 4 ; 20.9299</p>

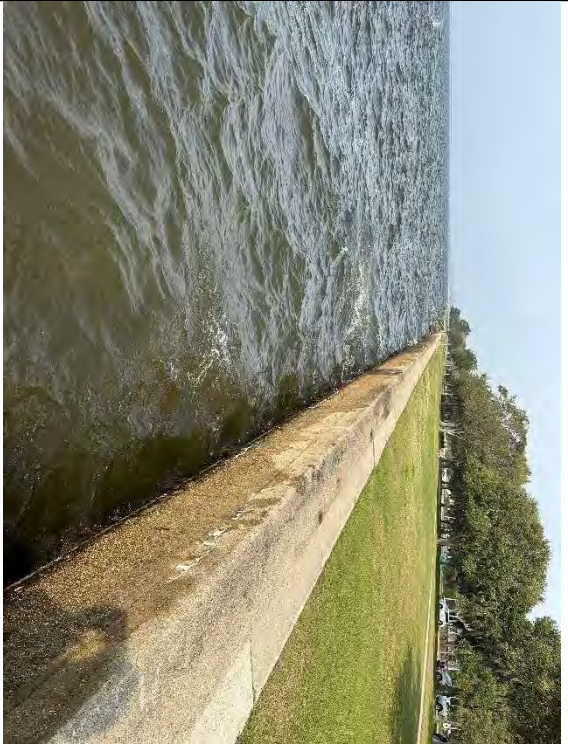
<p>Photo Name: IMG_0184 Inspection Field Notes Photo # : 131 Date: 12-14-22 Approximate Station: Station 43+63 to 46+00 Description: Horizontal cracks along the seaside face of the seawall. Coordinates: Latitude: 30 ; 21 ; 14.910 Longitude: 90 ; 4 ; 19.94</p>

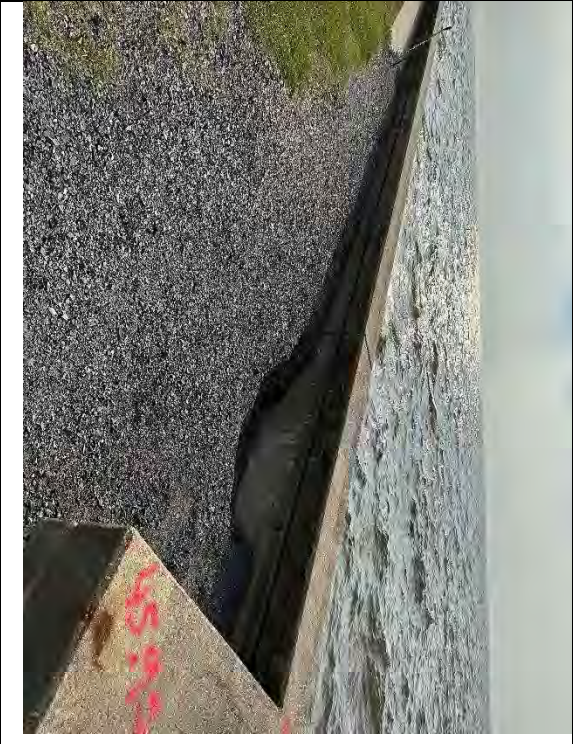
<p>Photo Name: IMG_0185 Inspection Field Notes Photo # : 132 Date: 12-14-22 Approximate Station: Station 45+95 to 46+26 Description: Horizontal cracks along the top side of the seawall. Horizontal cracks along the land face side of the seawall. Repairs are needed for sidewalk along seawall. Coordinates: Latitude: 30 ; 21 ; 14.8699 Longitude: 90 ; 4 ; 19.83</p>

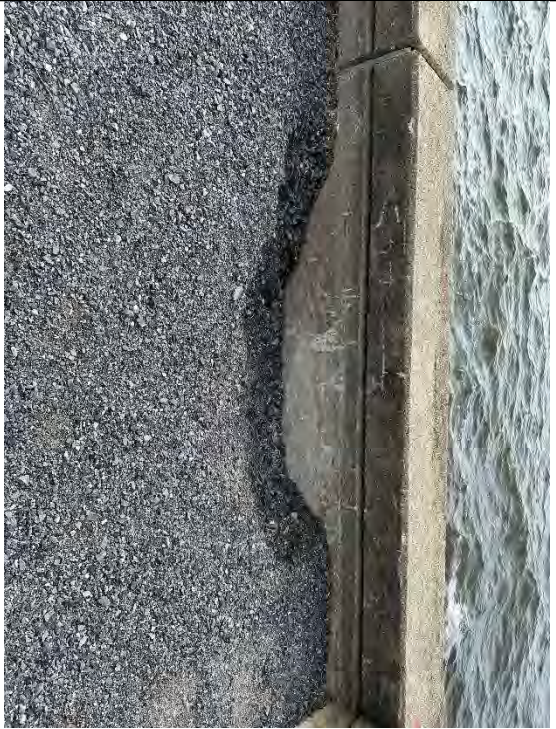
<p>Photo Name: IMG_0186 Inspection Field Notes Photo # : 133 Date: 12-14-22 Approximate Station: Station 46+02 to 46+07 Description: 5' long sunken hole along the land face side of the seawall Coordinates: Latitude: 30 ; 21 ; 15.7499 Longitude: 90 ; 4 ; 18.2299</p>

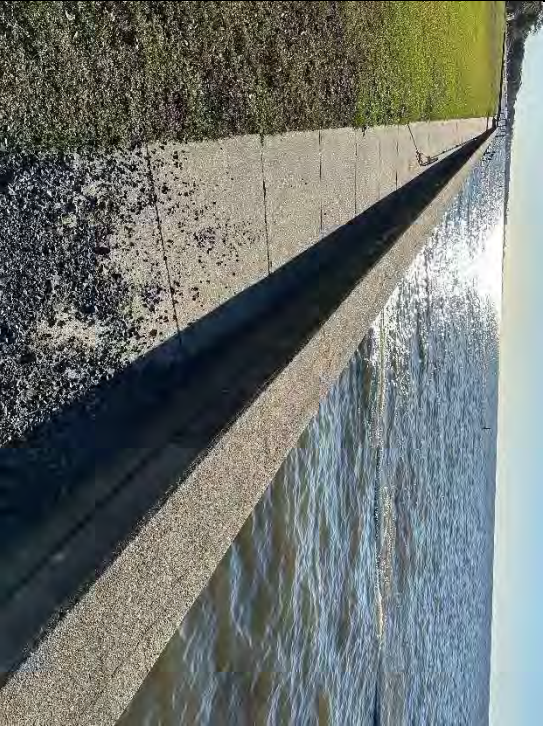
<p>Photo Name: IMG_0188 Inspection Field Notes Photo # : 134 Date: 12-15-22 Approximate Station: Station 46+90 to 47+00 Description: Horizontal cracks along the top side of the seawall. Horizontal cracks along the land face side of the seawall. Coordinates: Latitude: 30 ; 21 ; 14.5899 Longitude: 90 ; 4 ; 19.63</p>

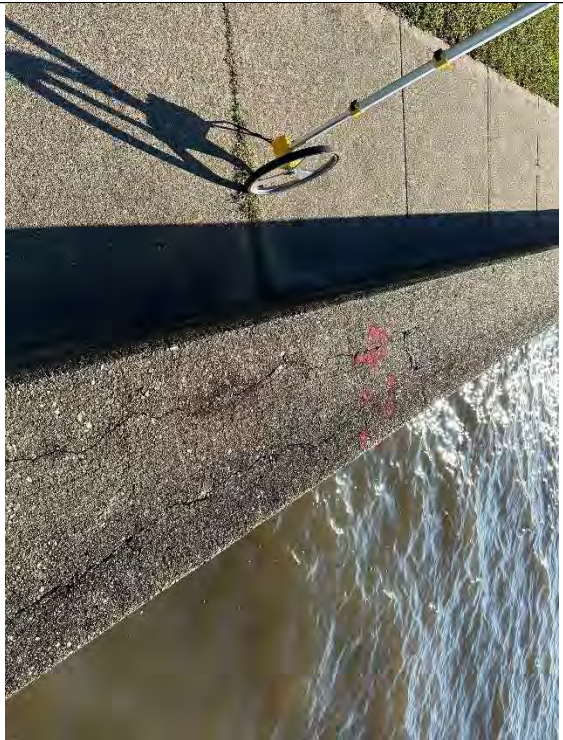
Photo Name: IMG_0189
Inspection Field Notes Photo # : 135
Date: 12-15-22
Approximate Station: Station 46+90 to 4+83
Description: Horizontal cracks along with rust spots on the top side of the seawall. Horizontal cracks along the land face side of the seawall. Sidewalk is also sunken along the seawall as well.
Coordinates:
Latitude: 30 ; 21 ; 14.2899
Longitude: 90 ; 4 ; 18.999

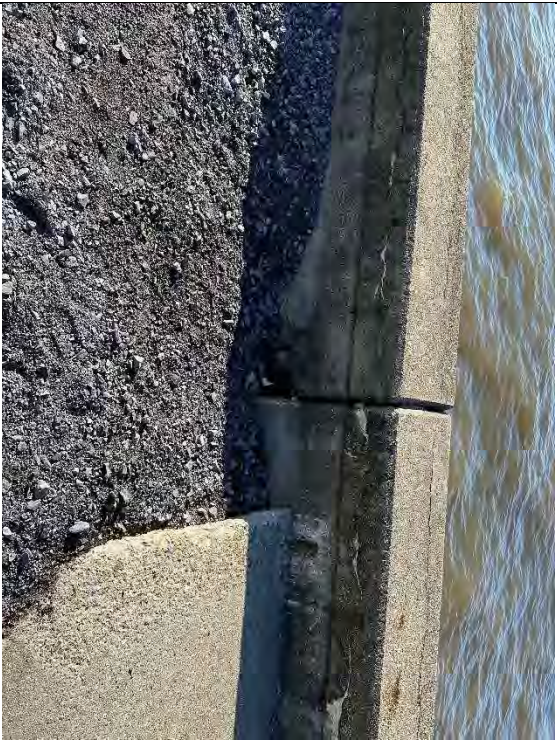
Photo Name: IMG_190
Inspection Field Notes Photo # : 136
Date: 12-15-22
Approximate Station: Station 47+83 to 47+92
Description: Concrete spall along the land face side of the sheet pile. Sidewalk repair is needed at concrete spall in seawall as well.
Coordinates:
Latitude: 30 ; 21 ; 13.8899
Longitude: 90 ; 4 ; 18.1199

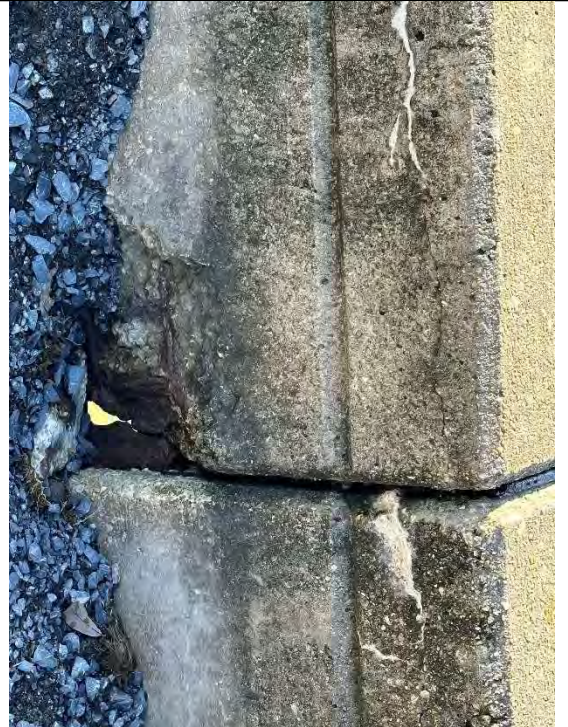
<p>Photo Name: IMG_0191 Inspection Field Notes Photo # : 136 Date: 12-15-22 Approximate Station: Station 47+83 to 47+92 Description: Concrete spall along the land face side of the sheet pile. Sidewalk repair is needed at concrete spall in seawall as well. Coordinates: Latitude: 30 ; 21 ; 13.88 Longitude: 90 ; 4 ; 18.070</p>

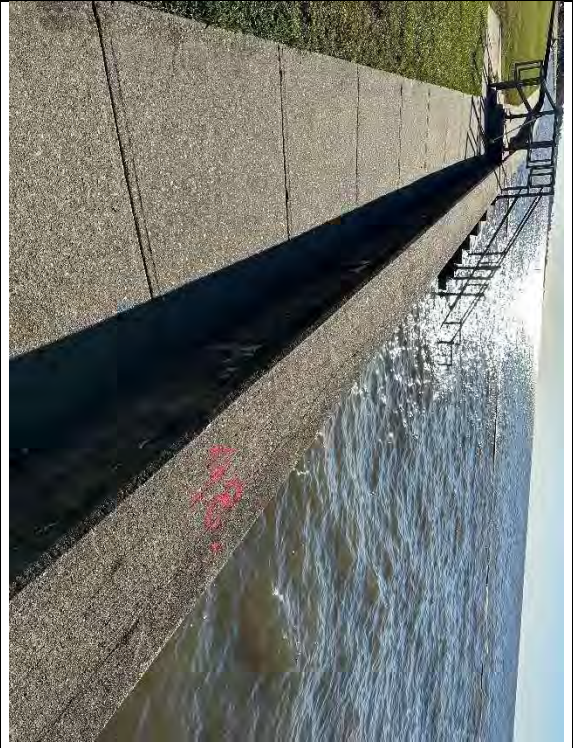
<p>Photo Name: IMG_0192 Inspection Field Notes Photo # : 137 Date: 12-15-22 Approximate Station: Station 48+00 to 48+36 Description: Horizontal cracks along the top side of the seawall that are reflective with rust spots. Horizontal cracks along the land face side of the seawall. Sidewalk settles along seawall. Coordinates: Latitude: 30 ; 21 ; 14.22 Longitude: 90 ; 4 ; 17.52</p>

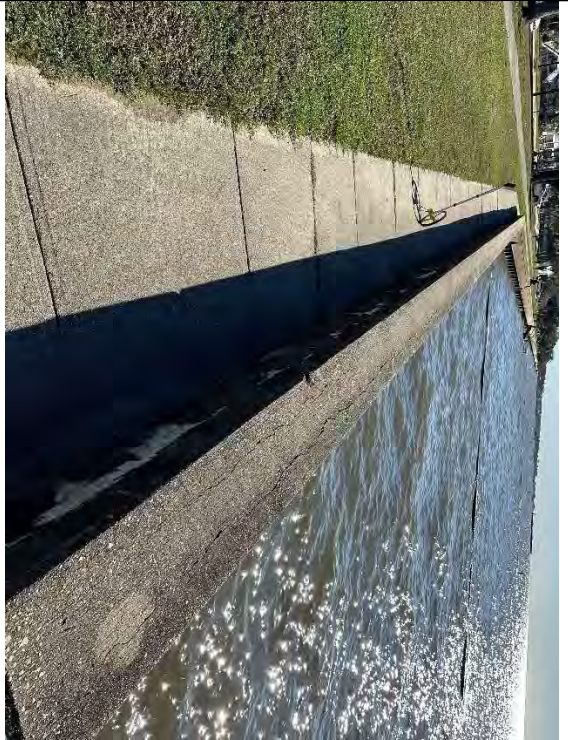
<p>Photo Name: IMG_0199 Inspection Field Notes Photo # : 144 Date: 12-15-22 Approximate Station: Station 50+80 to 51+00 Description: Horizontal cracks along the top side of the seawall. Large horizontal and vertical cracks along the land face side of the seawall. Coordinates: Latitude: 30 ; 21 ; 12.89999 Longitude: 90 ; 4 ; 15.08</p>

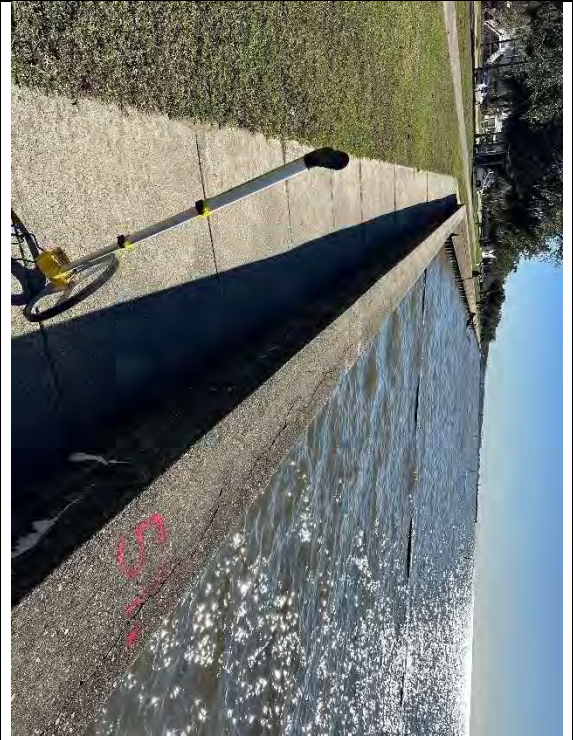
<p>Photo Name: IMG_0200 Inspection Field Notes Photo # : 145 Date: 12-15-22 Approximate Station: Station 51+00 to 51+74 Description: Horizontal cracks and rust spots along the top side of the seawall that are reflective of the sheet pile. Horizontal and vertical cracks and rust spots along the land face side of the seawall as well. Coordinates: Latitude: 30 ; 21 ; 12.74999 Longitude: 90 ; 4 ; 14.799</p>

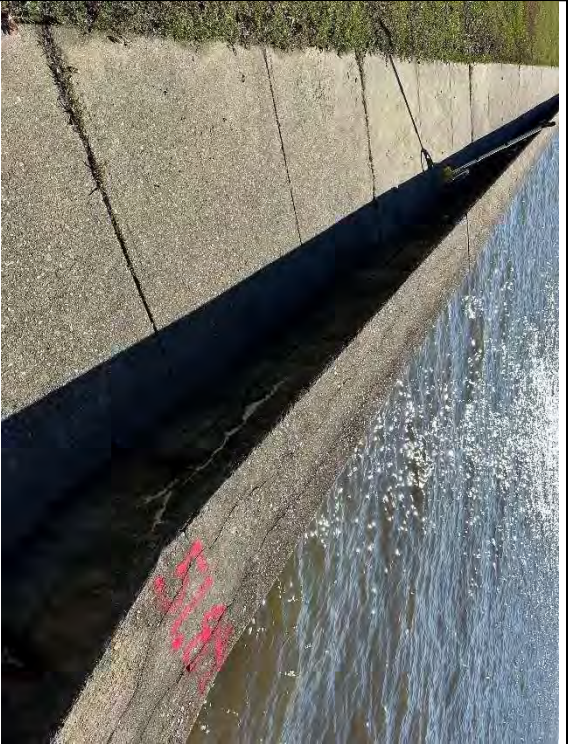
<p>Photo Name: IMG_0203 Inspection Field Notes Photo # : 146 Date: 12-15-22 Approximate Station: Station 51+84 to 52+00 Description: Point of curve in the seawall. Horizontal cracks along the top side of the seawall that are reflective of the sheet pile. Horizontal cracks along the land face side of the seawall as well. Coordinates: Latitude: 30 ; 21 ; 12.6499 Longitude: 90 ; 4 ; 13.8099</p>

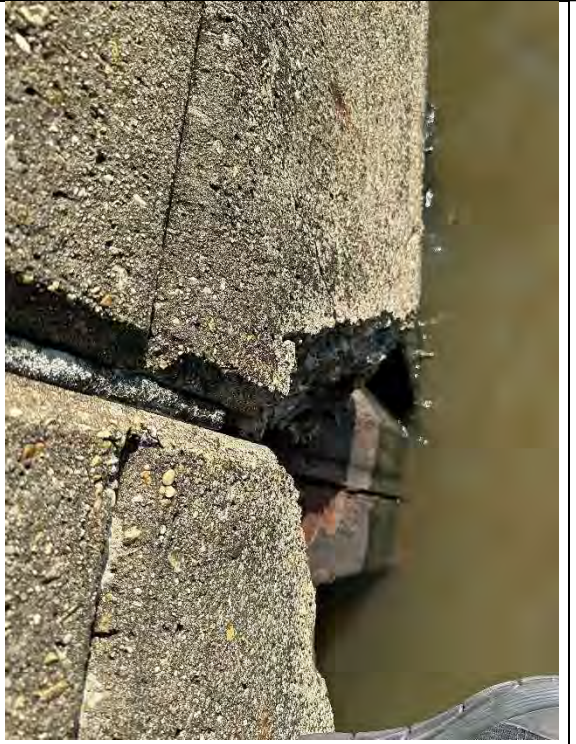
<p>Photo Name: IMG_0204 Inspection Field Notes Photo # : 147 Date: 12-15-22 Approximate Station: Station 51+97 Description: Concrete spall along the seaside face of the expansion joint Coordinates: Latitude: 30 ; 21 ; 12.55 Longitude: 90 ; 4 ; 13.6199</p>

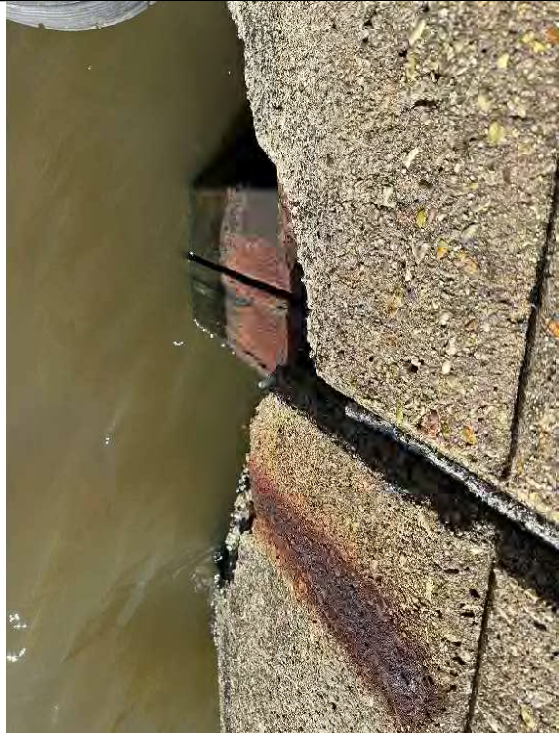
Photo Name: IMG_0205
Inspection Field Notes Photo # : 149
Date: 12-15-22
Approximate Station: Station 52+57
Description: Concrete spall along the seaside face of the expansion joint.
Coordinates:
Latitude: 30 ; 21 ; 12.22999
Longitude: 90 ; 4 ; 13.1799

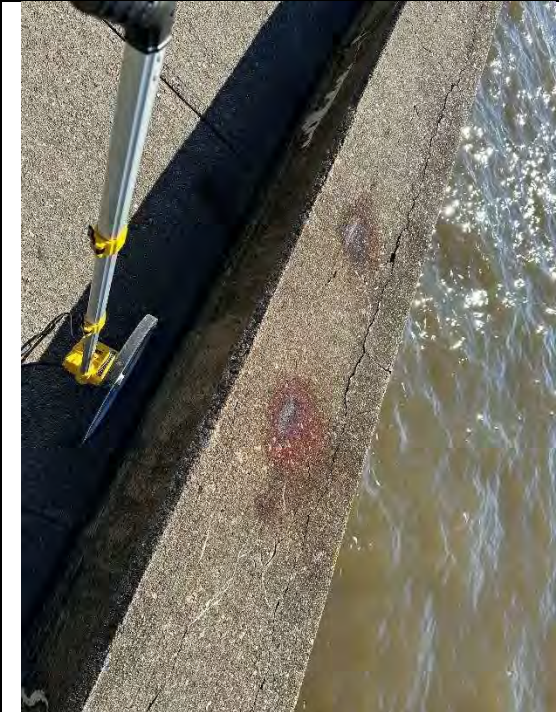
Photo Name: IMG_0206
Inspection Field Notes Photo # : 145 REPEATED
Date: 12-15-22
Approximate Station: Station 52+86
Description: Horizontal and vertical cracks, along with rust spots that are along the top side of the seawall.
Coordinates:
Latitude: 30 ; 21 ; 12.7699
Longitude: 90 ; 4 ; 13.4299

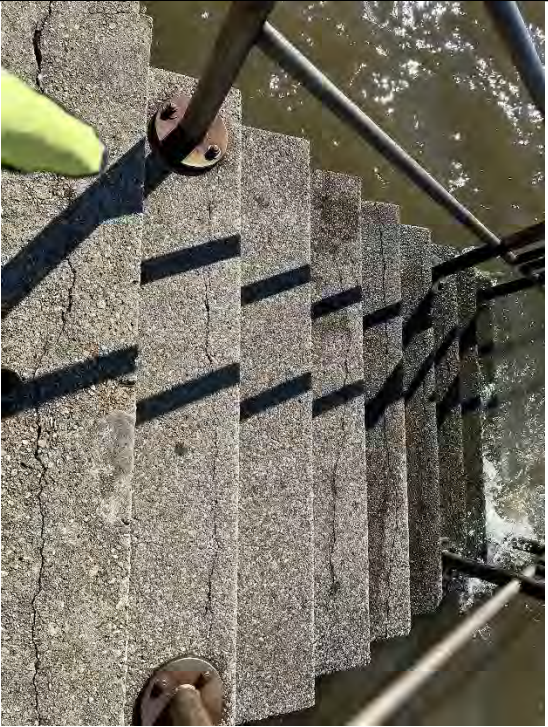
<p>Photo Name: IMG_0209 Inspection Field Notes Photo # : 148 REPEATED Date: 12-15-22 Approximate Station: Station 53+80 Description: Cracks along the seaside face of the stairway. Coordinates: Latitude: 30 ; 14 ; 11.5899 Longitude: 90 ; 4 ; 11.9699</p>

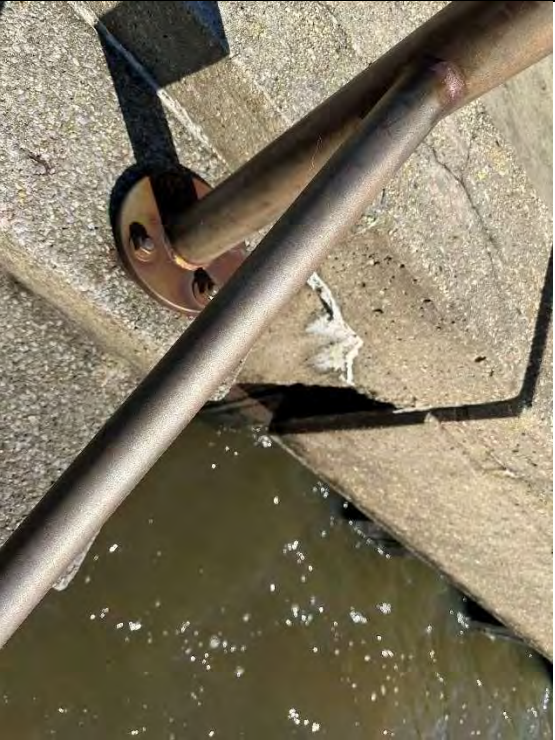
<p>Photo Name: IMG_0210 Inspection Field Notes Photo # : 149 REPEATED Date: 12-15-22 Approximate Station: Station 53+85 Description: Concrete spall along the seaside face of the expansion joint. Coordinates: Latitude: 30 ; 21 ; 11.60 Longitude: 90 ; 4 ; 11.9199</p>

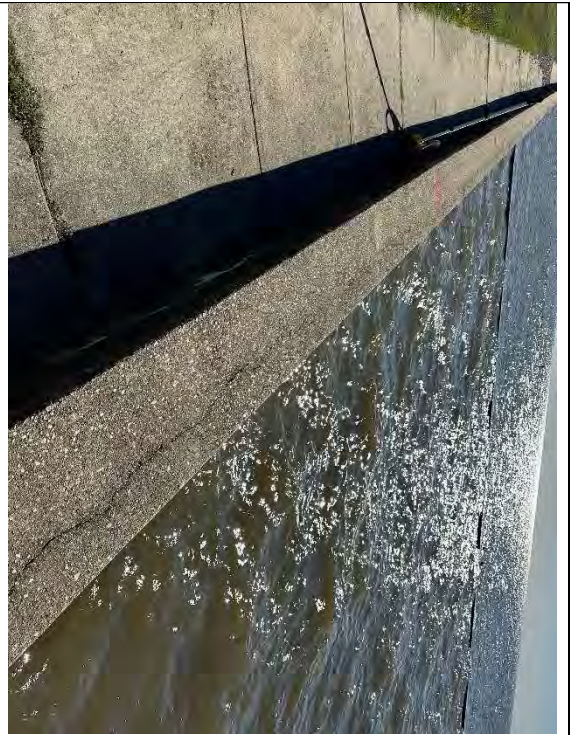
Photo Name: IMG_0211
Inspection Field Notes Photo # : 150
Date: 12-15-22
Approximate Station: Station 53+85 to 54+00
Description: Horizontal cracks along the top side of the seawall. Horizontal cracks along the land face side of the seawall as well.
Coordinates:
Latitude: 30 ; 21 ; 11.6499
Longitude: 90 ; 4 ; 11.8599

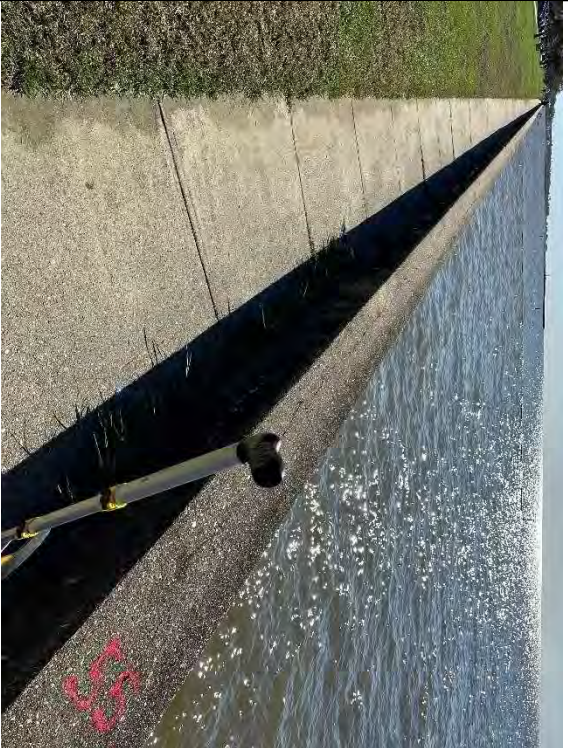
<p>Photo Name: IMG_0216 Inspection Field Notes Photo # : 155 Date: 12-15-22 Approximate Station: Station 55+00 to 55+80 Description: Horizontal cracks with rust spots along the top side of the seawall. Horizontal and vertical cracks along the land face side of the cap. Coordinates: Latitude: 30 ; 21 ; 11.050 Longitude: 90 ; 4 ; 10.710</p>

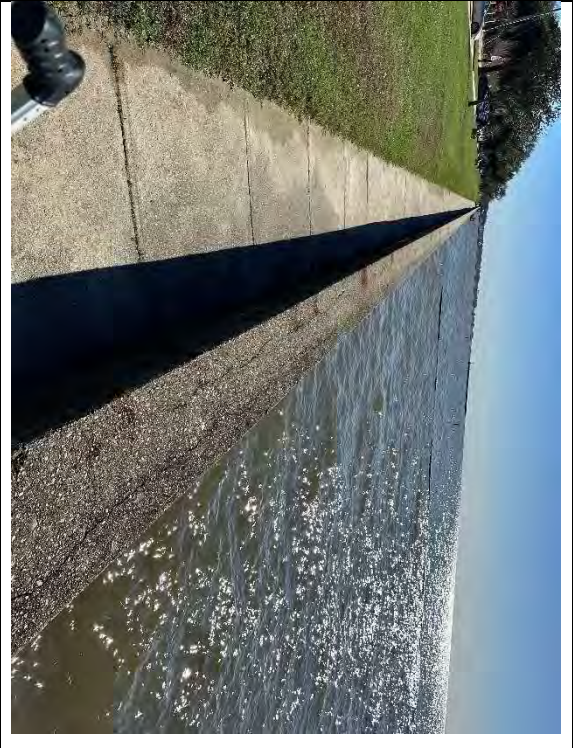
<p>Photo Name: IMG_0217 Inspection Field Notes Photo # : 156 Date: 12-15-22 Approximate Station: Station 55+80 to 56+00 Description: Horizontal cracks with rust spots along the top side of the seawall. Horizontal and vertical cracks along the land face side of the seawall. Coordinates: Latitude: 30 ; 21 ; 10.7299 Longitude: 90 ; 4 ; 9.88</p>

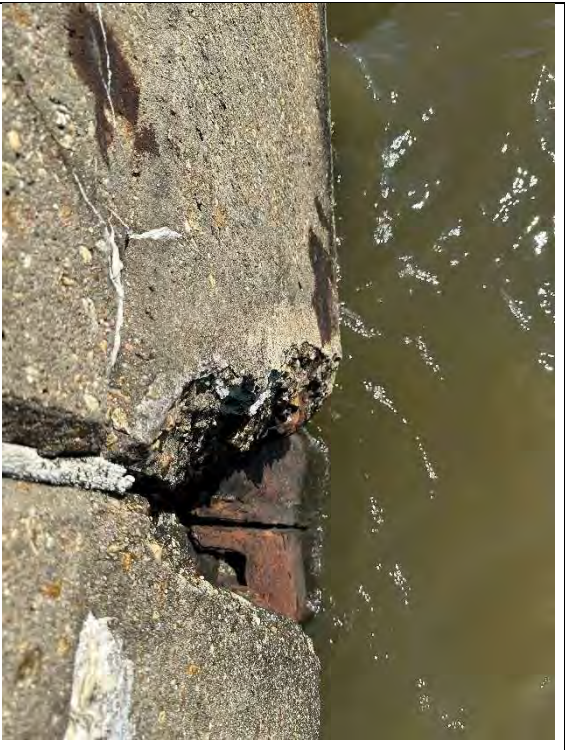
Photo Name: IMG_0219
Inspection Field Notes Photo # : 158
Date: 12-15-22
Approximate Station: Station 56+11
Description: Concrete spall along the seaside face of the expansion joint
Coordinates:
Latitude: 30 ; 21 ; 10.3999
Longitude: 90 ; 4 ; 9.6599

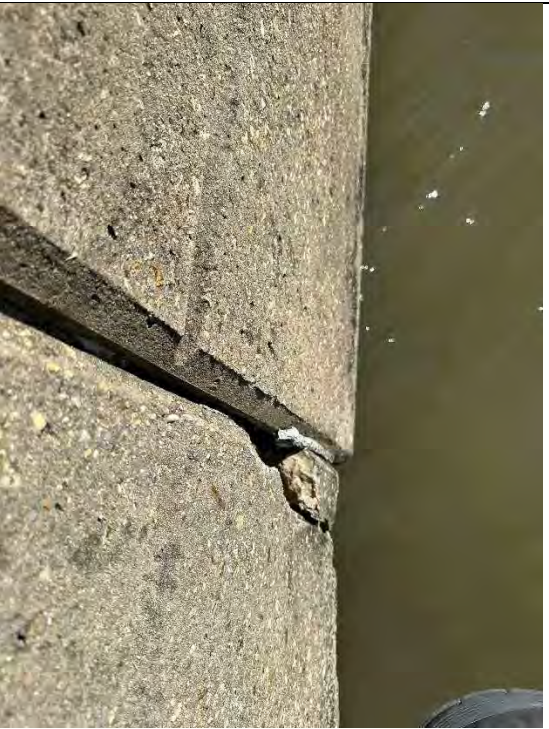
Photo Name: IMG_0224
Inspection Field Notes Photo # : 163
Date: 12-15-22
Approximate Station: Station 57+88
Description: Concrete spall along the seaside face of the expansion joint
Coordinates:
Latitude: 30 ; 21 ; 9.91
Longitude: 90 ; 4 ; 8.5399

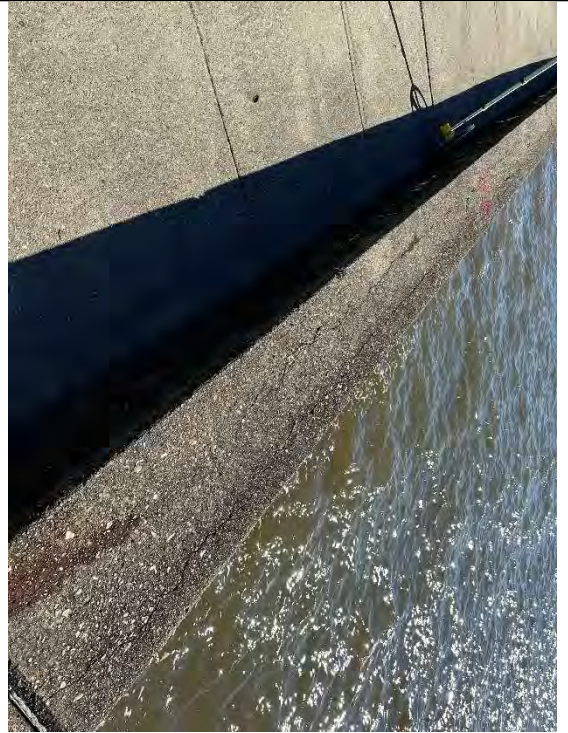
<p>Photo Name: IMG_0225 Inspection Field Notes Photo # : 164 Date: 12-15-22 Approximate Station: Station 57+88 to 58+00 Description: Horizontal cracks along the top side of the seawall. Horizontal and vertical cracks along the land face side of the cap. Coordinates: Latitude: 30 ; 21 ; 9.58999 Longitude: 90 ; 4 ; 7.96</p>
 	<p>Photo Name: IMG_0226 Inspection Field Notes Photo # : 164 Date: 12-15-22 Approximate Station: Station 57+88 to 58+00 Description: Horizontal cracks along the top side of the seawall. Horizontal and vertical cracks along the land face side of the cap. Coordinates: Latitude: 30 ; 21 ; 9.500 Longitude: 90 ; 4 ; 7.820</p>

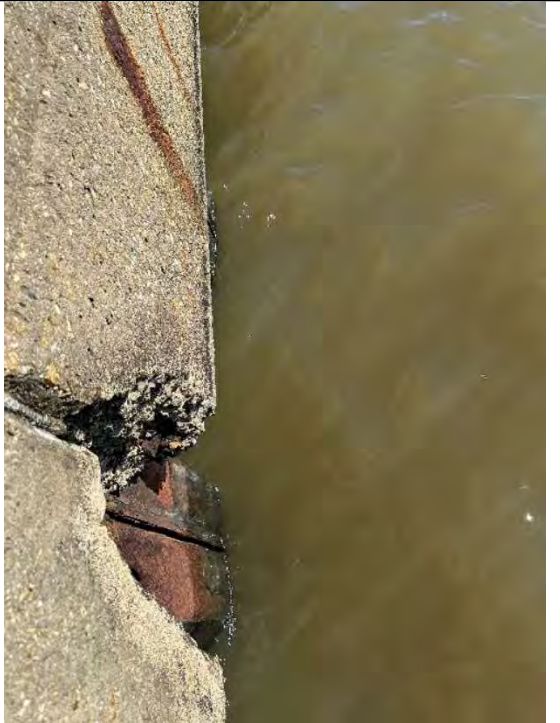
Photo Name: IMG_0227
Inspection Field Notes Photo # : 165
Date: 12-15-22
Approximate Station: Station 58+46
Description: Concrete spall and rust spot along the seaside face of the expansion joint
Coordinates:
Latitude: 30 ; 21 ; 9.020
Longitude: 90 ; 4 ; 7.44

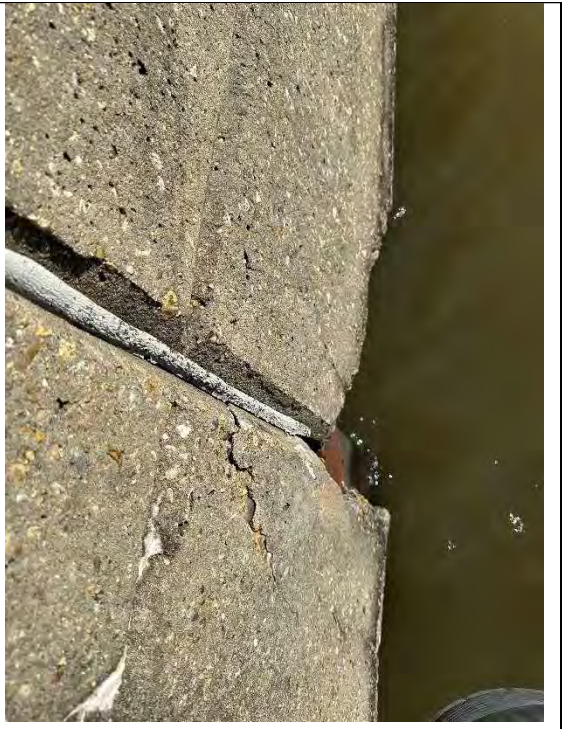
Photo Name: IMG_0229
Inspection Field Notes Photo # : 167
Date: 12-15-22
Approximate Station: Station 59+04
Description: Concrete spall along the seaside face of the expansion joint
Coordinates:
Latitude: 30 ; 21 ; 9.020
Longitude: 90 ; 4 ; 6.7499

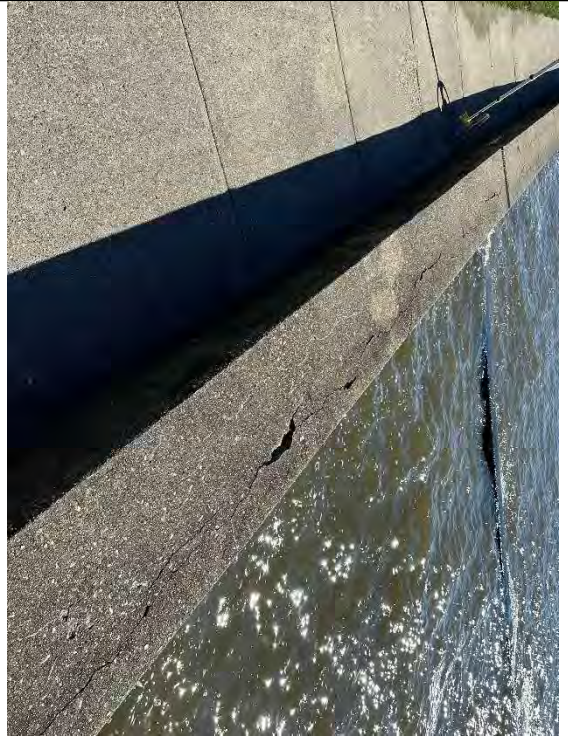
<p>Photo Name: IMG_0231 Inspection Field Notes Photo # : 168 Date: 12-15-22 Approximate Station: Station 59+04 to 59+50 Description: Horizontal cracks along the top side of the cap. Horizontal cracks along the land face side of the cap as well. Coordinates: Latitude: 30 ; 21 ; 8.6699 Longitude: 90 ; 4 ; 6.1799</p>

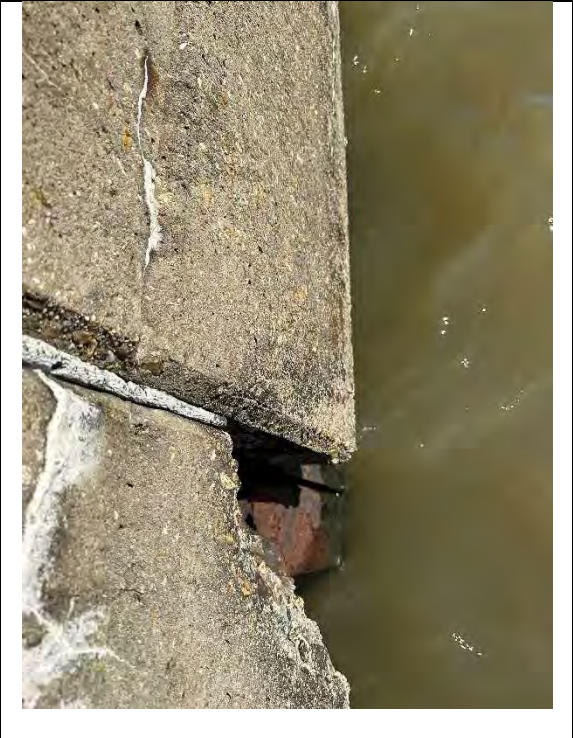
<p>Photo Name: IMG_0232 Inspection Field Notes Photo # : 169 Date: 12-15-22 Approximate Station: Station 59+62 Description: Concrete spall along the seaside face of the expansion joint Coordinates: Latitude: 30 ; 21 ; 8.63 Longitude: 90 ; 4 ; 6.1199</p>

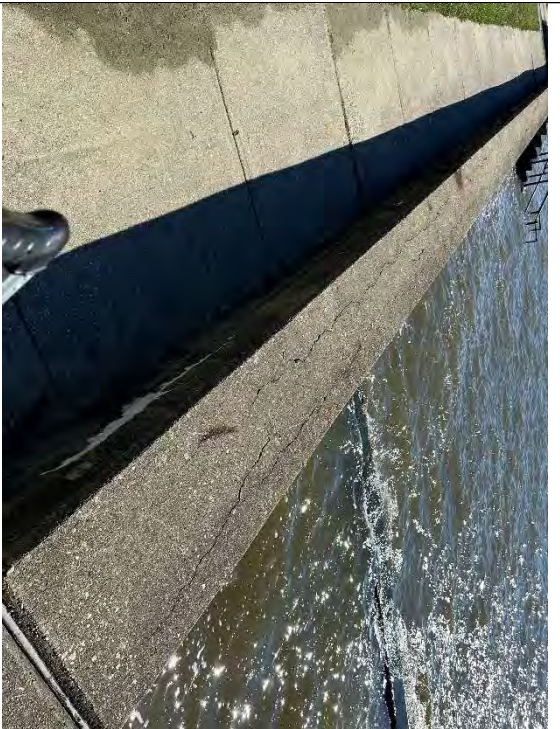
Photo Name: IMG_0233
Inspection Field Notes Photo # : 170
Date: 12-15-22
Approximate Station: Station 59+62 to 60+00
Description: Horizontal cracks with rust spots along the top side of the cap that is reflective of the sheet piles
Coordinates:
Latitude: 30 ; 21 ; 8.4299
Longitude: 90 ; 4 ; 6.070

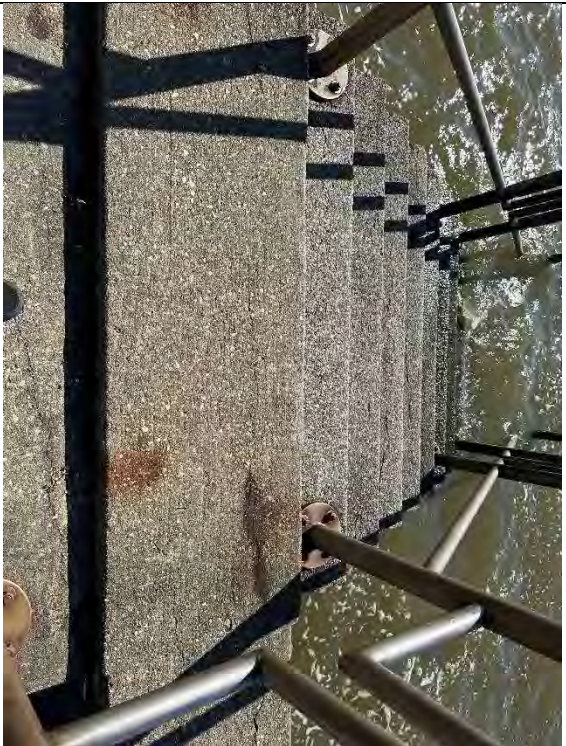
Photo Name: IMG_0234
Inspection Field Notes Photo # : 170.2
Date: 12-15-22
Approximate Station: Station 60+26
Description: Stairway. Rust spots along the top side of the seaside face stairway. Steps appear to contain cracks on the top of the seaside face of the stairway.
Coordinates:
Latitude: 30 ; 21 ; 8.6399
Longitude: 90 ; 4 ; 5.2399

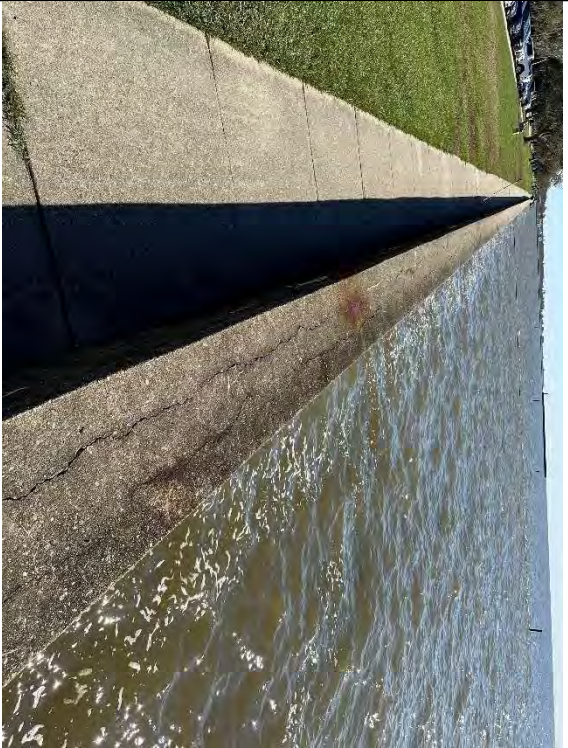
<p>Photo Name: IMG_0235 Inspection Field Notes Photo # : 172 Date: 12-15-22 Approximate Station: Station 60+26 to 61+00 Description: Horizontal and vertical cracks with rust spots along the top side of the seawall. Coordinates: Latitude: 30 ; 21 ; 8.1499 Longitude: 90 ; 4 ; 5.2999</p>

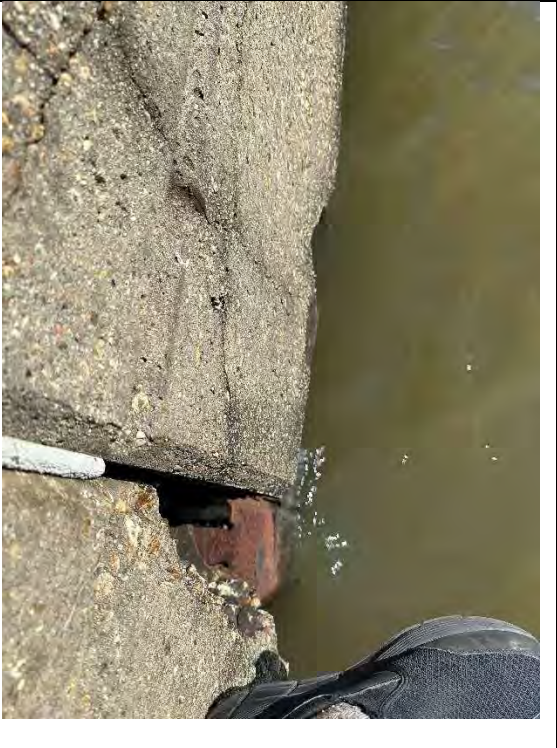
<p>Photo Name: IMG_0236 Inspection Field Notes Photo # : 173 Date: 12-15-22 Approximate Station: Station 60+80 Description: Concrete spall along the seaside face of the expansion joint. Coordinates: Latitude: 30 ; 21 ; 8.0599 Longitude: 90 ; 4 ; 4.8599</p>

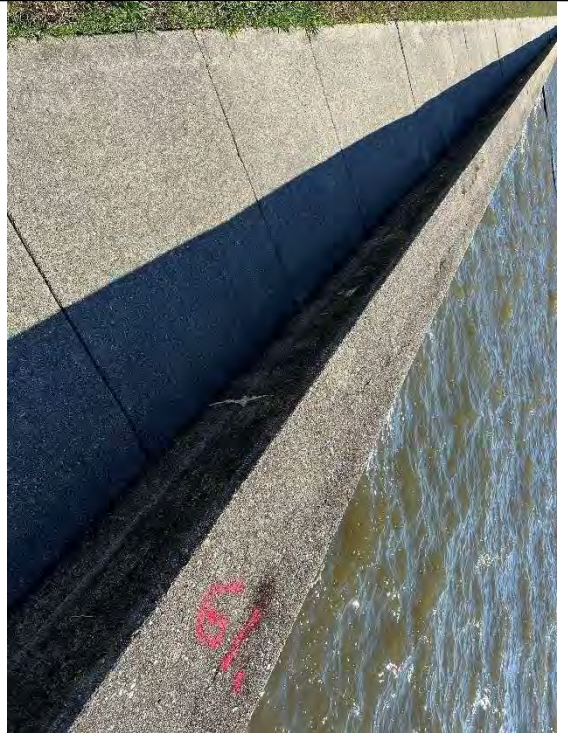
<p>Photo Name: IMG_0237 Inspection Field Notes Photo # : 174 Date: 12-15-22 Approximate Station: Station 61+00 to 62+00 Description: Horizontal cracks along the top side of the seawall. Horizontal and vertical cracks along the land face side as well. Coordinates: Latitude: 30 ; 21 ; 7.9299 Longitude: 90 ; 4 ; 4.64</p>
 	<p>Photo Name: IMG_0238 Date: 12-15-22 Inspection Field Notes Photo # : 175 Approximate Station: Station 61+39 Description: Concrete spall along the seaside face of the expansion joint. Coordinates: Latitude: 30 ; 21 ; 8.0599 Longitude: 90 ; 4 ; .7299</p>

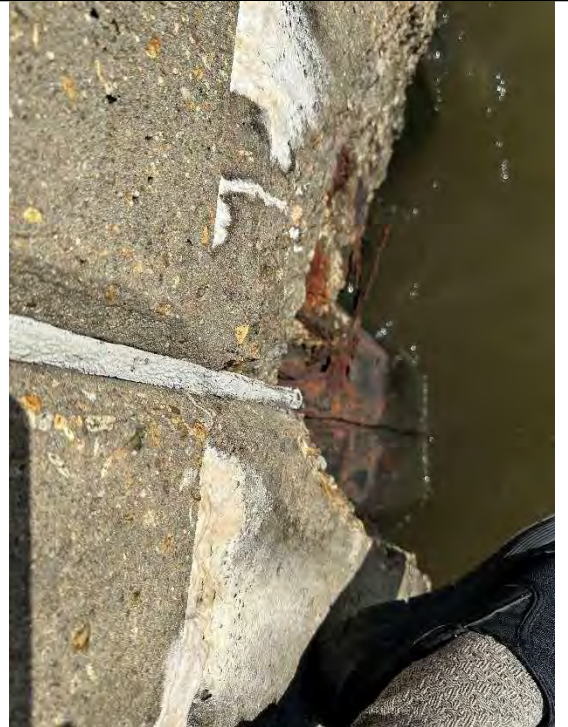
<p>Photo Name: IMG_0239 Inspection Field Notes Photo # : 176 Date: 12-15-22 Approximate Station: Station 61+98 Description: Concrete spall along the seaside face of the expansion joint. There is also some rebar exposure as well. Coordinates: Latitude: 30 ; 21 ; 7.47 Longitude: 90 ; 4 ; 3.900</p>

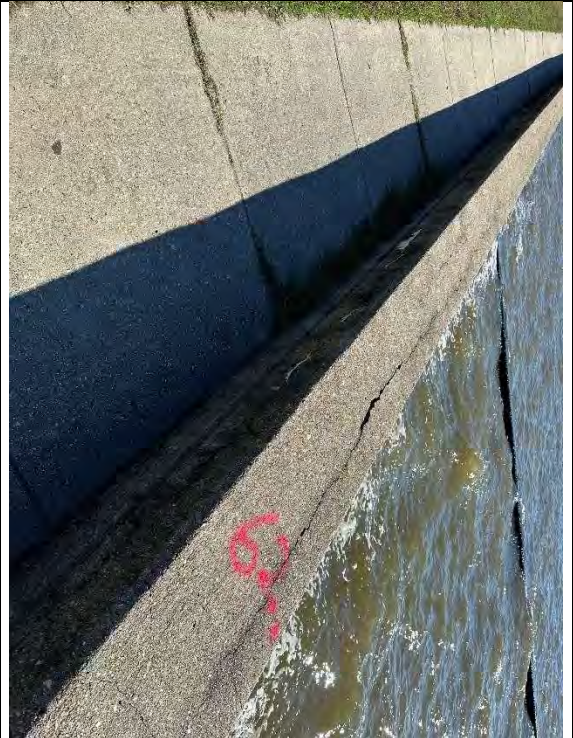
<p>Photo Name: IMG_0240 Inspection Field Notes Photo # : 177 Date: 12-15-22 Approximate Station: Station 62+00 to 62+60 Description: Horizontal cracks along the top side of the seawall that is reflective of the sheet pile. Horizontal and vertical cracks with some rust spots along the land face side of the seawall. Coordinates: Latitude: 30 ; 21 ; 7.6399 Longitude: 90 ; 4 ; 3.57</p>

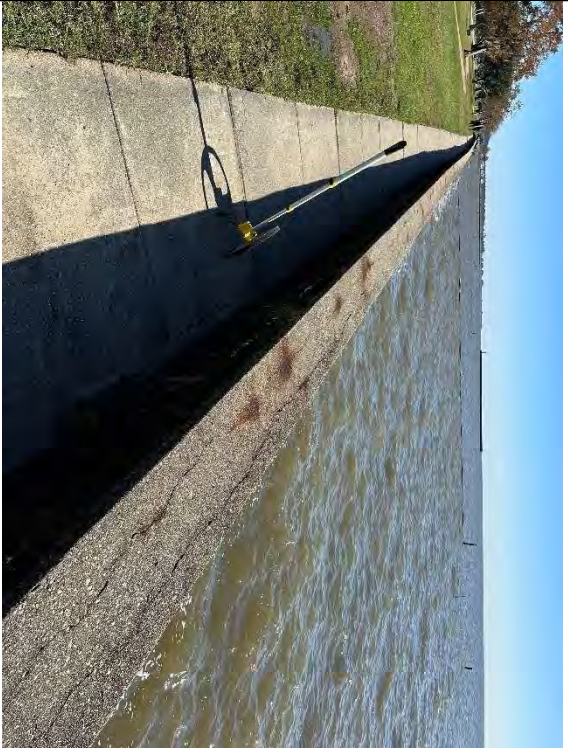
<p>Photo Name: IMG_0241 Inspection Field Notes Photo # : 178 Date: 12-15-22 Approximate Station: Station 62+60 to 63+00 Description: Horizontal cracks with heavy rust spots along the top side of the seawall that are reflective of the sheet pile. Horizontal and vertical cracks along the land face side of the seawall as well. Coordinates: Latitude: 30 ; 21 ; 7.5399 Longitude: 90 ; 4 ; 3.0499</p>

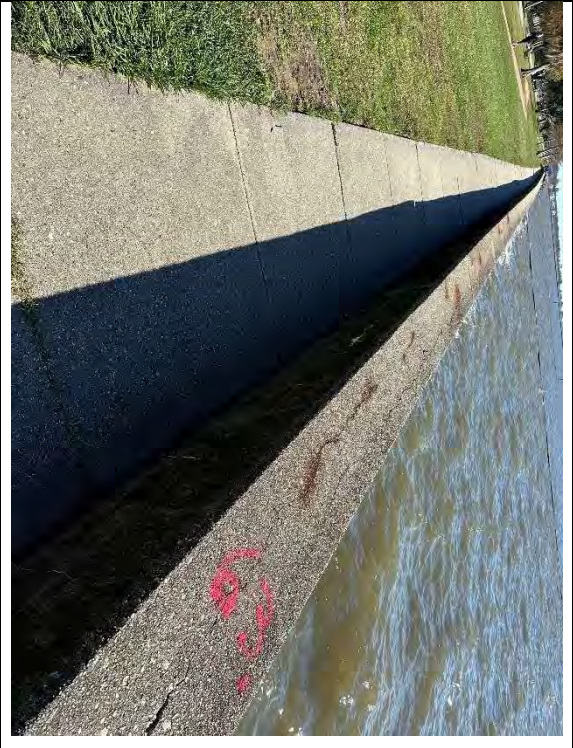
<p>Photo Name: IMG_0242 Inspection Field Notes Photo # : 179 Date: 12-15-22 Approximate Station: Station 63+00 to 64+00 Description: Horizontal cracks and rust spots along the top side of the seawall that are reflective of the sheet pile. Coordinates: Latitude: 30 ; 21 ; 7.050 Longitude: 90 ; 4 ; 2.69</p>

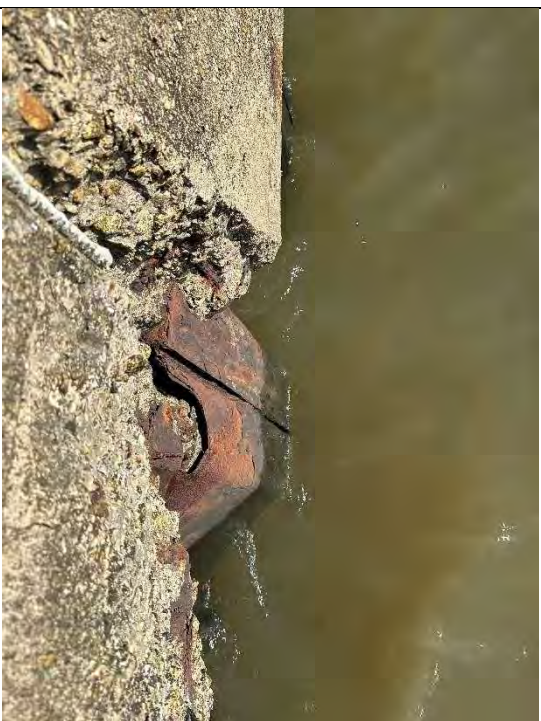
Photo Name: IMG_0244
Inspection Field Notes Photo # : 180
Date: 12-15-22
Approximate Station: Station 63+15
Description: Concrete spall along the seaside face of the expansion joint. Rebar is exposed as well.
Coordinates:
Latitude: 30 ; 21 ; 6.9199
Longitude: 90 ; 4 ; 2.7399

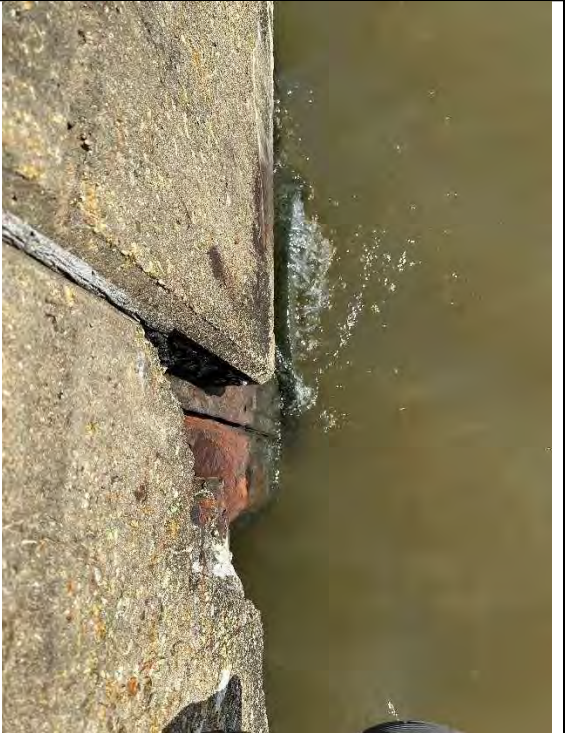
Photo Name: IMG_0245
Inspection Field Notes Photo # : 180
Date: 12-15-22
Approximate Station: Station 63+15
Description: Concrete spall along the seaside face of the expansion joint. Rebar is exposed as well.
Coordinates:
Latitude: 30 ; 21 ; 6.6999
Longitude: 90 ; 4 ; 1.9699

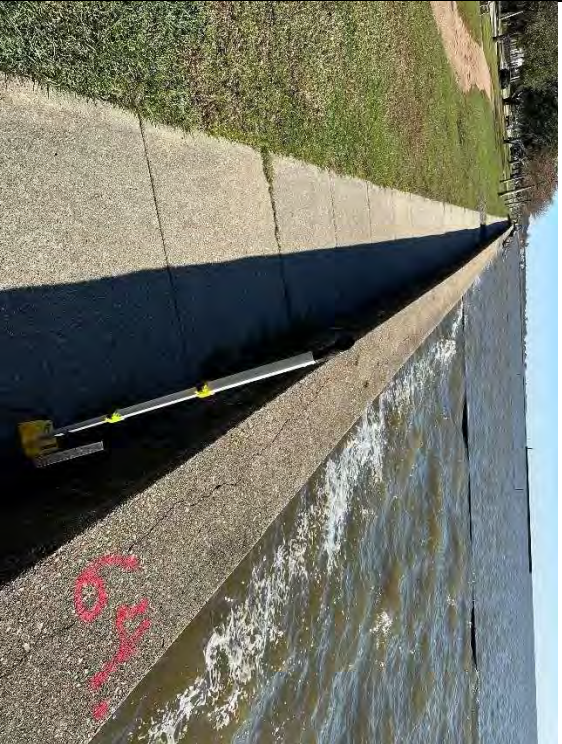
Photo Name: IMG_0246
Inspection Field Notes Photo # : 181
Date: 12-15-22
Approximate Station: Station 64+00 to 65+00
Description: Horizontal cracks along the top side of the seawall. Horizontal and vertical cracks along the land face side of the seawall as well.
Coordinates:
Latitude: 30 ; 21 ; 6.5899
Longitude: 90 ; 4 ; 1.6699

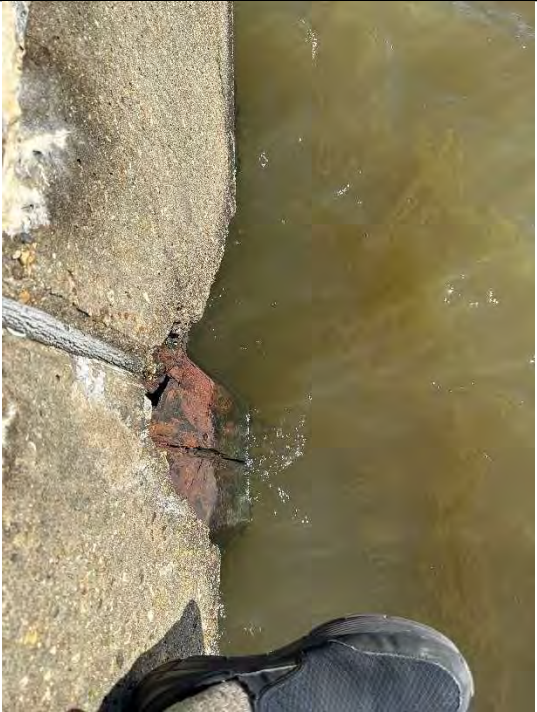
Photo Name: IMG_0247
Inspection Field Notes Photo # : 182
Date: 12-15-22
Approximate Station: Station 64+32
Description: Concrete spall along the seaside face of the expansion joint.
Coordinates:
Latitude: 30 ; 21 ; 6.33
Longitude: 90 ; 4 ; 1.51
