**COM PROJ. NO. 100.21.019
SEAWALL REPAIR (INSPECTION PROJECT)
FINAL FINDINGS/ASSESSMENT REPORT**

The City of Mandeville
1100 Mandeville High Blvd.
Mandeville, LA 70471

Prepared by
BURK-KLEINPETER, INC.
4176 Canal Street
New Orleans, LA 70119

APRIL 2023

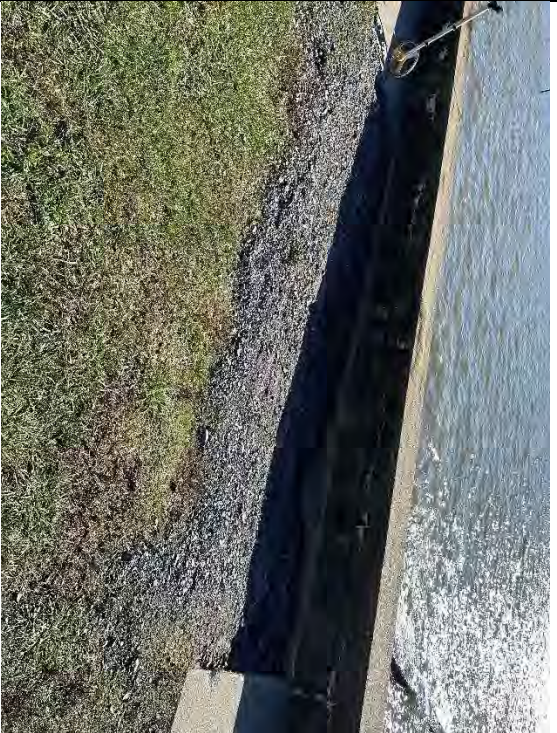
Photo Name: IMG_0248
Inspection Field Notes Photo # : 183
Date: 12-15-22
Approximate Station: Station 64+72 to 64+88
Description: Missing sidewalk along the seawall. Suggest repairing sidewalk.
Coordinates:
Latitude: 30 ; 21 ; 6.270
Longitude: 90 ; 4 ; 0.96

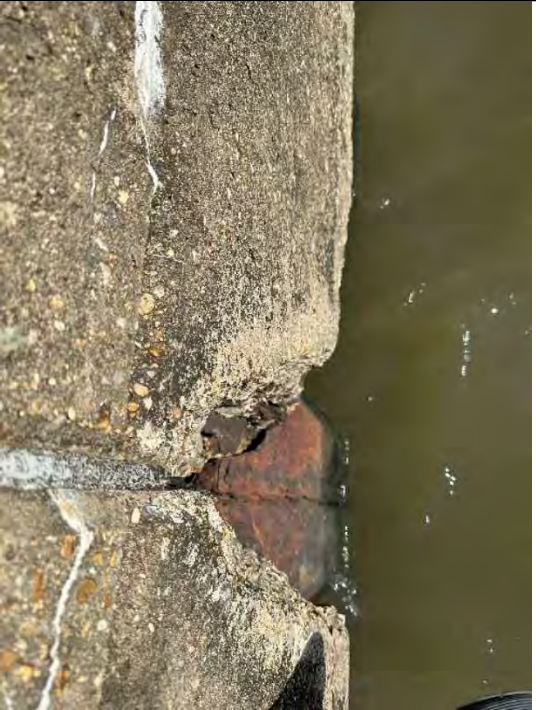
Photo Name: IMG_0249
Inspection Field Notes Photo # : 184
Date: 12-15-22
Approximate Station: Station 64+90
Description: Concrete spall along the seaside face of the expansion joint. Rebar is also exposed as well.
Coordinates:
Latitude: 30 ; 21 ; 5.6799
Longitude: 90 ; 4 ; 1.45

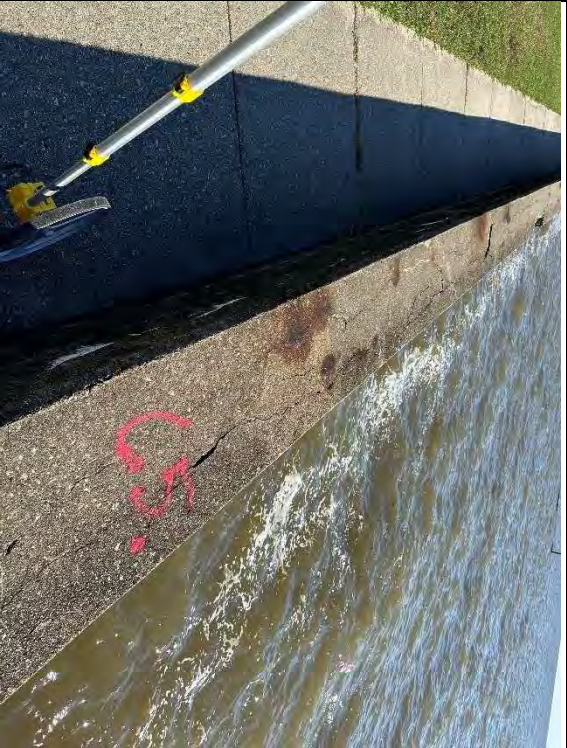
Photo Name: IMG_0250
Inspection Field Notes Photo # : 185
Date: 12-15-22
Approximate Station: Station 65+00 to 66+00
Description: Horizontal cracks with rust spots and flakey concrete along the top side of the seawall. Horizontal and vertical cracks along the land face side as well.
Coordinates:
Latitude: 30 ; 21 ; 6.0899
Longitude: 90 ; 4 ; 0.5700

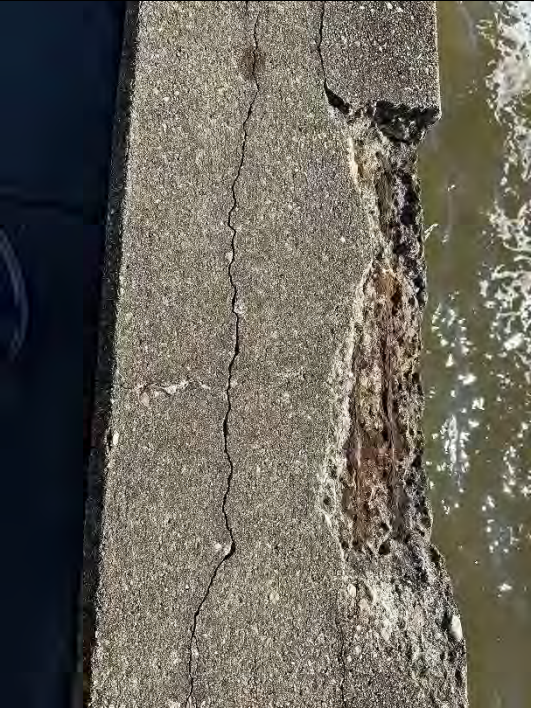
Photo Name: IMG_0251
Inspection Field Notes Photo # : 186
Date: 12-15-22
Approximate Station: Station 65+23
Description: Concrete spall along the top side of cap. Rebar is exposed as well.
Coordinates:
Latitude: 30 ; 21 ; 6.070
Longitude: 90 ; 4 ; 0.38

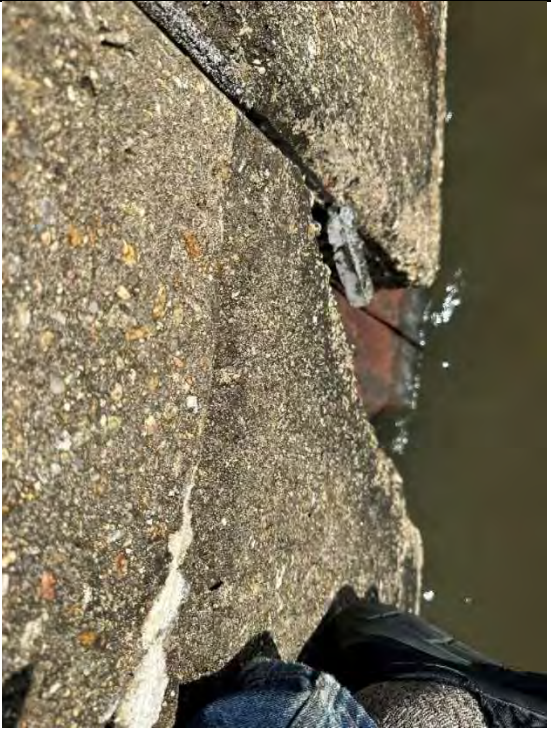
Photo Name: IMG_0252
Inspection Field Notes Photo # : 187
Date: 12-15-22
Approximate Station: Station 65+49
Description: Concrete spall along the seaside face of the expansion joint.
Coordinates:
Latitude: 30 ; 21 ; 5.7599
Longitude: 90 ; 4 ; 0.2999

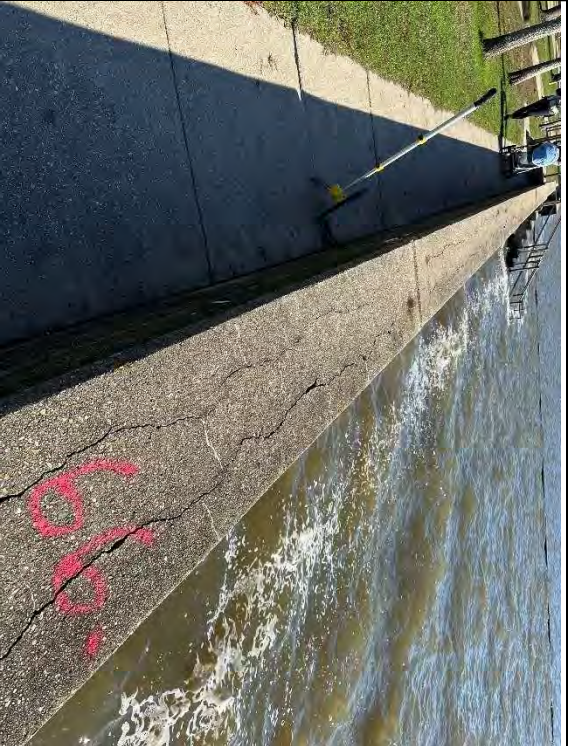
Photo Name: IMG_0253
Inspection Field Notes Photo # : 188
Date: 12-15-22
Approximate Station: Station 66+00
Description: Horizontal cracks and rust spots along the top side of the cap that is reflective of the sheet pile. Horizontal and vertical cracks along the land face side of the cap as well.
Coordinates:
Latitude: 30 ; 21 ; 5.5599
Longitude: 90 ; 3 ; 59.58

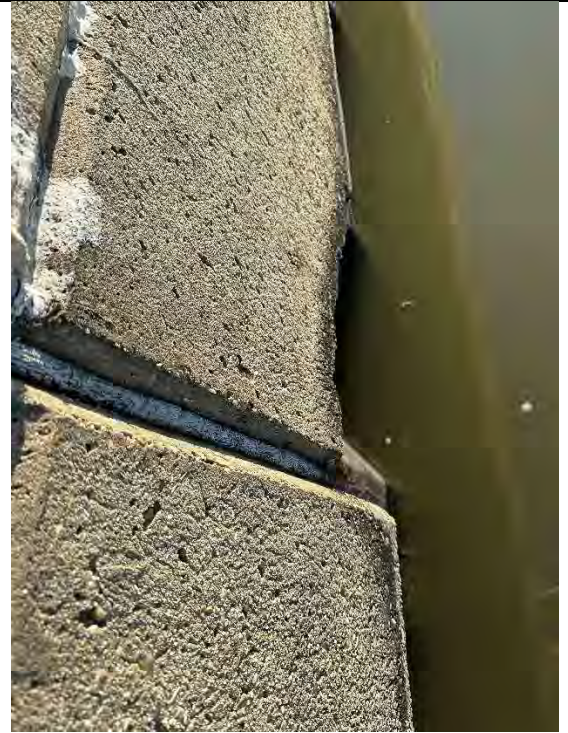
Photo Name: IMG_0257
Inspection Field Notes Photo # : 189
Date: 12-16-22
Approximate Station: Station 66+08
Description: Concrete spall along the seaside face of the expansion joint
Coordinates:
Latitude: 30 ; 21 ; 5.41
Longitude: 90 ; 3 ; 59.75

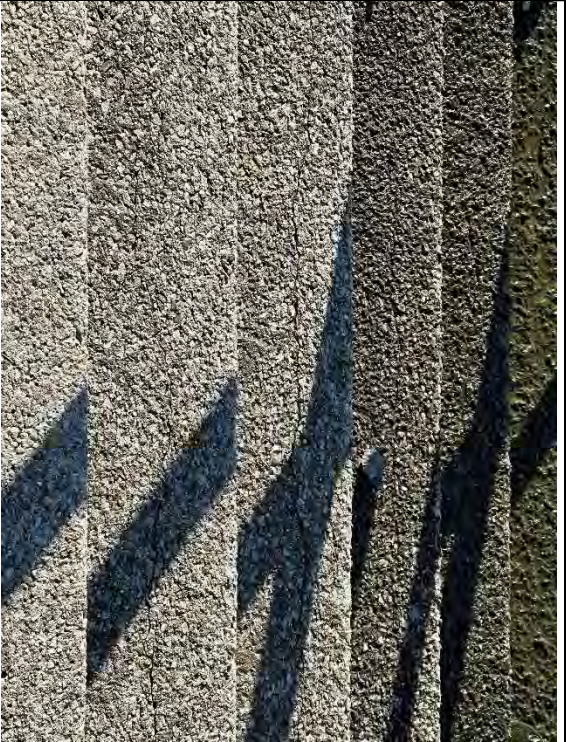
Photo Name: IMG_0258
Inspection Field Notes Photo # : 189
Date: 12-16-22
Approximate Station: Station 66+86
Description: Stairway. Cracks along the top side of the seaside steps.
Coordinates:
Latitude: 30 ; 21 ; 5.19
Longitude: 90 ; 3 ; 59.0399

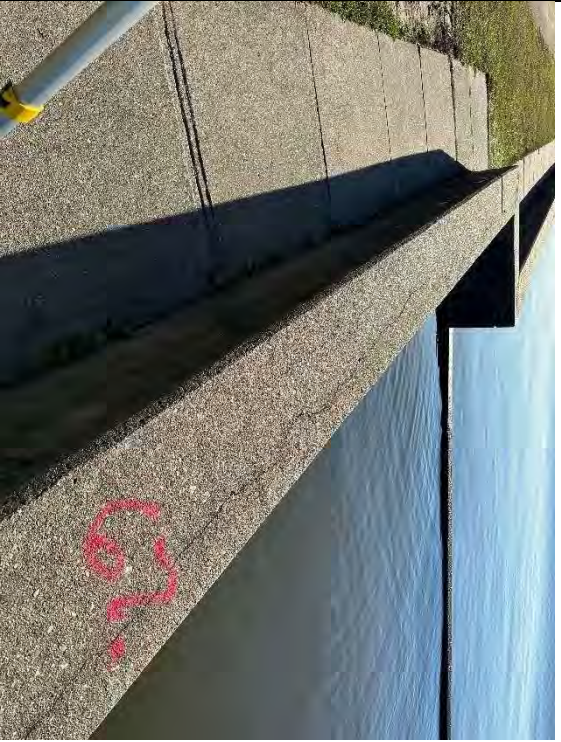
Photo Name: IMG_0259
Inspection Field Notes Photo # : 190
Date: 12-16-22
Approximate Station: Station 67+00 to 67+22
Description: Horizontal cracks along the top side of the seawall. Horizontal and vertical cracks with rust spots along the land face side of the seawall as well.
Coordinates:
Latitude: 30 ; 21 ; 5.0299
Longitude: 90 ; 3 ; 58.95

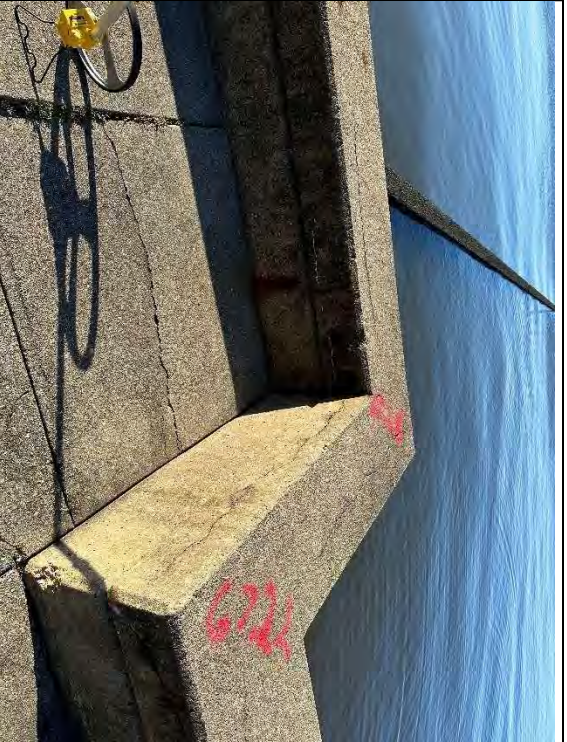
Photo Name: IMG_0260
Inspection Field Notes Photo # : 190
Date: 12-16-22
Approximate Station: Station 67+22 to 67+26
Description: Jog in the seawall.
Coordinates:
Latitude: 30 ; 21 ; 5.7799
Longitude: 90 ; 3 ; 57.030

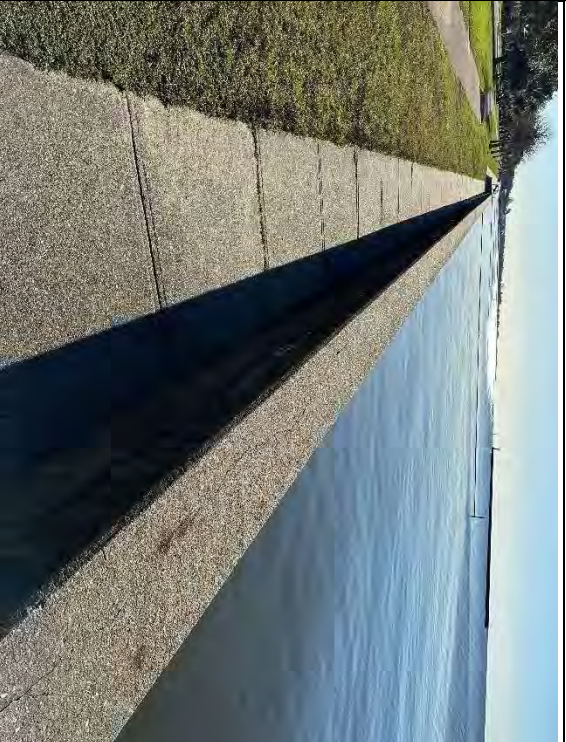
Photo Name: IMG_0261
Inspection Field Notes Photo # : 190
Date: 12-16-22
Approximate Station: Station 67+26 to 67+28
Description: Horizontal cracks along the top side of the seawall. Horizontal and vertical cracks with rust spots along the land face side of the seawall as well.
Coordinates:
Latitude: 30 ; 21 ; 4.8899
Longitude: 90 ; 3 ; 58.6199

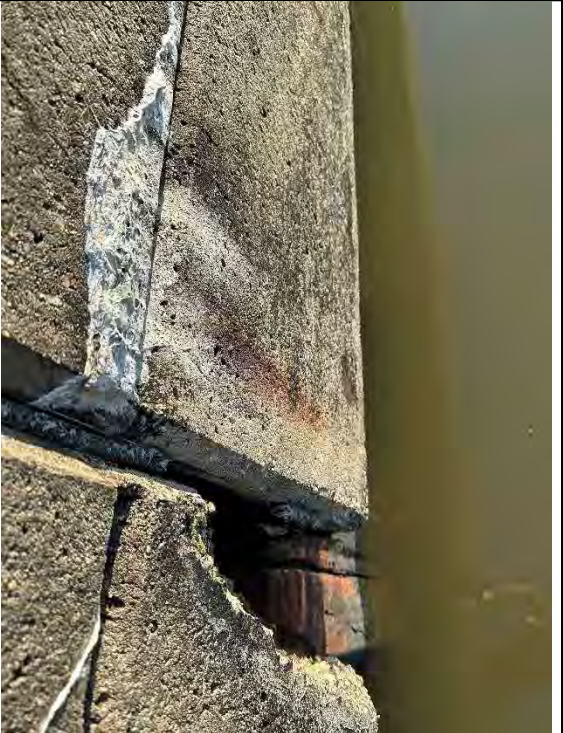
Photo Name: IMG_0262
Inspection Field Notes Photo # : 191
Date: 12-16-22
Approximate Station: Station 67+75
Description: Concrete spall along the seaside face of the expansion joint.
Coordinates:
Latitude: 30 ; 21 ; 4.5299
Longitude: 90 ; 3 ; 58.2399

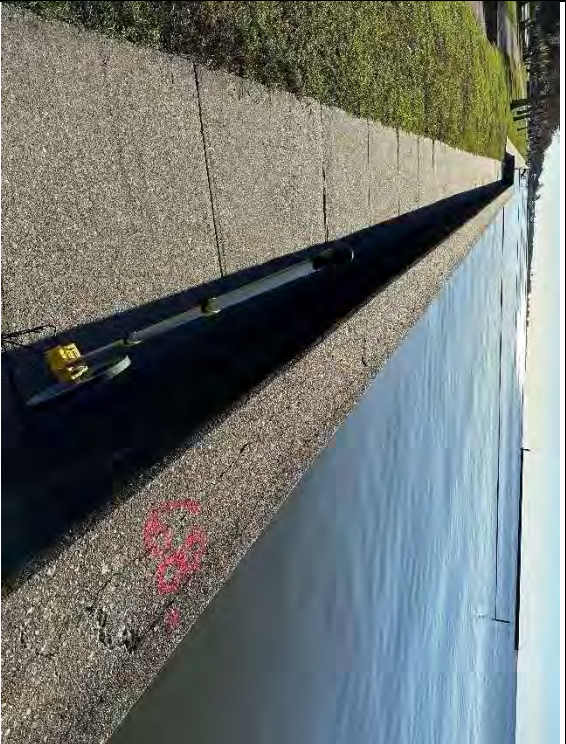
Photo Name: IMG_0263
Inspection Field Notes Photo # : 192
Date: 12-16-22
Approximate Station: Station 68+00 to 69+00
Description: Horizontal cracks along the top side of the seawall that are reflective of the sheet pile.
Coordinates:
Latitude: 30 ; 21 ; 4.77
Longitude: 90 ; 3 ; 58.1599

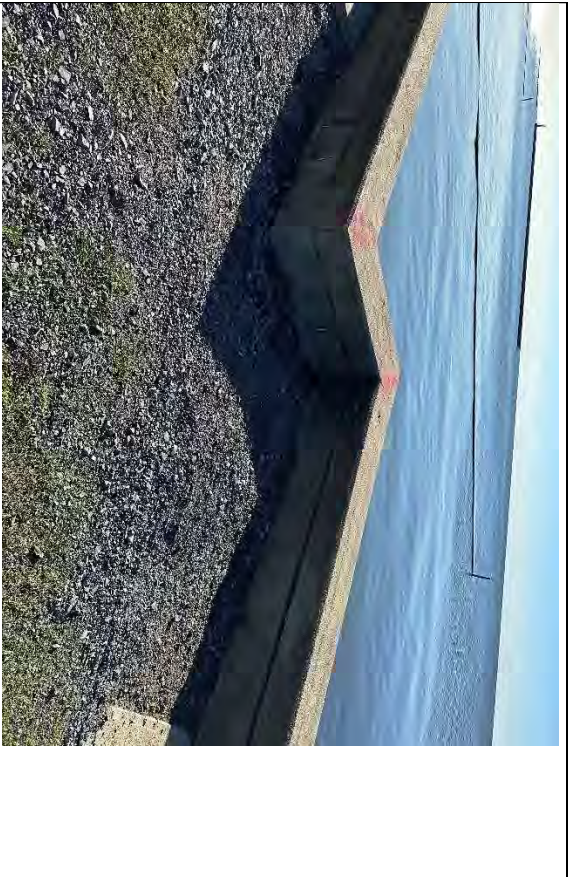
<p>Photo Name: IMG_0266 Inspection Field Notes Photo # : 192 Date: 12-16-22 Approximate Station: Station 69+00 to 69+12 Description: Jog along the seawall. Coordinates: Latitude: 30 ; 21 ; 4.1499 Longitude: 90 ; 3 ; 56.8699</p>

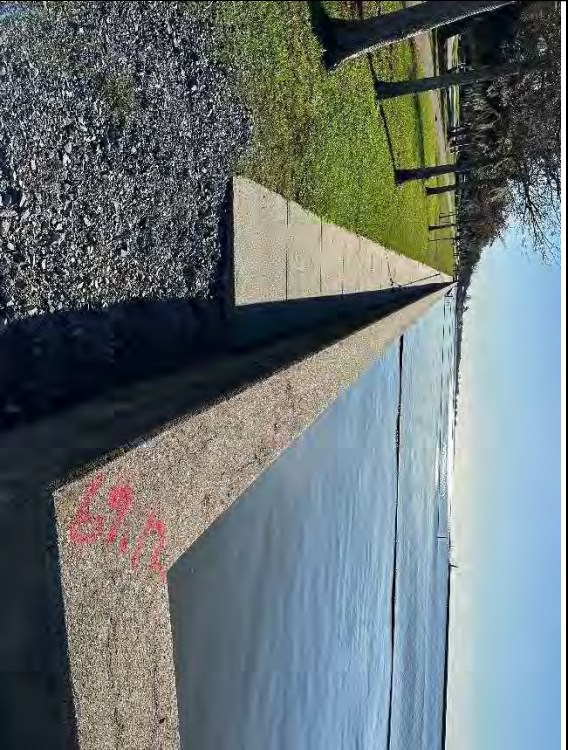
Photo Name: IMG_0267
Inspection Field Notes Photo # : 193
Date: 12-16-22
Approximate Station: Station 69+12 to 69+52
Description: Horizontal cracks along the top side of the seawall. Vertical cracks along the land face side of the seawall as well.
Coordinates:
Latitude: 30 ; 21 ; 4.070
Longitude: 90 ; 3 ; 56.84

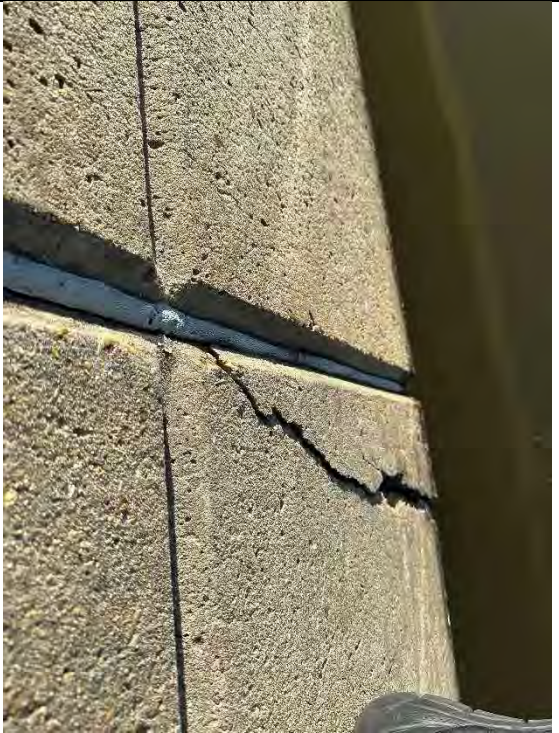
Photo Name: IMG_0268
Inspection Field Notes Photo # : 194
Date: 12-16-22
Approximate Station: Station 69+52
Description: Concrete spall along the seaside face of the expansion joint
Coordinates:
Latitude: 30 ; 21 ; 4.16
Longitude: 90 ; 3 ; 56.4299

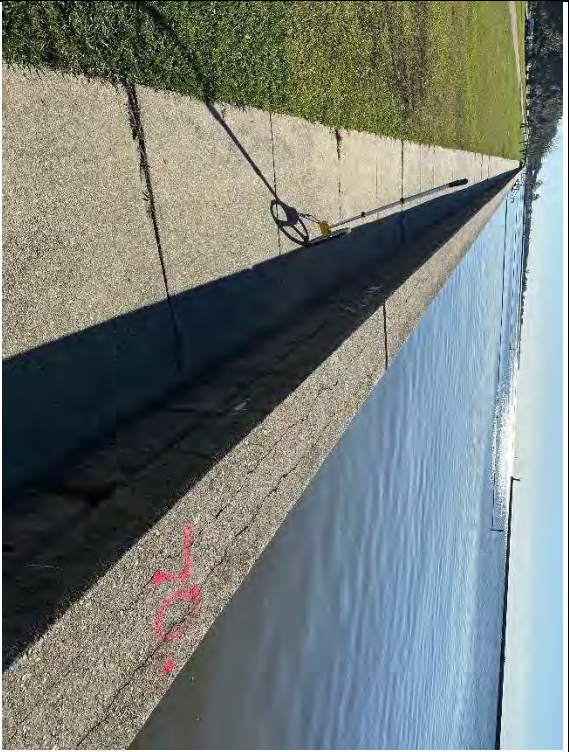
Photo Name: IMG_0271
Inspection Field Notes Photo # : 196
Date: 12-16-22
Approximate Station: Station 70+00 to 71+00
Description: Horizontal cracks along the top side of the cap that is reflective of the sheet pile. Horizontal and vertical cracks with rust spots along the land face side of the cap as well.
Coordinates:
Latitude: 30 ; 21 ; 3.58
Longitude: 90 ; 3 ; 55.90

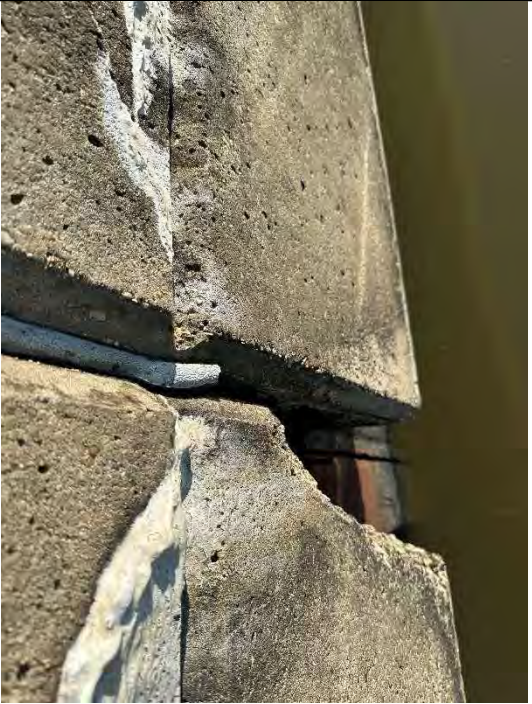
Photo Name: IMG_0272
Inspection Field Notes Photo # : 197
Date: 12-16-22
Approximate Station: Station 70+08
Description: Concrete spall along the seaside face of the expansion joint
Coordinates:
Latitude: 30 ; 21 ; 3.5399
Longitude: 90 ; 3 ; 55.7899

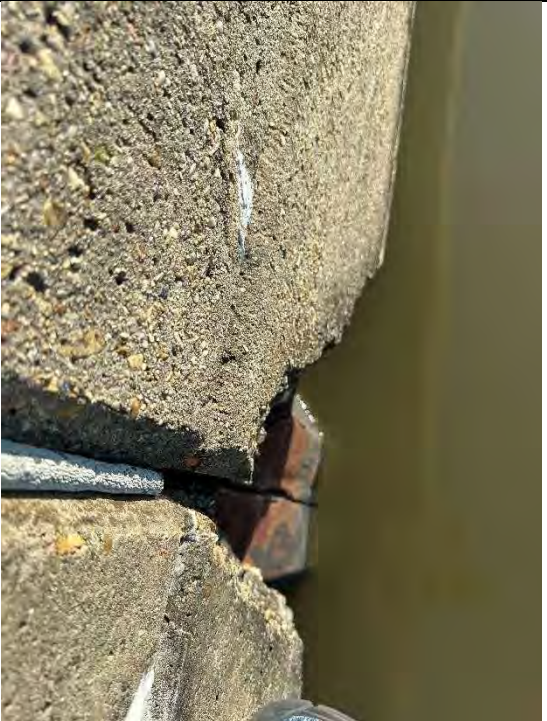
Photo Name: IMG_0273
Inspection Field Notes Photo # : 198
Date: 12-16-22
Approximate Station: Station 70+67
Description: Concrete spall along the seaside face of the expansion joint
Coordinates:
Latitude: 30 ; 21 ; 3.2299
Longitude: 90 ; 3 ; 54.28

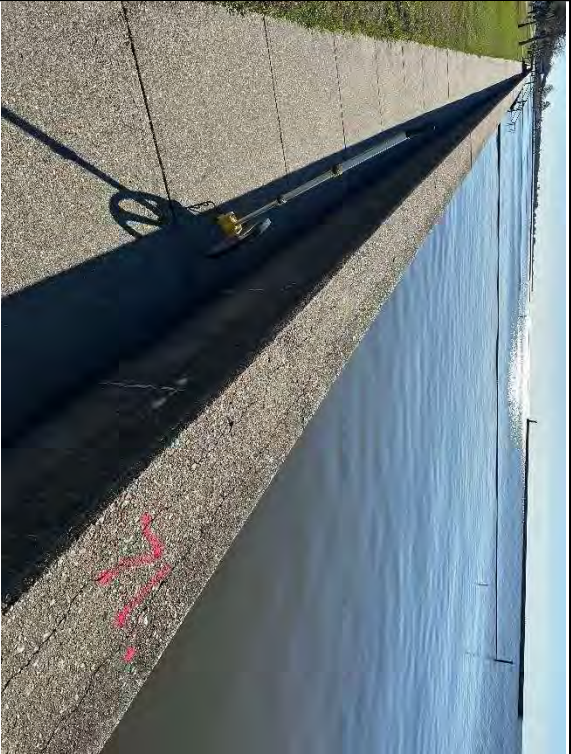
Photo Name: IMG_0274
Inspection Field Notes Photo # : 199
Date: 12-16-22
Approximate Station: Station 71+00 to 71+85
Description: Horizontal cracks along the top side of the seawall that are reflective of the sheet pile. Vertical cracks with rust spots along the land face side of the seawall as well.
Coordinates:
Latitude: 30 ; 21 ; 3.22
Longitude: 90 ; 3 ; 54.89

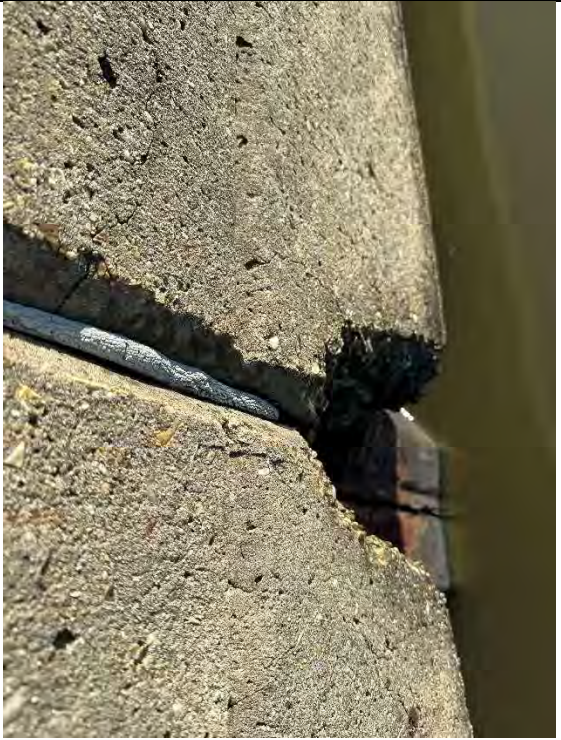
Photo Name: IMG_0275
Inspection Field Notes Photo # : 200
Date: 12-16-22
Approximate Station: Station 71+26
Description: Concrete spall along the seaside face of the expansion joint
Coordinates:
Latitude: 30 ; 21 ; 3.41
Longitude: 90 ; 3 ; 53.020

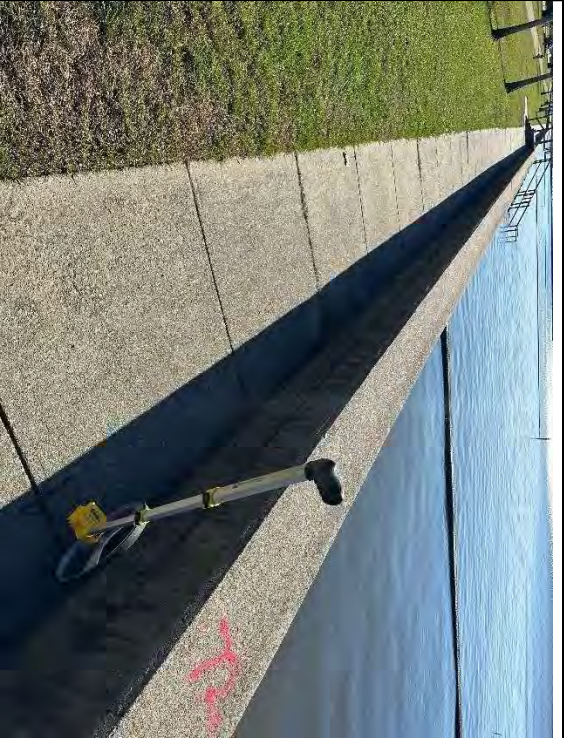
Photo Name: IMG_0276
Inspection Field Notes Photo # : 202
Date: 12-16-22
Approximate Station: Station 72+00 to 73+00
Description: Horizontal cracks along the top side of the seawall that are reflective of the sheet pile. Minor vertical cracks along the land face side of the seawall as well.
Coordinates:
Latitude: 30 ; 21 ; 2.60
Longitude: 90 ; 3 ; 54.090

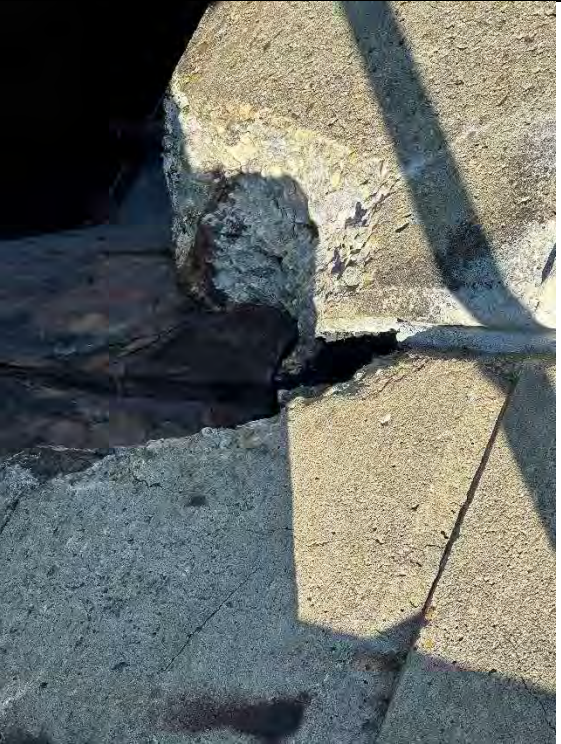
Photo Name: IMG_0277
Inspection Field Notes Photo # : 203
Date: 12-16-22
Approximate Station: Station 73+03
Description: Concrete spall along the seaside face of the expansion joint
Coordinates:
Latitude: 30 ; 21 ; 1.9299
Longitude: 90 ; 3 ; 52.9899

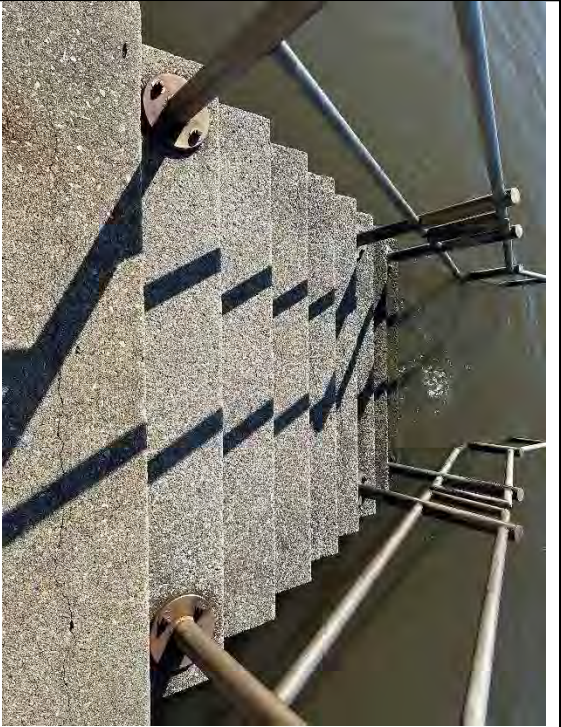
Photo Name: IMG_0278
Inspection Field Notes Photo # : 204
Date: 12-16-22
Approximate Station: Station 73+09
Description: Stairway. Only one seaside step contains cracks.
Coordinates:
Latitude: 30 ; 21 ; 3.5299
Longitude: 90 ; 3 ; 53.2399

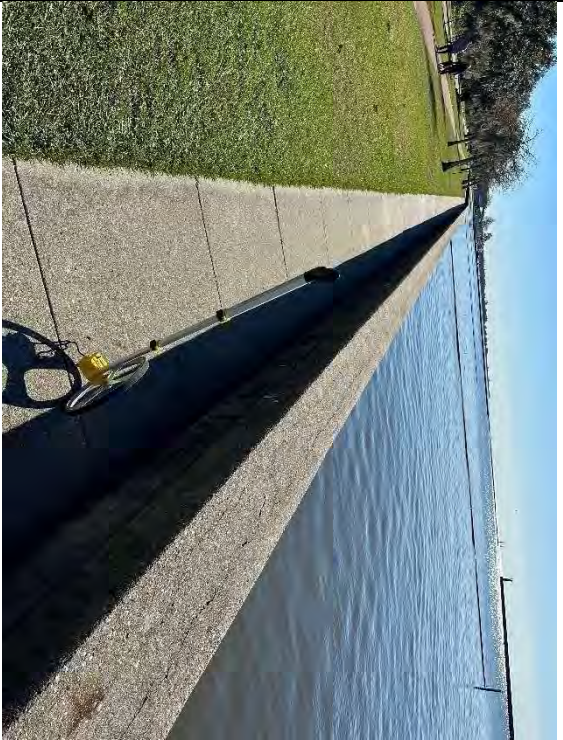
Photo Name: IMG_0286
Inspection Field Notes Photo # : 205
Date: 12-16-22
Approximate Station: Station 73+00 to 73+64
Description: Horizontal cracks along the top side of the seawall that are reflective of the sheet pile. Minor vertical cracks along the land face side of the seawall as well.
Coordinates:
Latitude: 30 ; 21 ; 1.99
Longitude: 90 ; 3 ; 52.88

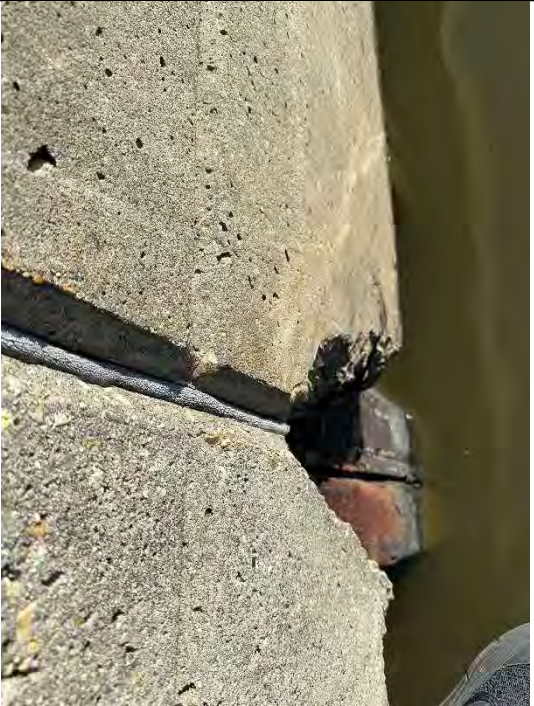
Photo Name: IMG_0287
Inspection Field Notes Photo # : 206
Date: 12-16-22
Approximate Station: Station 73+64
Description: Concrete spall along the seaside face of the expansion joint
Coordinates:
Latitude: 30 ; 21 ; 1.800
Longitude: 90 ; 3 ; 52.39

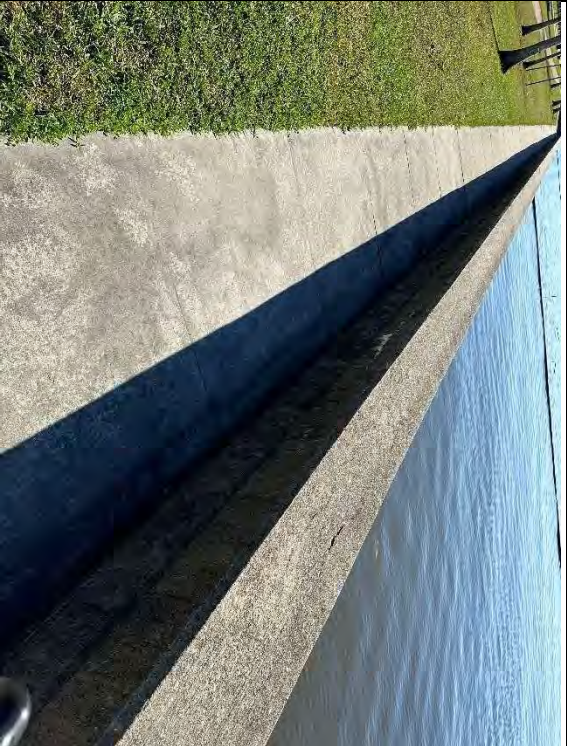
Photo Name: IMG_0288
Inspection Field Notes Photo # : 207
Date: 12-16-22
Approximate Station: Station 73+64 to 74+00
Description: Minor horizontal cracks along the top side of the seawall. Minor horizontal cracks along the land face side of the seawall as well.
Coordinates:
Latitude: 30 ; 21 ; 2.35
Longitude: 90 ; 3 ; 52.25

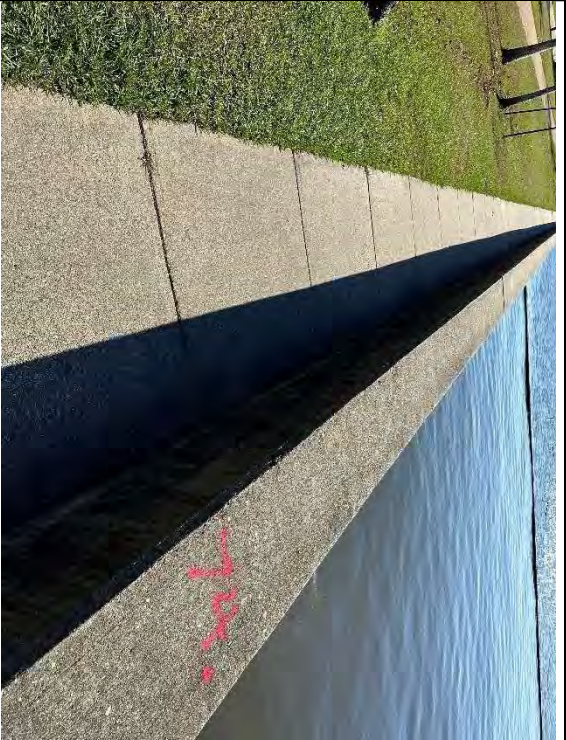
Photo Name: IMG_0289
Inspection Field Notes Photo # : 208
Date: 12-16-22
Approximate Station: Station 74+00 to 75+00
Description: Minor horizontal cracks along the top side of the seawall. Minor cracks along the land face side of the seawall as well.
Coordinates:
Latitude: 30 ; 21 ; 1.6699
Longitude: 90 ; 3 ; 52.1099

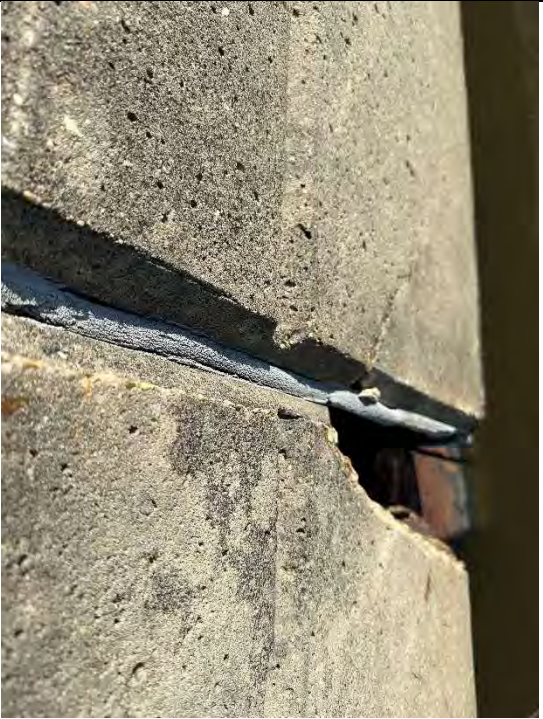
Photo Name: IMG_0290
Inspection Field Notes Photo # : 209
Date: 12-16-22
Approximate Station: Station 74+73
Description: Concrete spall along the seaside face of the expansion joint.
Coordinates:
Latitude: 30 ; 21 ; 1.6699
Longitude: 90 ; 3 ; 51.9799

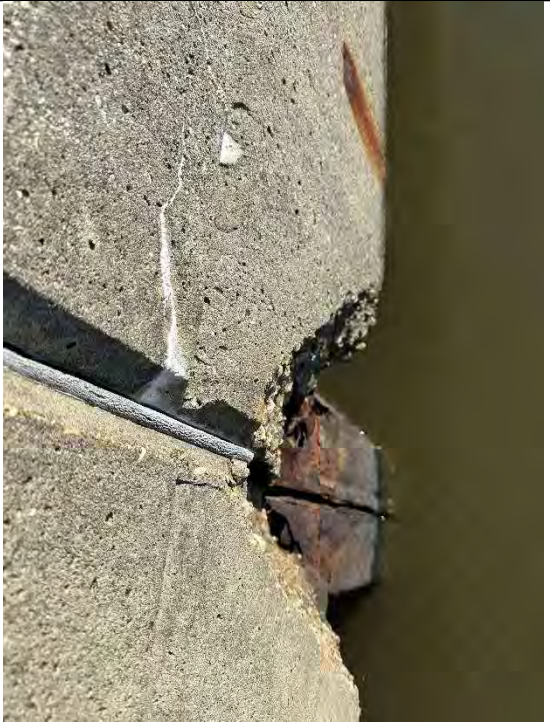
Photo Name: IMG_0291
Inspection Field Notes Photo # : 210
Date: 12-16-22
Approximate Station: Station 74+80
Description: Concrete spall along the seaside face of the expansion joint.
Coordinates:
Latitude: 30 ; 21 ; 1.30
Longitude: 90 ; 3 ; 51.26

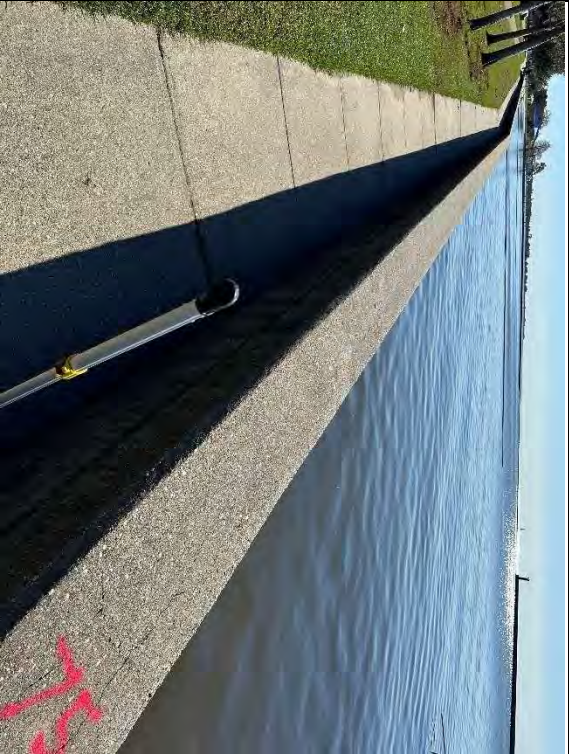
Photo Name: IMG_0292
Inspection Field Notes Photo # : 211
Date: 12-16-22
Approximate Station: Station 75+00 to 75+95
Description: Horizontal cracks along the top side of the seawall.
Coordinates:
Latitude: 30 ; 21 ; 1.1799
Longitude: 90 ; 3 ; 51.21

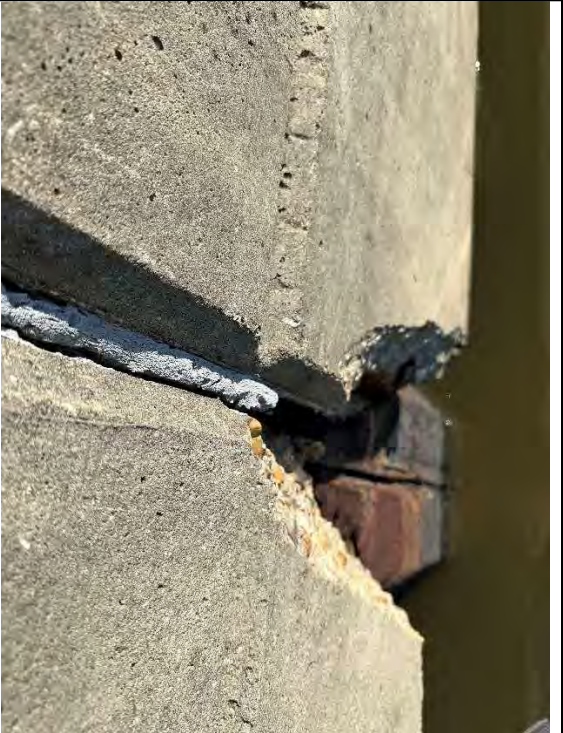
Photo Name: IMG_0293
Inspection Field Notes Photo # : 211
Date: 12-16-22
Approximate Station: Station 75+91
Description: Concrete spall along the seaside face of the expansion joint.
Coordinates:
Latitude: 30 ; 21 ; 0.69
Longitude: 90 ; 3 ; 50.19

- 211 75+00 to 75+95
75+91 conc. spoil sea side @ Exp JT
- 212 75+95 wall P.I. curve)
75+95 to 76+00 no cracks top or landside
~~OK~~
- 213 76+48 conc. spoil sea side @ Exp JT

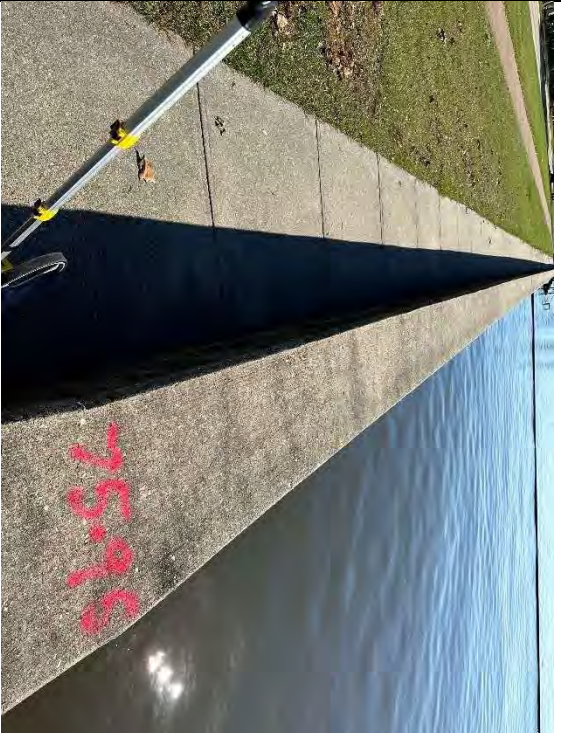
Photo Name: IMG_0294
Inspection Field Notes Photo # : 212
Date: 12-16-22
Approximate Station: Station 75+95 to 76+00
Description: No cracks on either the top side or the land face side of the seawall. Point of curve in the seawall as well.
Coordinates:
Latitude: 30 ; 21 ; 0.8899
Longitude: 90 ; 3 ; 47.2199

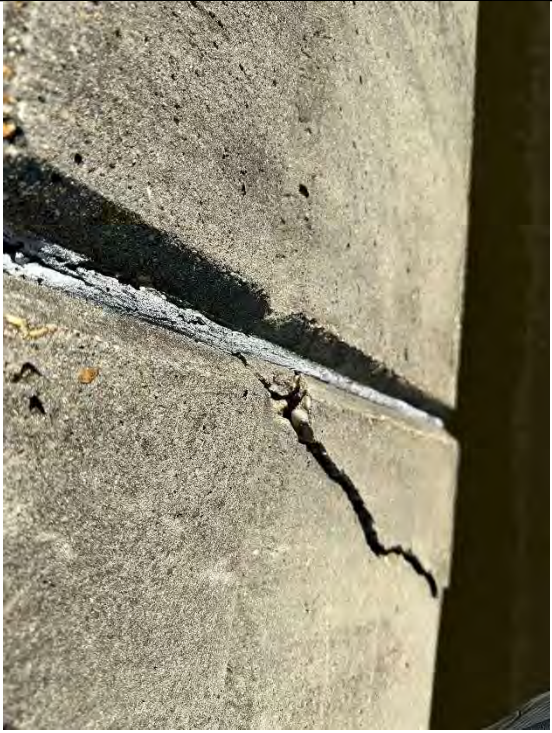
Photo Name: IMG_0295
Inspection Field Notes Photo # : 213
Date: 12-16-22
Approximate Station: Station 76+68
Description: Concrete spall along the seaside face of the expansion joint
Coordinates:
Latitude: 30 ; 21 ; 0.3899
Longitude: 90 ; 3 ; 49.6099

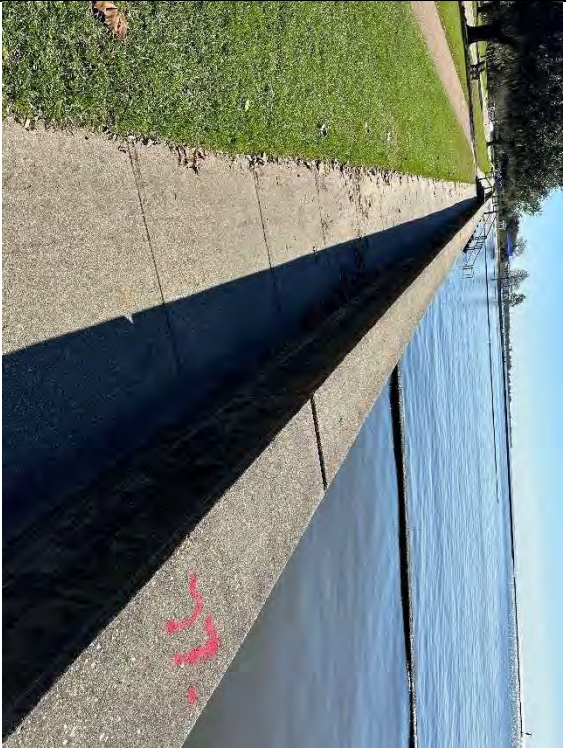
Photo Name: IMG_0296
Inspection Field Notes Photo # : 214
Date: 12-16-22
Approximate Station: Station 77+00 to 77+20
Description: No cracks on either the top side or the land face side of the seawall.
Coordinates:
Latitude: 30 ; 21 ; 0.020
Longitude: 90 ; 3 ; 48.82

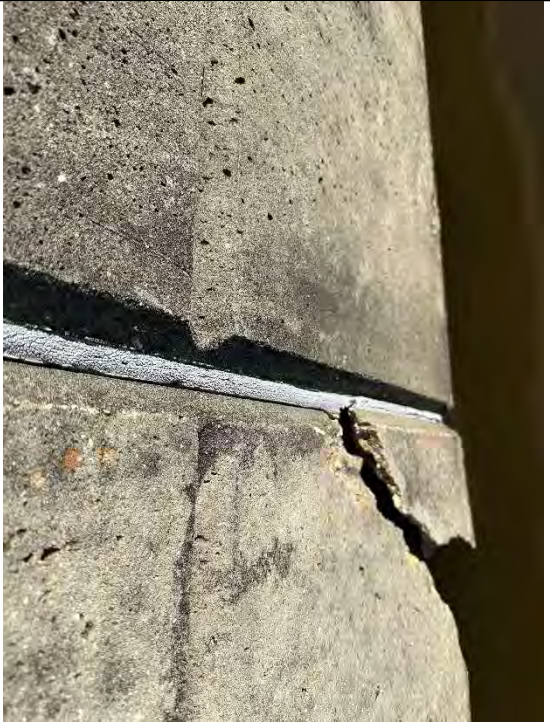
Photo Name: IMG_0297
Inspection Field Notes Photo # : 216
Date: 12-16-22
Approximate Station: Station 77+62
Description: Concrete spall along the seaside face of the expansion joint.
Coordinates:
Latitude: 30 ; 21 ; 0.1199
Longitude: 90 ; 3 ; 47.7999

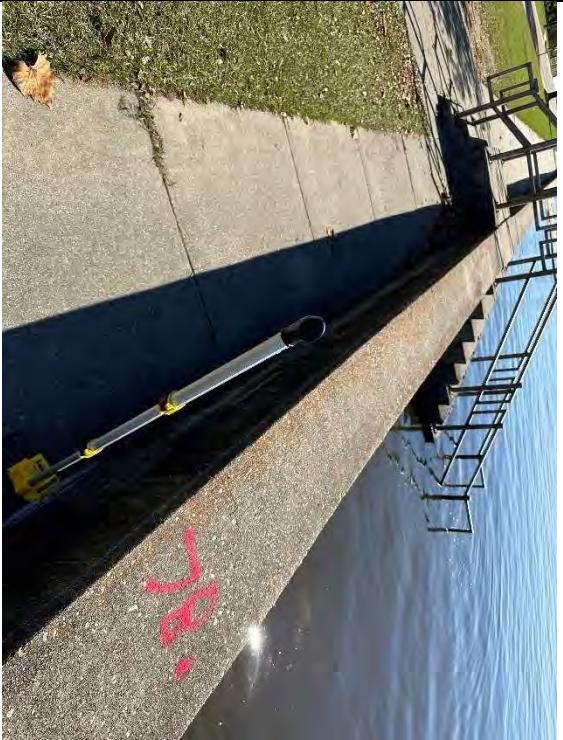
Photo Name: IMG_0298
Inspection Field Notes Photo # : 217
Date: 12-16-22
Approximate Station: Station 78+00 to 79+00
Description: No cracks on either the top side or the land face side of the seawall.
Coordinates:
Latitude: 30 ; 20 ; 59.77
Longitude: 90 ; 3 ; 48.0200

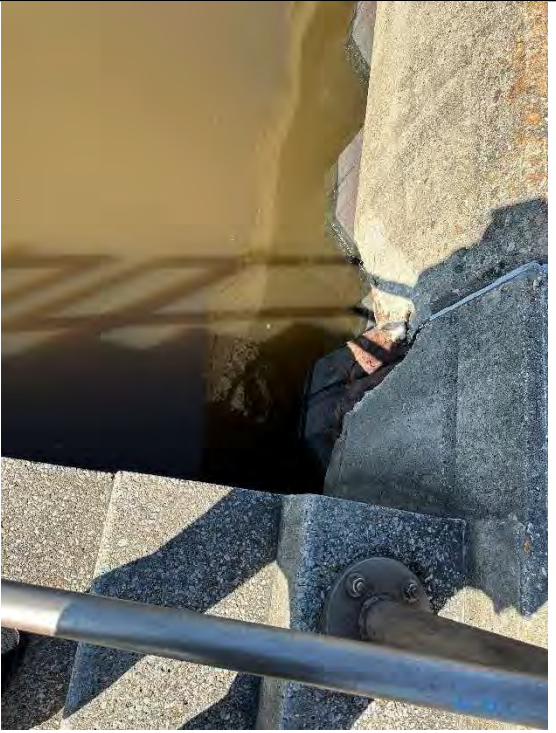
Photo Name: IMG_0299
Inspection Field Notes Photo # : 218
Date: 12-16-22
Approximate Station: Station 78+20
Description: Concrete spall along the seaside face of the expansion joint
Coordinates:
Latitude: 30 ; 20 ; 59.7799
Longitude: 90 ; 3 ; 47.9899

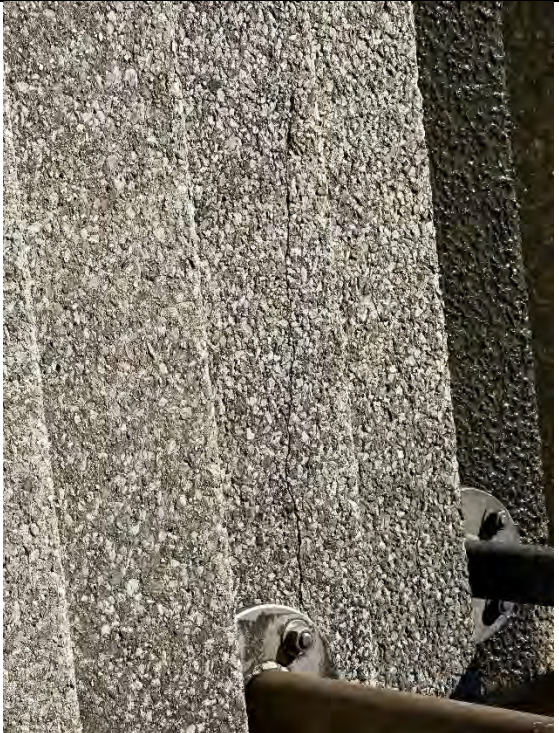
Photo Name: IMG_0300
Inspection Field Notes Photo # : 219
Date: 12-16-22
Approximate Station: Station 78+25
Description: Stairway. One step contains cracks along the seaside face of the stairway.
Coordinates:
Latitude: 30 ; 20 ; 59.4199
Longitude: 90 ; 3 ; 48.0499

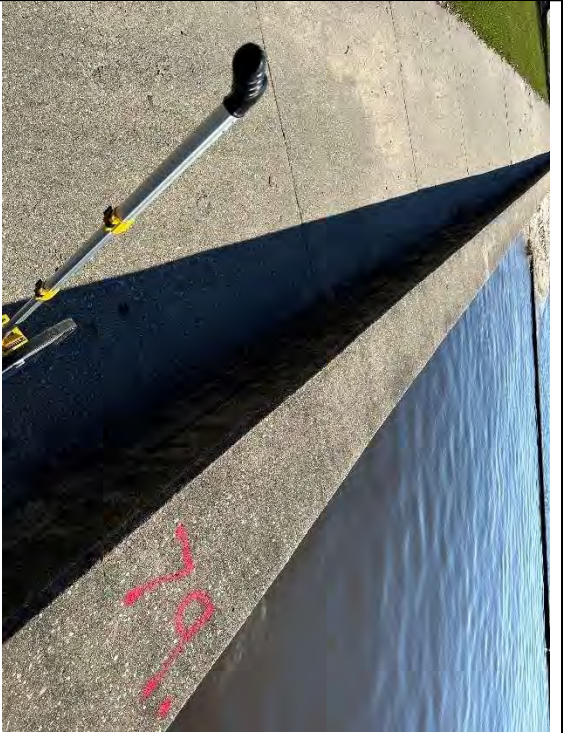
Photo Name: IMG_0301
Inspection Field Notes Photo # : 221
Date: 12-16-22
Approximate Station: Station 79+00 to 80+00
Description: No cracks on either the top side or the land face side of the seawall.
Coordinates:
Latitude: 30 ; 20 ; 59.49
Longitude: 90 ; 3 ; 46.7899

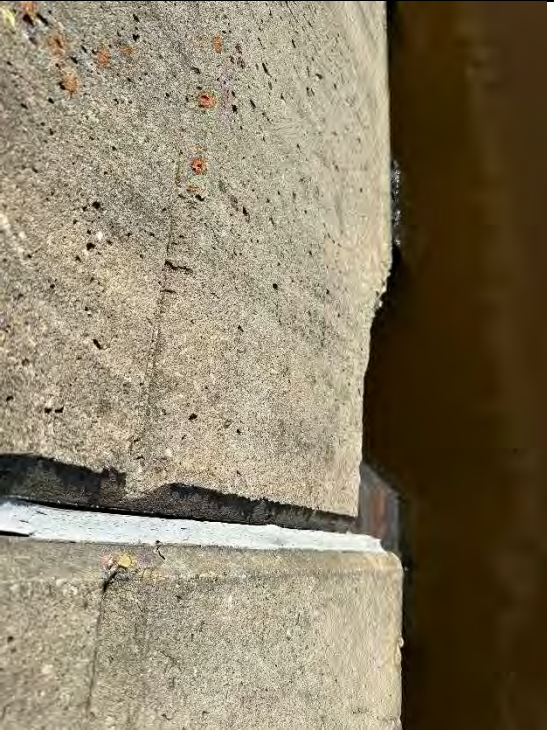
Photo Name: IMG_0302
Inspection Field Notes Photo # : 222
Date: 12-16-22
Approximate Station: Station 79+38
Description: Concrete spall along the seaside face of the expansion joint
Coordinates:
Latitude: 30 ; 20 ; 59.1900
Longitude: 90 ; 3 ; 46.46

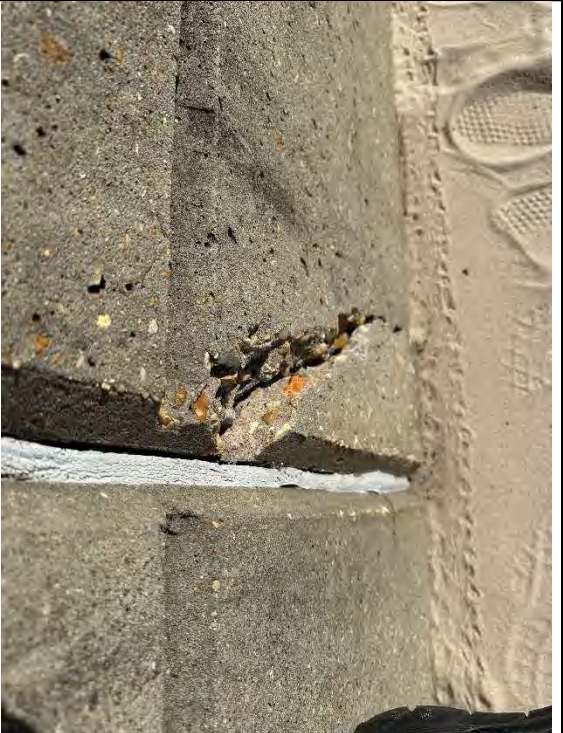
Photo Name: IMG_0303
Inspection Field Notes Photo # : 223
Date: 12-16-22
Approximate Station: Station 79+96
Description: Concrete spall along the seaside face of the expansion joint
Coordinates:
Latitude: 30 ; 20 ; 59.44
Longitude: 90 ; 3 ; 44.1199

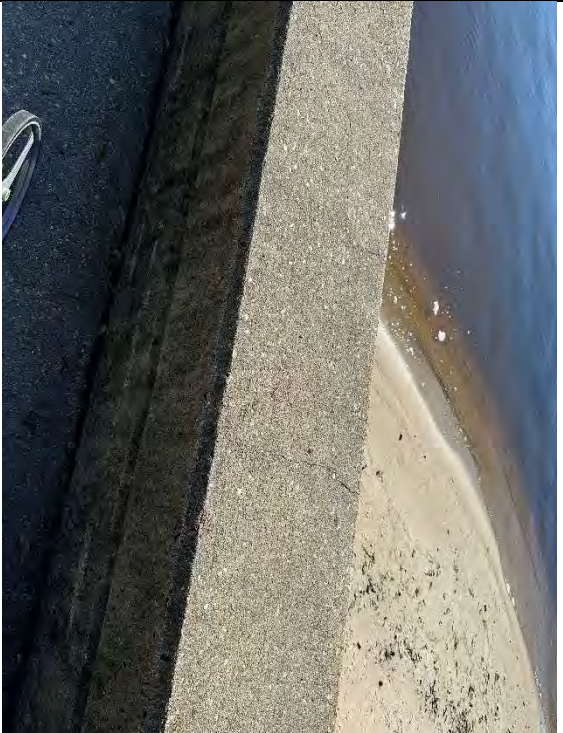
Photo Name: IMG_0304
Inspection Field Notes Photo # : 224
Date: 12-16-22
Approximate Station: Station 80+30 to 80+35
Description: Vertical hairline cracks along the top side of the seawall
Coordinates:
Latitude: 30 ; 20 ; 58.7799
Longitude: 90 ; 3 ; 45.25

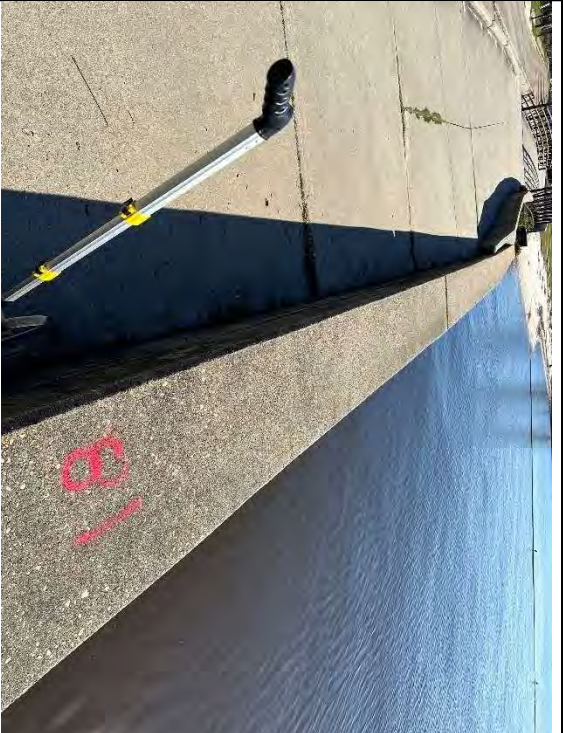
Photo Name: IMG_0305
Inspection Field Notes Photo # : 226
Date: 12-16-22
Approximate Station: Station 81+00 to 82+04
Description: No cracks on either the top side or the land face side of the seawall.
Coordinates:
Latitude: 30 ; 20 ; 58.60
Longitude: 90 ; 3 ; 44.8599

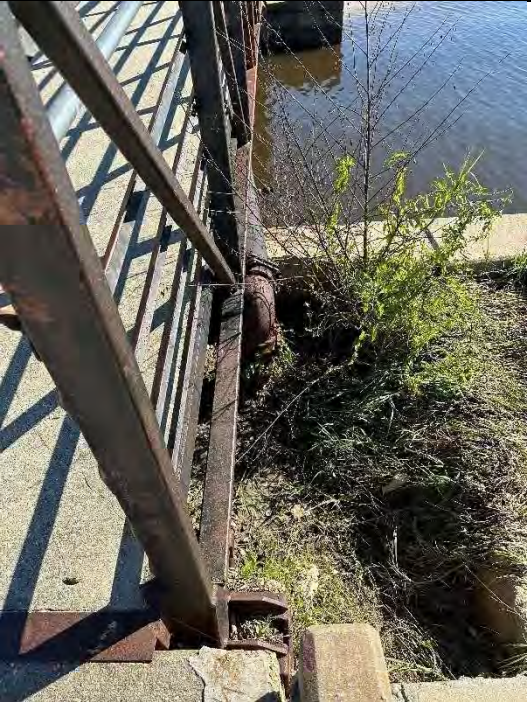
Photo Name: IMG_0306
Inspection Field Notes Photo # : 226
Date: 12-16-22
Approximate Station: Station 82+04
Description: 6" water or sewer line that is running along the bridge across the canal
Coordinates:
Latitude: 30 ; 20 ; 58.22
Longitude: 90 ; 3 ; 44.200

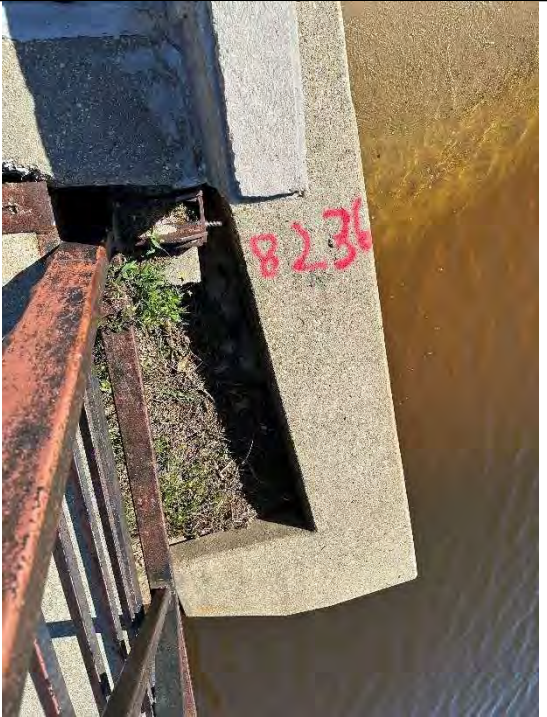
Photo Name: IMG_0309
Inspection Field Notes Photo # : 227
Date: 12-16-22
Approximate Station: Station 82+36
Description: No cracks along the corner of the seawall
Coordinates:
Latitude: 30 ; 20 ; 57.9100
Longitude: 90 ; 3 ; 43.7899

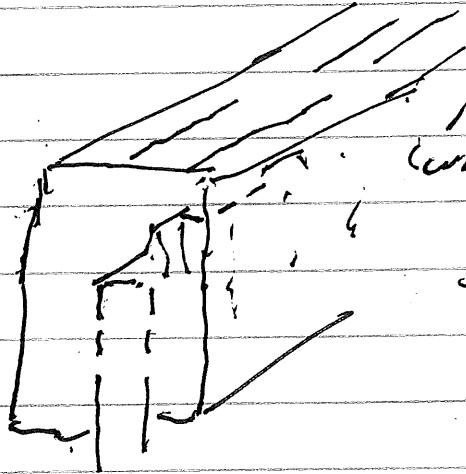
Sample Details

Reflective cracks HORTZ
with Rest spots (sheet pile
