**COM PROJ. NO. 100.21.019
SEAWALL REPAIR (INSPECTION PROJECT)
FINAL FINDINGS/ASSESSMENT REPORT**

The City of Mandeville
1100 Mandeville High Blvd.
Mandeville, LA 70471

Prepared by
BURK-KLEINPETER, INC.
4176 Canal Street
New Orleans, LA 70119

APRIL 2023

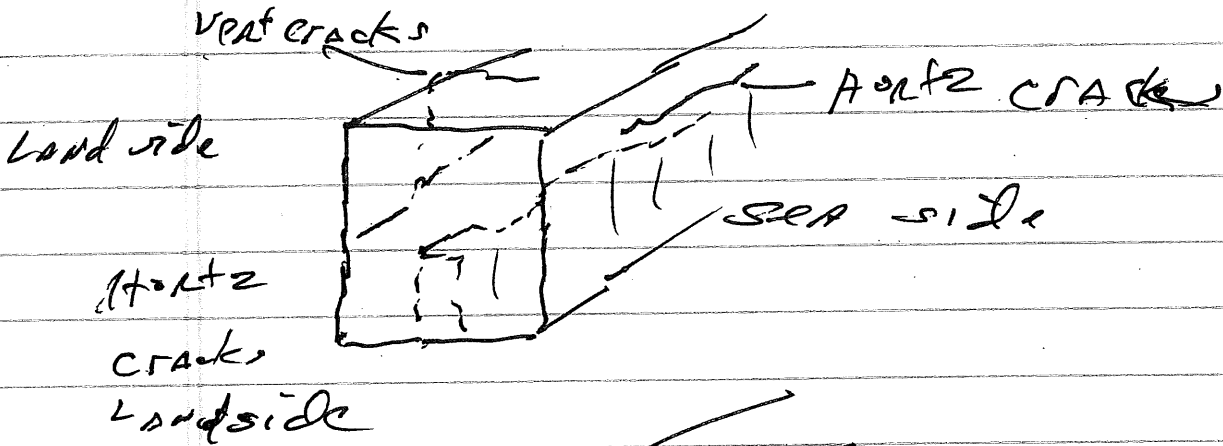
VERT CRACKS
