Table of Contents

CASE SUMMARY SHEET

CASE NUMBER: V25-10-22  
DATE RECEIVED: September 2, 2025  
DATE OF MEETING: October 14, 2025 and October 28, 2025

REQUEST: V25-10-22 – Richard and Linda James request a variance to CLURO Section 7.5.1.3. R-1 Site Development Regulations, Old Town of Mandeville, Square 85B Lots 21-24, 26, 28, 30, 32, 34, & 36, R-1 Single Family Residential District, 527 Albert

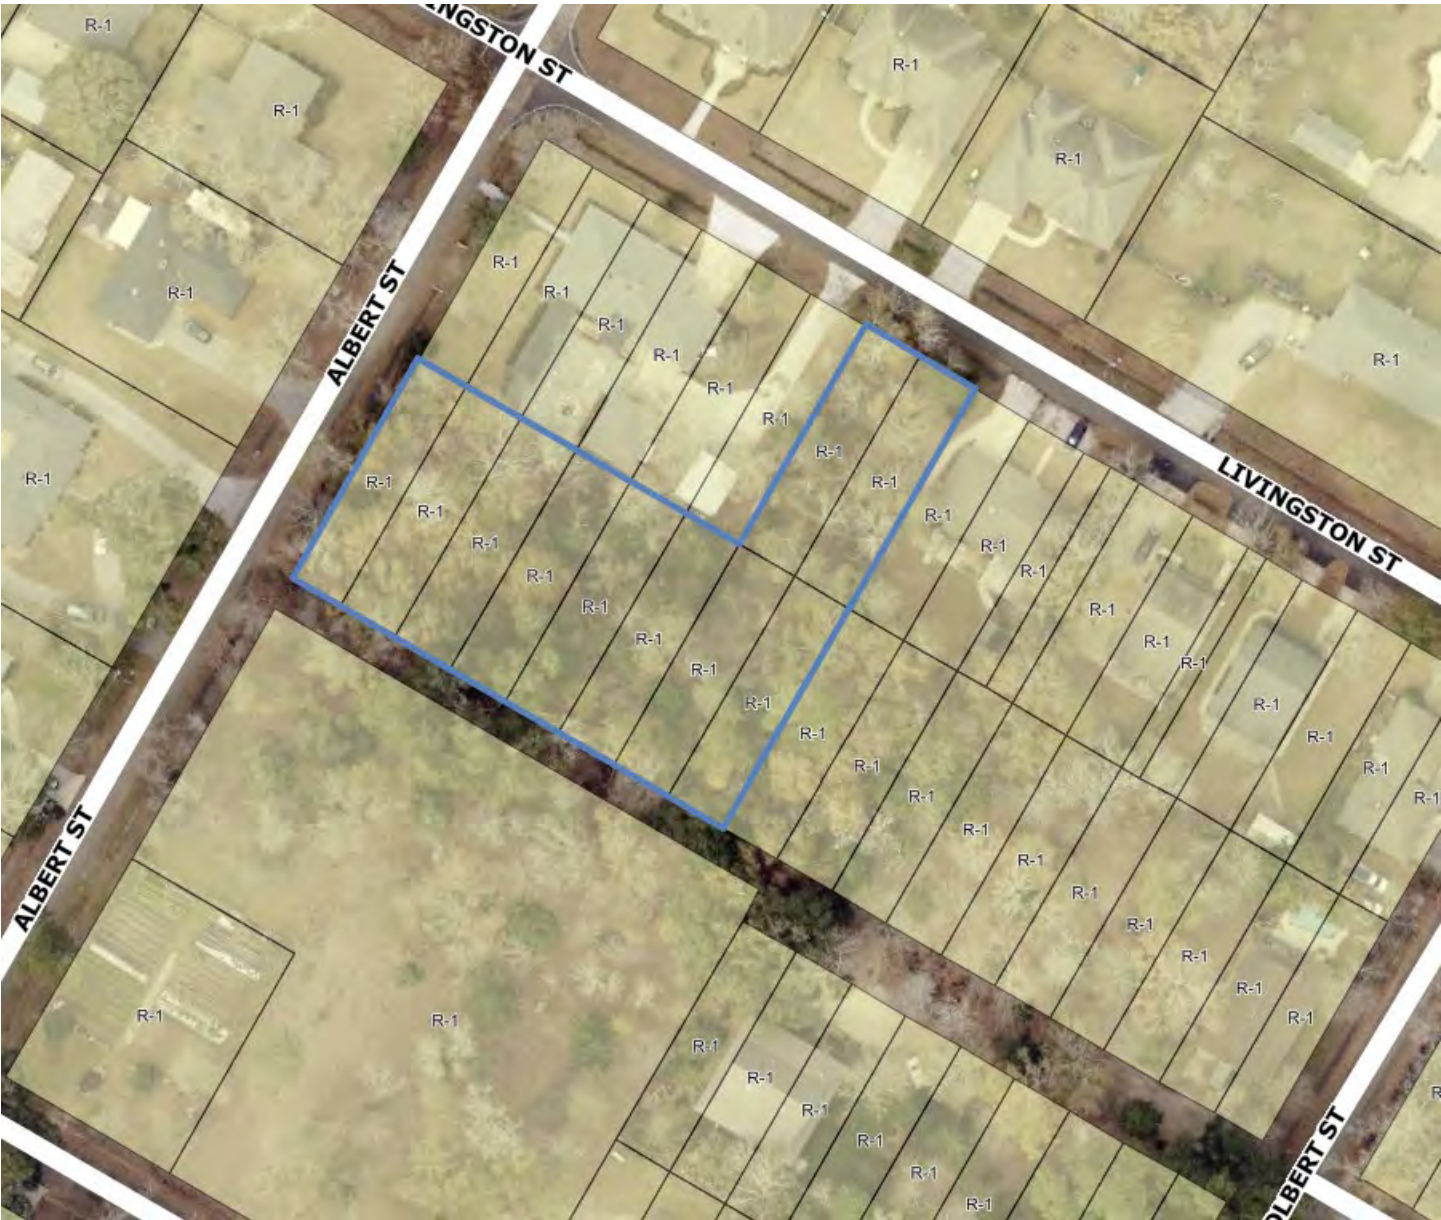
APPROX. LOCATION OF FLOOD ZONE LINE

FLOOD ZONE X  
FLOOD ZONE A10  
B.F.E.=10.0'

HAROLD ST.

(NOT CONSTRUCTED)

THIS PROPERTY IS LOCATED IN FLOOD  
ZONE A10 & X; BASE FLOOD ELEV. 10.0';  
F.I.R.M. PANEL NO.2202020431D;  
REV.05-16-2012

The applicants own the property at 527 Albert Street, located on the east side of Albert St., north of Monroe St., south of Livingston St., and west of Colbert St. The property is an irregularly shaped flag lot, measuring 119’ along Albert St., 236’ along the south property line, 240’ along the east property line, 60’ along Livingston St., then south for 120’, and west for 175’ and contains 35,696 sqft per a survey prepared by Kelly McHugh & Associates and dated 7.31.2025. The property is currently unimproved.

The applicants are requesting to encroach 20’ into the south side setback, up to the property line, to construct a new single-family residence. The south side of the property borders the right of way for the unimproved Harold Street. The eastern half of the Harold Street right of way was previously revoked back in 2008 while the western half remains owned by the City.

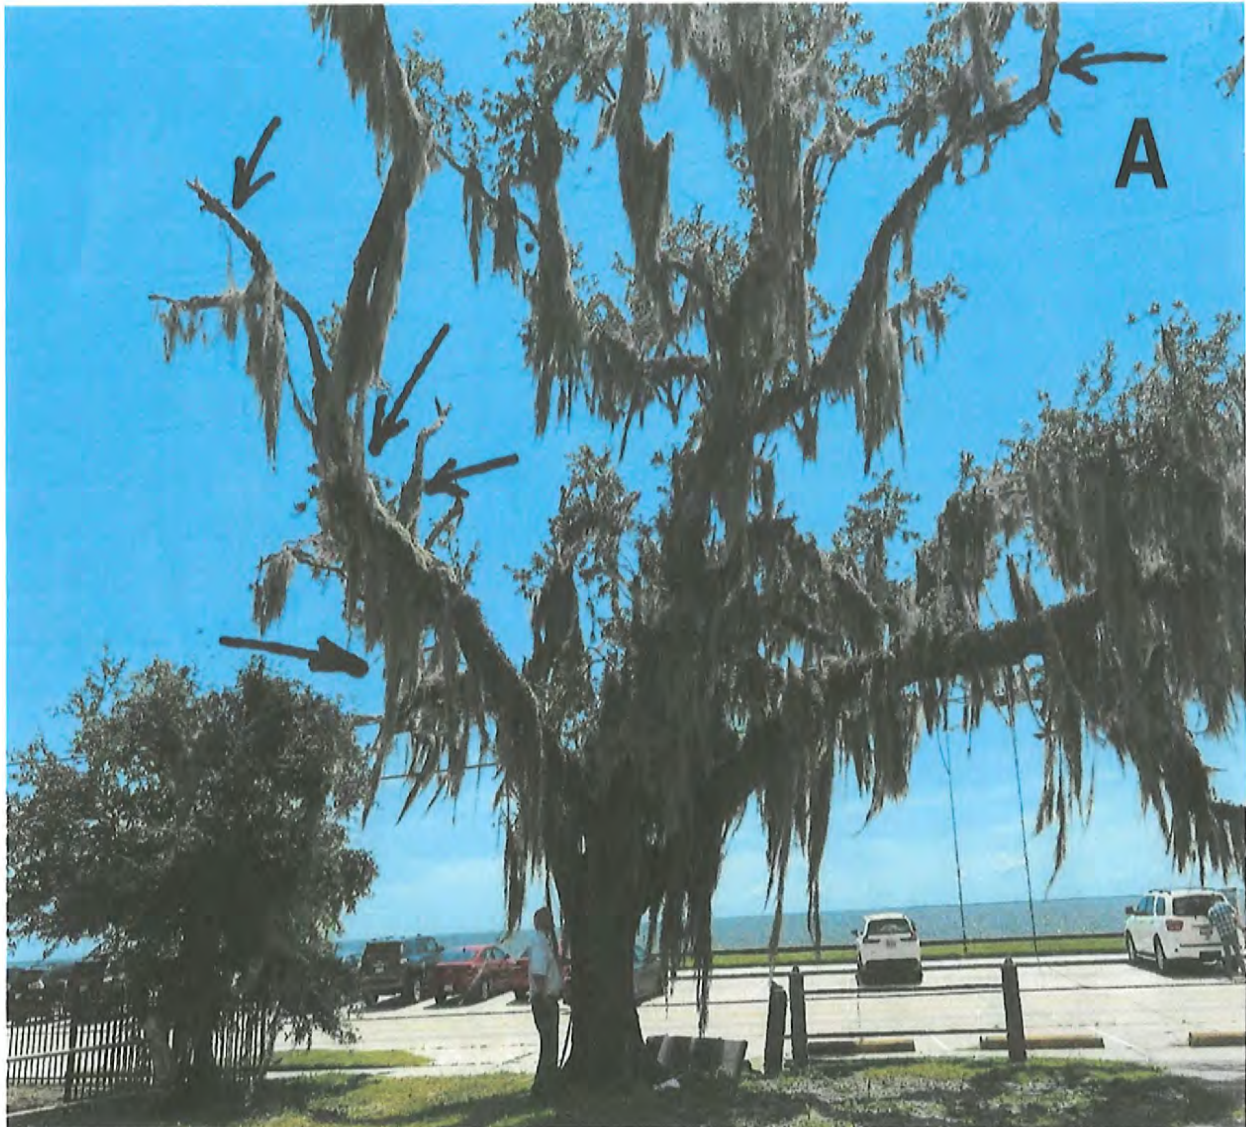
## Photograph A

**The tree exists in a state of decline, note arrows pointing to dead and dying branches.**

There is an old expression, where there is life there is hope, but not for this tree. Efforts to have had benefits to save this tree have long passed many years ago. The tree that was once green and healthy no longer exists. Its beauty and dignity no longer exist. Currently, there exists a very unsightly tree. The current condition of the branched architecture of the tree consists of a few branches which exhibit stress sprouts which is an attempt by the tree to survive. Additionally, there is likely chance of harm to people on the sidewalk beneath the tree where these branches will fall.

Regarding the health and structural condition of the tree, one only needs to see the tree to know the tree is dying. The demise of the tree had everything to do with hard compacted soil which has existed for a very long time beneath its canopy. This problem is not fixable. To do so would require complete replacing of the soil within the root area of the tree. Such an effort at this time would be of little to no benefit to the tree..

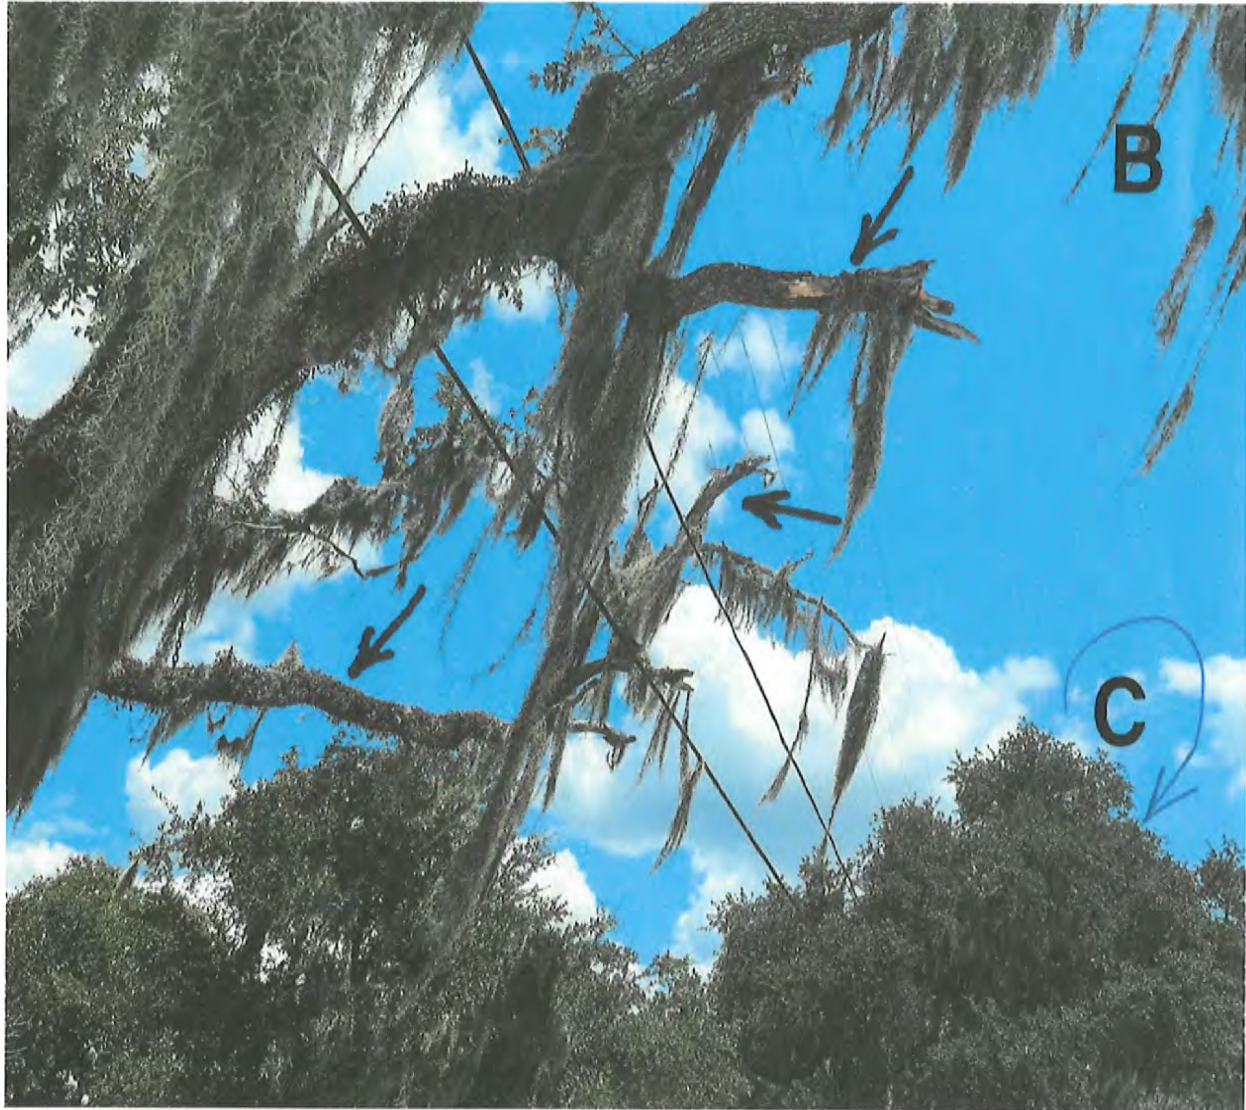
## Photograph B

Dead and dying branches exist throughout the canopy of the tree.

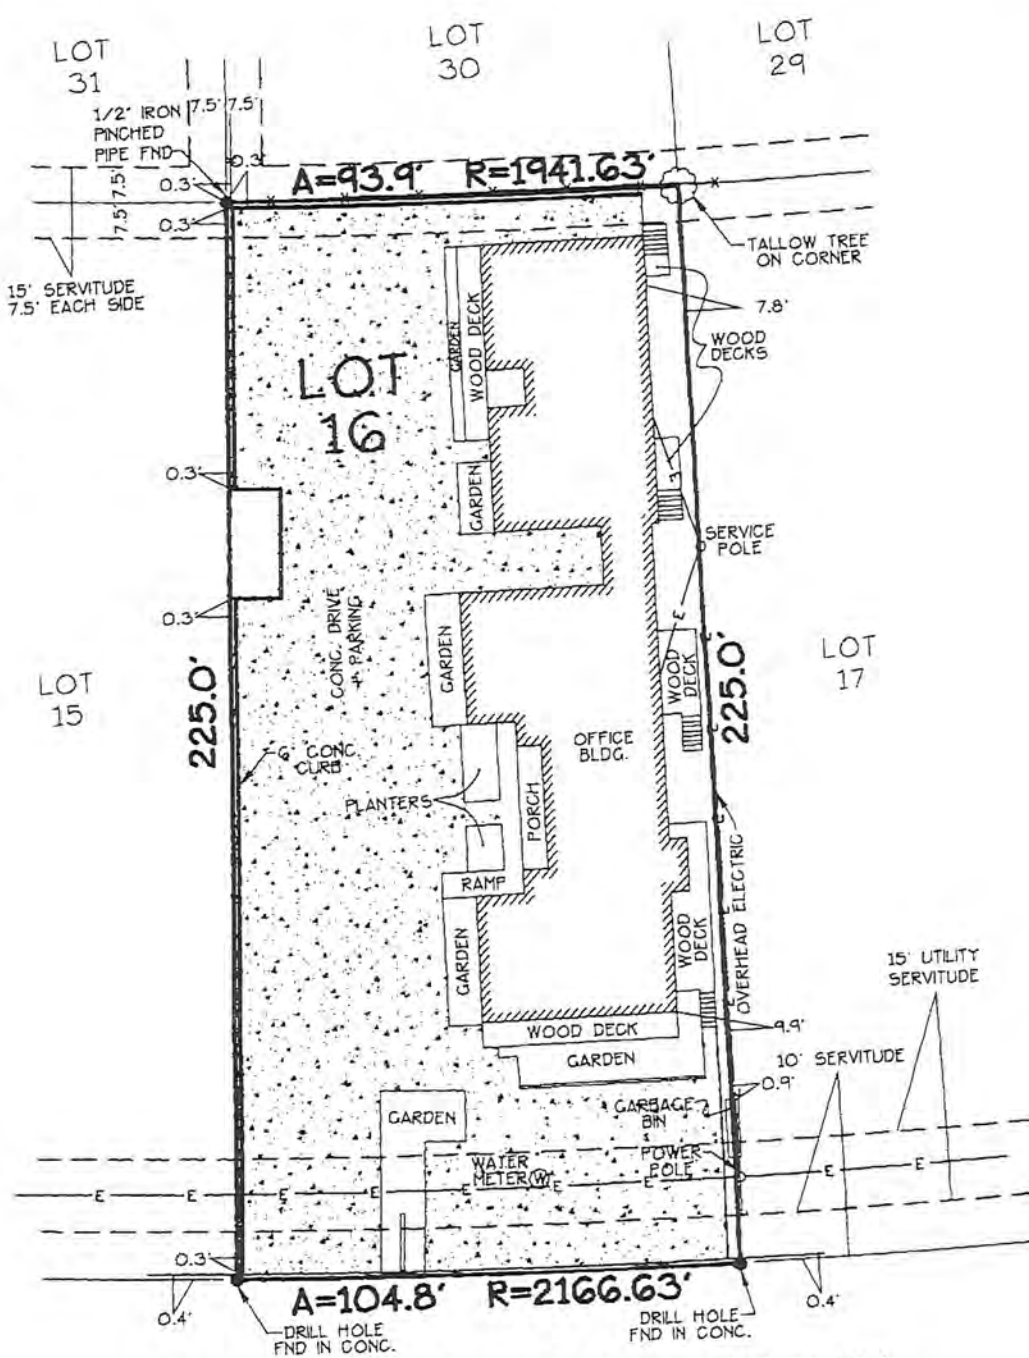
639 LOTUS DRIVE NORTH

Note: This is to certify that I have consulted the Federal Insurance Administration Flood Hazard Boundary Maps and found the property described IS NOT located in a special flood hazard area. It is located in Flood Zone C.

The applicant is looking to purchase and develop the property at 639 Lotus Dr. N. located along Lotus Dr. N just off of W Causeway Approach. The property is slightly irregular in shape, measuring 104’ along Lotus Dr N, 93’ along the rear property line, and 225’ along the sides containing approximately 22,233 sqft per a survey prepared by Randall Brown & Associates and dated 2.01.2001.
